CHICHICA AQUEDUCT SYSTEM

CHICHICA, PANAMA

• International Senior Design 2011

TMC Engineering

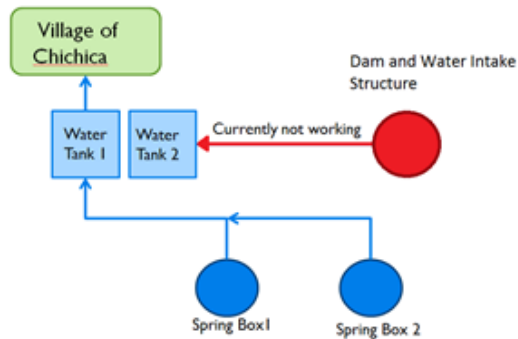
Currently the village of Chichica has three sources of water that are connected to two storage tanks (Figure 2). Two of the sources are functioning and provide Chichica with 10,000 gallons of water daily. Those sources only provide approximately 4.4 gallons (16.7 liters) per person daily, which is below the World Health Organization (Reed, 2005) standard for minimum water requirements. A third source was added along with a 20,000 gallon tank in 2009 but was never functional. This third source has the potential of adding more than 100,000 gal in the wet seasons and 30,000 gallons in the dry seasons. This would provide a range of 17 to 48 gallons (64-177 Liters) per person daily, depending on the season.

Figure 2. Existing water system in Chichica. The intake structure and pipeline noted in red is currently nonfunctional.

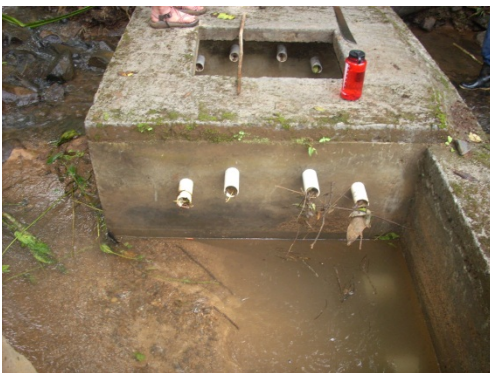
The intake structure consists of a dam on a small creek and a modified spring box. It is remotely located approximately three miles from the village and requires hiking from the main road a third of mile up a steep valley. The intake box is located directly behind the dam and has 2" intake pipes that are placed parallel to the flow of the river as seen in Figure 3. During the wet season, when there is increased flow and sediment in the water, the intake box and the area directly behind the dam fill up with sediment. The area behind the dam is normally filled with large stones. Within a few days of heavy flow the intake box becomes filled with sediment and the large stones need to be moved to clean out the sediment. This is a labor intensive job and requires frequent checking.

Figure 3. Current intake structure attached to the dam.

It is recommended that a new intake structure be constructed and the old intake structure removed. The constraints for the intake structure are: (1) no more than fifty percent of the river can be diverted during the dry season, and (2) the intake should filter out sediment in the water during high flows. The existing dam will be used, and all the existing pipes through the dam will be closed. The new structure will be placed on the west river bank. This structure consists of an intake entry perpendicular to the flow of the river. The amount of water entering the intake structure will be regulated by the spillway. The intake spillway will be built to the exact elevation and width as the spillway on the dam. This will prevent too much water from being diverted from the river during the dry season. The intake structure itself is 16' long, 8.5' wide, and 6' tall. All of the walls will be 6" thick and reinforced by rebar. It has three evenly spaced wing walls inside it to slow the water down as seen in Figure 18. The retention time of the water is designed to be 30 minutes so that all of the large and some of the small particles will settle out. The sand filters at the end of the pipeline will filter out the rest of the particles before the water is distributed to the community. See calculations in Appendix K.

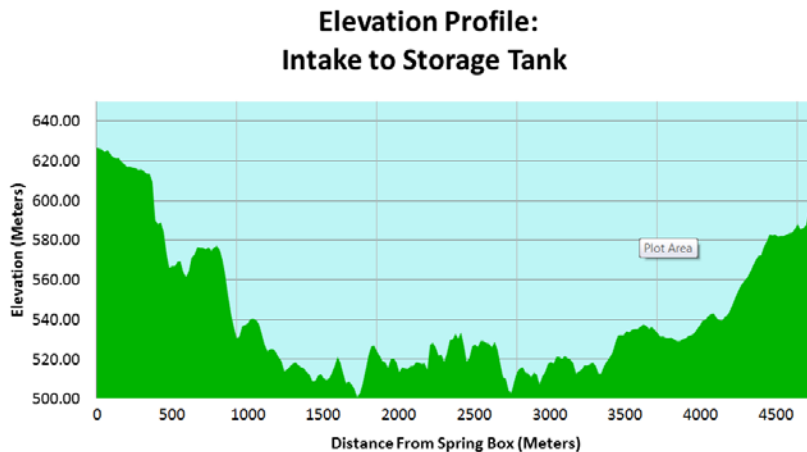
The pipeline is approximately three miles long and is made of 4" SDR 26 and Schedule 40 PVC pipe. As seen in Figure 4 the pipeline drops down into a large valley before heading up to the storage tank located in Chichica. The pipeline goes over multiple small hills and spans several creeks. At the creek crossings, the pipeline is suspended by a cable. At these points the pipes are exposed without any protection from ultraviolet radiation. The pipeline is buried except for a section in the middle of the pipeline. This section has multiple breaks and is located in farmland that is frequently burned to kill vegetation. Because of this, much of this section is scorched. Only two air relief valves were found on the pipeline.

Figure 4. Pipeline elevation profile from the river intake (left) to the storage tank (right).

A section of approximately 7550 feet of pipeline will need to be replaced with 4" schedule 40 PVC pipe. These sections are located in the highest pressure areas in the middle of the pipeline. Because these sections of pipe have not been buried, they have been extensively damaged by UV exposure and agricultural field burns. These sections are noted in Appendix G. Trenches will be dug prior to laying the new pipe. The new pipe will be laid using the same alignment as the previous pipeline and should be buried with at least 36" of cover (Jordan, 1980). In the two suspended valley crossings that will be replaced, the original cable spanning the gorge along with the concrete footings will be reused. The pipe will be tied every 24 inches using 1 mm rebar tie wire on one foot centers. The exposed pipe will be painted to reduce UV exposure. A cleanout valve should be added to the pipeline. The location and maintenance procedure is outlined in Appendix F. Detailed drawings of the cleanout valve are located in Appendix H.

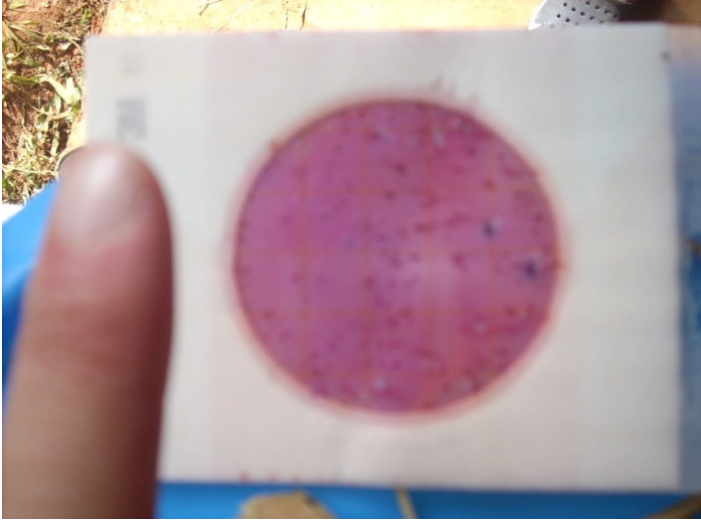
Eight 3M Petrifilm tests were taken from the Chichica water supply. Three samples were taken upstream of the broken spring box, two samples were taken at the functioning spring box, two samples were taken from the Peace Corps volunteers' tap water, and one sample was taken from the Peace Corps volunteer's water bucket. Samples were taken upstream of the broken spring box to determine the quality of water in the stream and compare it to the quality of water from the other spring boxes. The samples taken at the functioning spring box were obtained to test the spring water going into the existing system. Water samples from the Peace Corps tap water were taken so the source water can be compared with the distributed chlorinated water samples. The sample taken in the Peace Corps water tank was taken to estimate what amounts of contamination occur during water storage. Figure 9 shows an example of a completed 3M Petrifilm test. This particular sample was taken from behind the broken spring box. The blue dots indicated E. coli, while the red dots indicated coliforms.

Figure 9. Completed 3M Petrifilm test

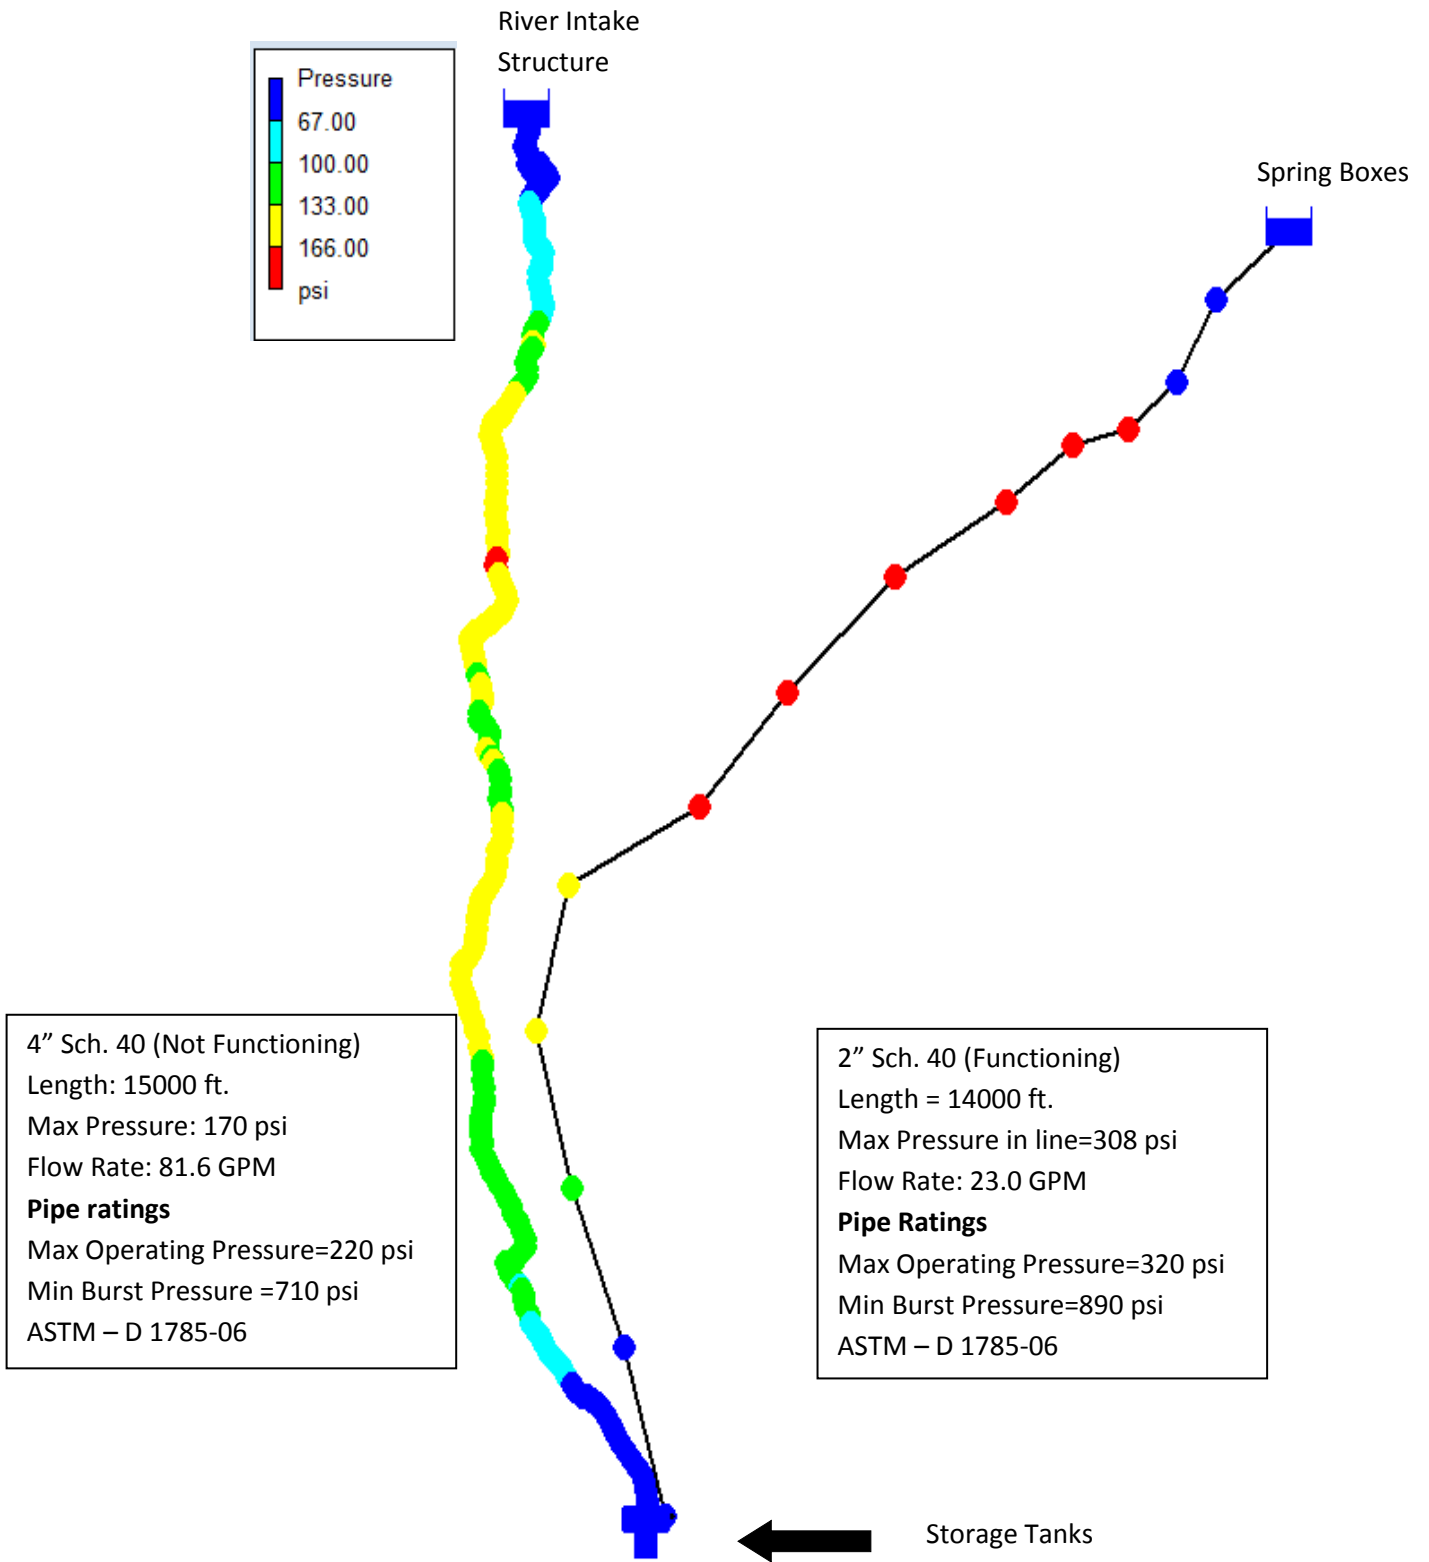
Another issue that arose was the analysis of why the pipes burst in the first place. Since we have now determined that, according to the EPANET simulation, the maximum pressure in the pipeline was not exceeded, alternate causes were examined. It has been hypothesized, based on the fact that the line claimed to be working for the first 20 minutes, the initial surge of the water flowing through the pipes may have caused the pipes to burst. It is also possible that air pockets in the pipeline stopped the flow completely and caused the dynamic pressure to be converted to static pressure. Another potential reason for the bursting pipes is poor quality pipes or improper installation. In the field study, many pipes had small patches placed on them to fix cracks or holes. These homemade patches or homemade couplings could also have been causes for the pipes to fail.

Figure13. EPANET simulation showing the two pipelines feeding the Chichica water system. The node colors correspond to different pressures as seen in the upper left key.

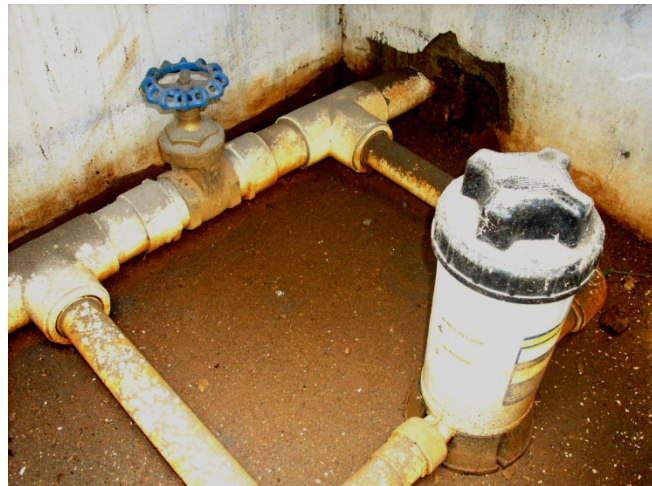
The village of Chichica currently has an in-line chlorinator connected to their gravity-fed potable water system. The current operating system consisting of two spring boxes and one 10,000 gallon tank utilizes the present chlorinator by adding chlorine tablets supplied by the government free of charge. It is unclear as to how often the chlorine tablets are changed and what condition they are in at the time the refill takes place. Essentially, the chlorinator delivers a controlled dosage of chlorine that is sufficient to inactivate most disease-causing organisms. As show in Figures 14 and 15, the flow of water is directed to the center of the chlorinator, allowing a portion of the flow to encounter the chlorine tablets. This drawing does not represent the exact chlorinator found in Chichica, but the function is the same. If the flow of water is increased, the water travels upward in the chlorinator stand pipe and comes in contact with a greater amount of surface area of the tablets. This ensures that no matter the flow rate, the concentration of incoming chlorine will, for the most part, remain constant.

Figure 15. Chlorinator connected in parallel on the 2" waterline in Panama.

The residual chlorine concentration present in the tank and distribution system is a function of organic matter found in the water. Since the water in the tank was not tested, it is recommending that a chlorination test kit be purchased and the testing be performed. Based on this test, the water committee will know how many chlorine tablets are necessary and how often they need to be changed to keep the residual chlorine level at World Health Organization drinking water standards of 0.2 to 1.0 mg chlorine/L water (Guidelines 2011). The basic calculations for various amounts of tablets may be found in Appendix E and are provided simply as a reference. These calculations do

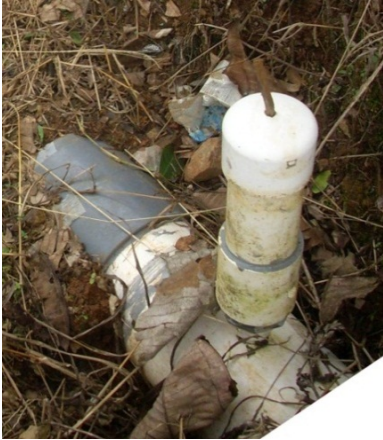
Figure16. Homemade air relief valve used on the working waterline.

feeding the village. These valves are homemade and maintained by the water committee as seen in figure 16. Similar valves will be constructed and placed along pipeline. Reinforced concrete boxes will be constructed to be placed over the valves and protect them. Drawings of the air relief valves and the protective boxes can be seen in Appendix H. An estimated eighteen air relief valves are needed to adequately relieve the system of air pockets. These valves will be placed along the main peaks in the water system. These locations are mapped out in Appendix I.

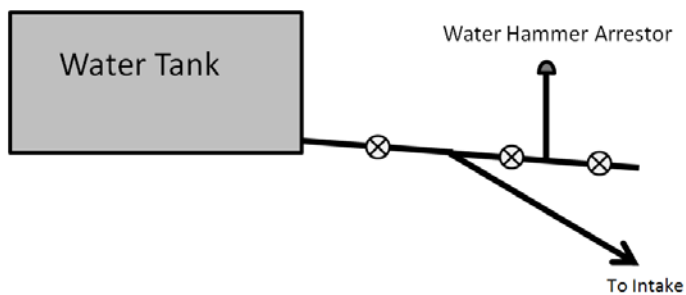
Water hammer is caused by closing a valve on the system too quickly. This can cause pressure waves to travel through the pipeline. In a system of this size, water hammer can cause a surge of up to 220 psi if the valve leading to the storage tank were to be closed quickly. This pressure surge would be added to the dynamic pressure and could cause damage to the system, especially in the high pressure areas. To counter this potential problem, a water hammer arrestor valve will be added directly behind the valve leading to the storage tank. The arrestor consists of a 4" PVC standpipe 24 inches tall. This can be seen in figure 17. Details of the arrestor valve can be seen in Appendix H. Calculations for sizing the arrestor and calculating pressure surges can be found in Appendix J. The arrestor has two valves on the line that allow the standpipe to be drained. More details of this procedure are found in the maintenance manual in Appendix F.

Figure 17. Water hammer arrestor located directly behind the storage tank.
