Road and Drainage Project in the Los Bosques Neighborhood

2007 International Senior Design: Santa Cruz, Bolivia

Integrated Stormwater Solutions
Ryan Biehl • Travis Ostrom • Cindy Schafer

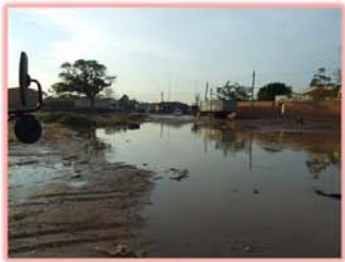
Figure 1: Flooding in the market area. Currently the market is a relative low spot where water collects with no effective outlet.

Flat terrain coupled with heavy rainfall leads to frequent flooding along the 5th Ring road. The market area within the project site is especially affected by the flooding. Standing water creates breeding grounds for mosquitoes which carry diseases such as malaria and dengue fever.

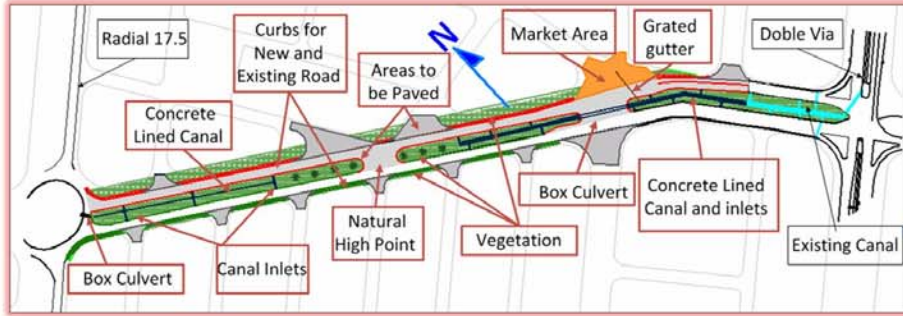
Figure 3: Recommended Design outlined in red, existing structures outlined in black

- Divide drainage system at natural high point
- Construct open trapezoidal concrete lined canal
- Pave 2nd half of 5th Ring with curbs
- Install box culvert at market area and Radial 17.5
- Pave market entrance area
- Install grated gutter to drain market area
- Install sidewalks
- Pave side street entrances with curbs
- Grade side roads
- Plant vegetation within project area

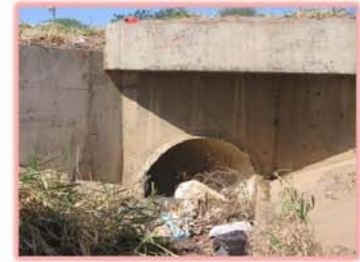
Figure 2: Culvert leading from existing canal to Doble Via. Regular cleaning of the existing and proposed canals is essential for proper functioning.

The project site is located along the 5th Ring between Doble Via La Guardia and Radial 17.5 road. A portion of a concrete lined canal already exists on the 5th Ring road. Only one side of 5th Ring road is paved. Culverts lead into the underground storm sewer along Doble Via and also into the earthen canal along Radial 17.5. Within the project area there is a market and multiple truck tire changing businesses.
