# CHICHICA AQUEDUCT SYSTEM

## NGOBE-BUGLE COMARCA, PANAMA DESIGN FALL 2011

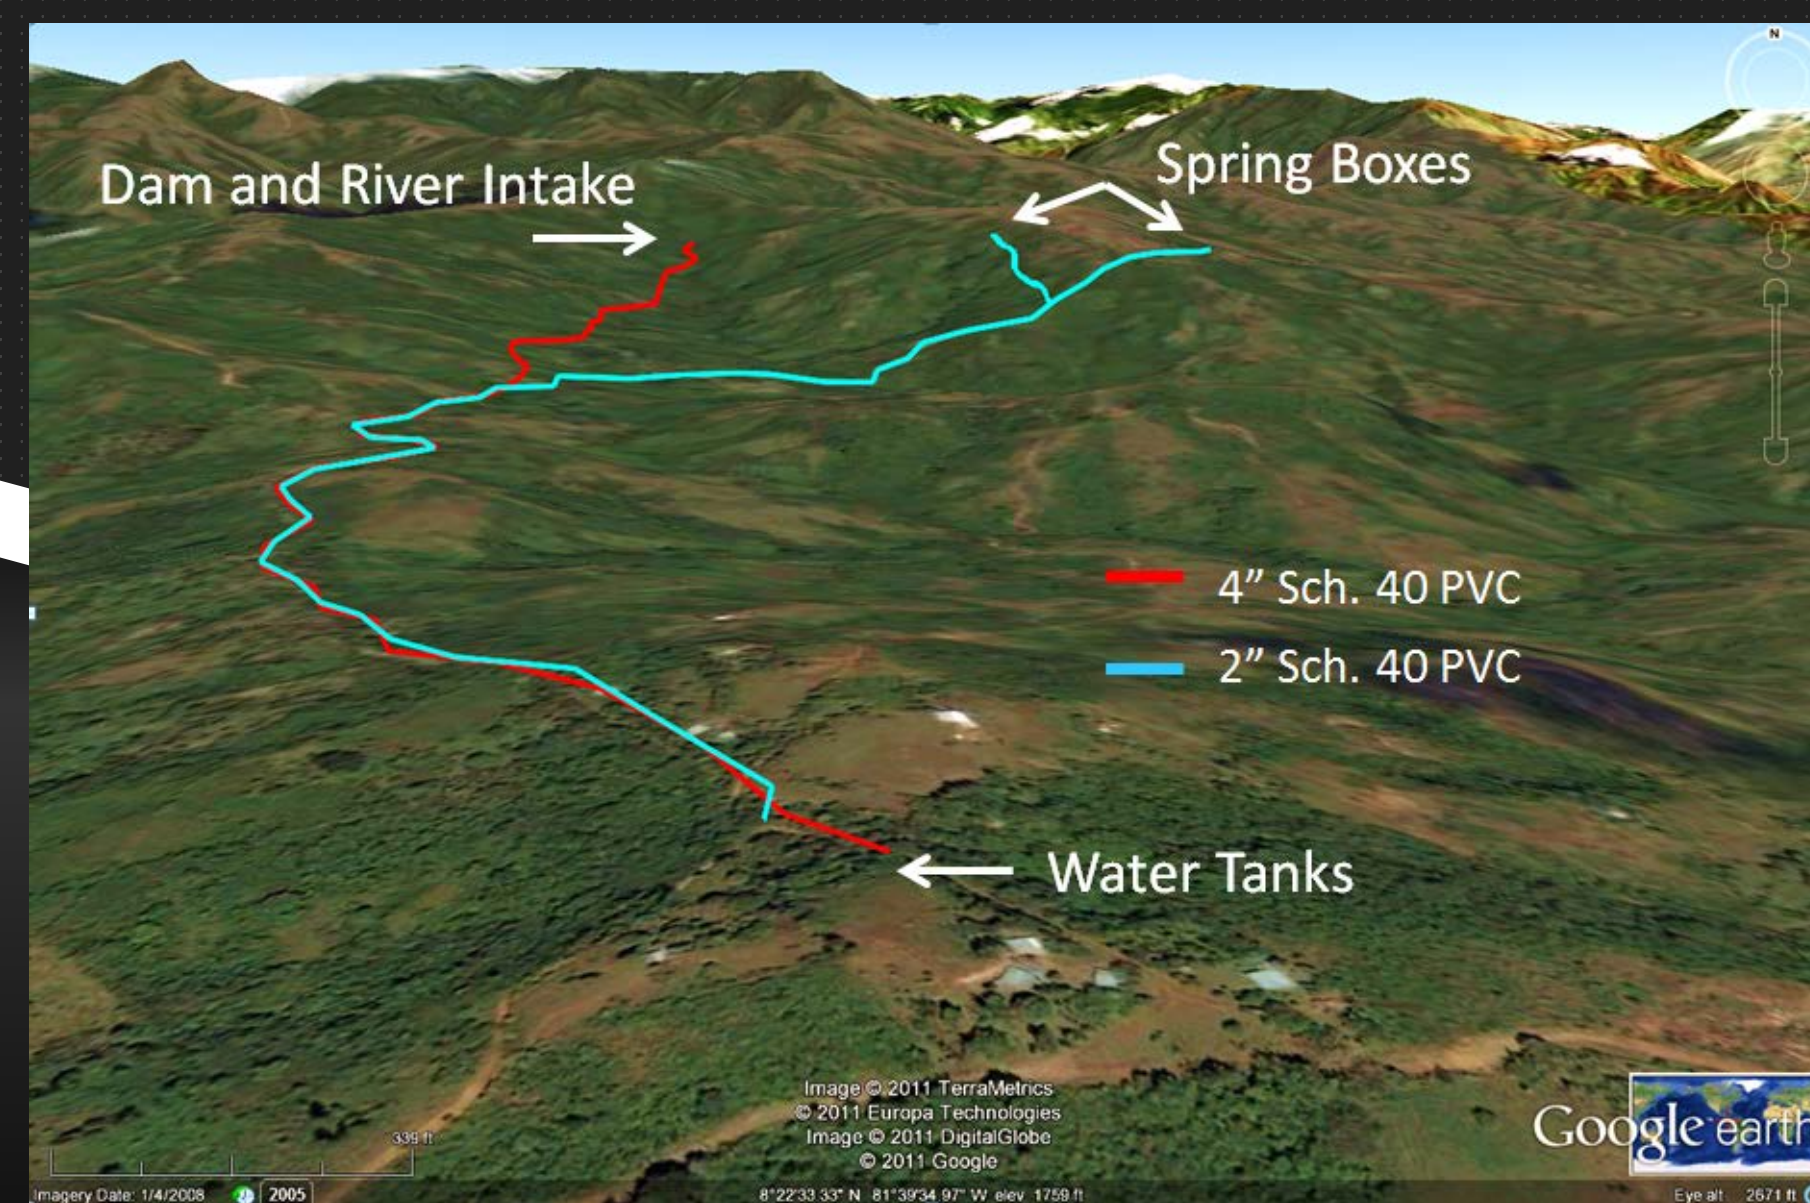
Pipeline routes to storage tanks

We determined that a survey of the existing pipeline would need to be conducted in order to determine the elevation and pressure differences from the intake structure to the collection tank. We used an abney level, compass, and GPS unit to collect this data. The existing intake structure needed to be rebuilt to prevent sediment buildup. Therefore, measurements were taken of the intake structure. A functional chlorinator and sand filters were found on site. To determine the water quality, a 3M Petrifilm Testing Kit was used to test several sources of water in the area.

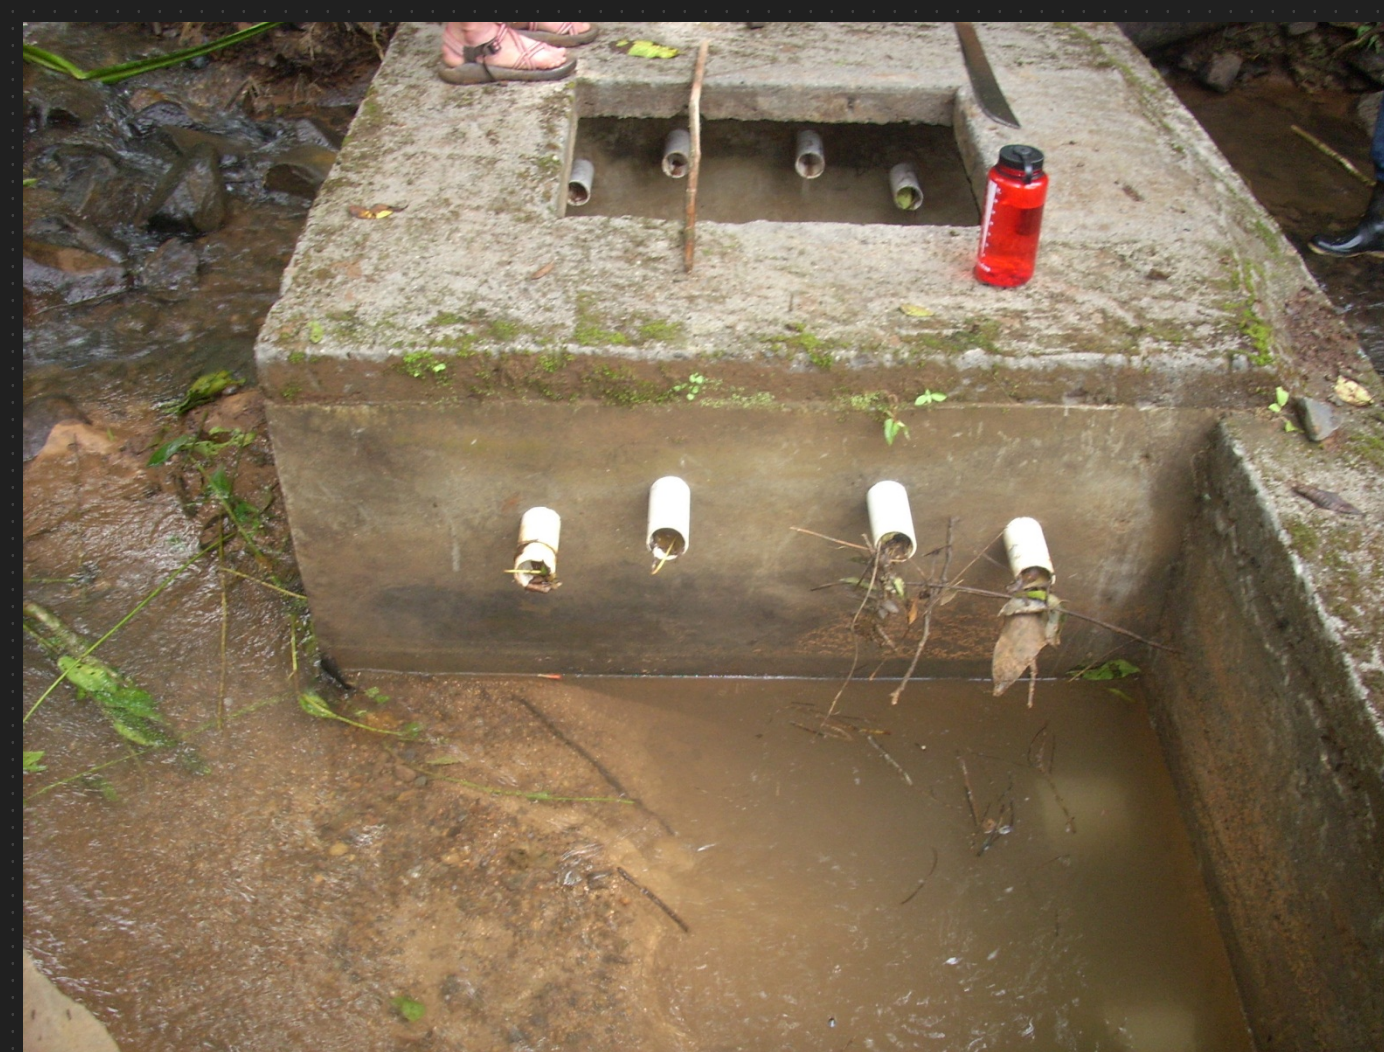
Existing small Intake structure attached to dam.

It is recommended that a new intake structure be constructed and the existing intake structure removed. The existing structure can be seen below (left). In the final design, the existing dam will be used, and all the existing pipes through the dam will be closed. The new structure will be placed on the west river bank. An AutoCAD drawing of the structure is shown below (right). The structure consists of an intake entry perpendicular to the flow of the river. The amount of water entering the intake structure will be regulated by the spillway. The intake spillway will be built to the exact elevation and width as the spillway on the dam to ensure that no more than 50% of the river is diverted in the dry season. The walls will be 6" thick and reinforced by rebar. It has three evenly spaced baffles inside it to increase the flow length and settling time of the water.

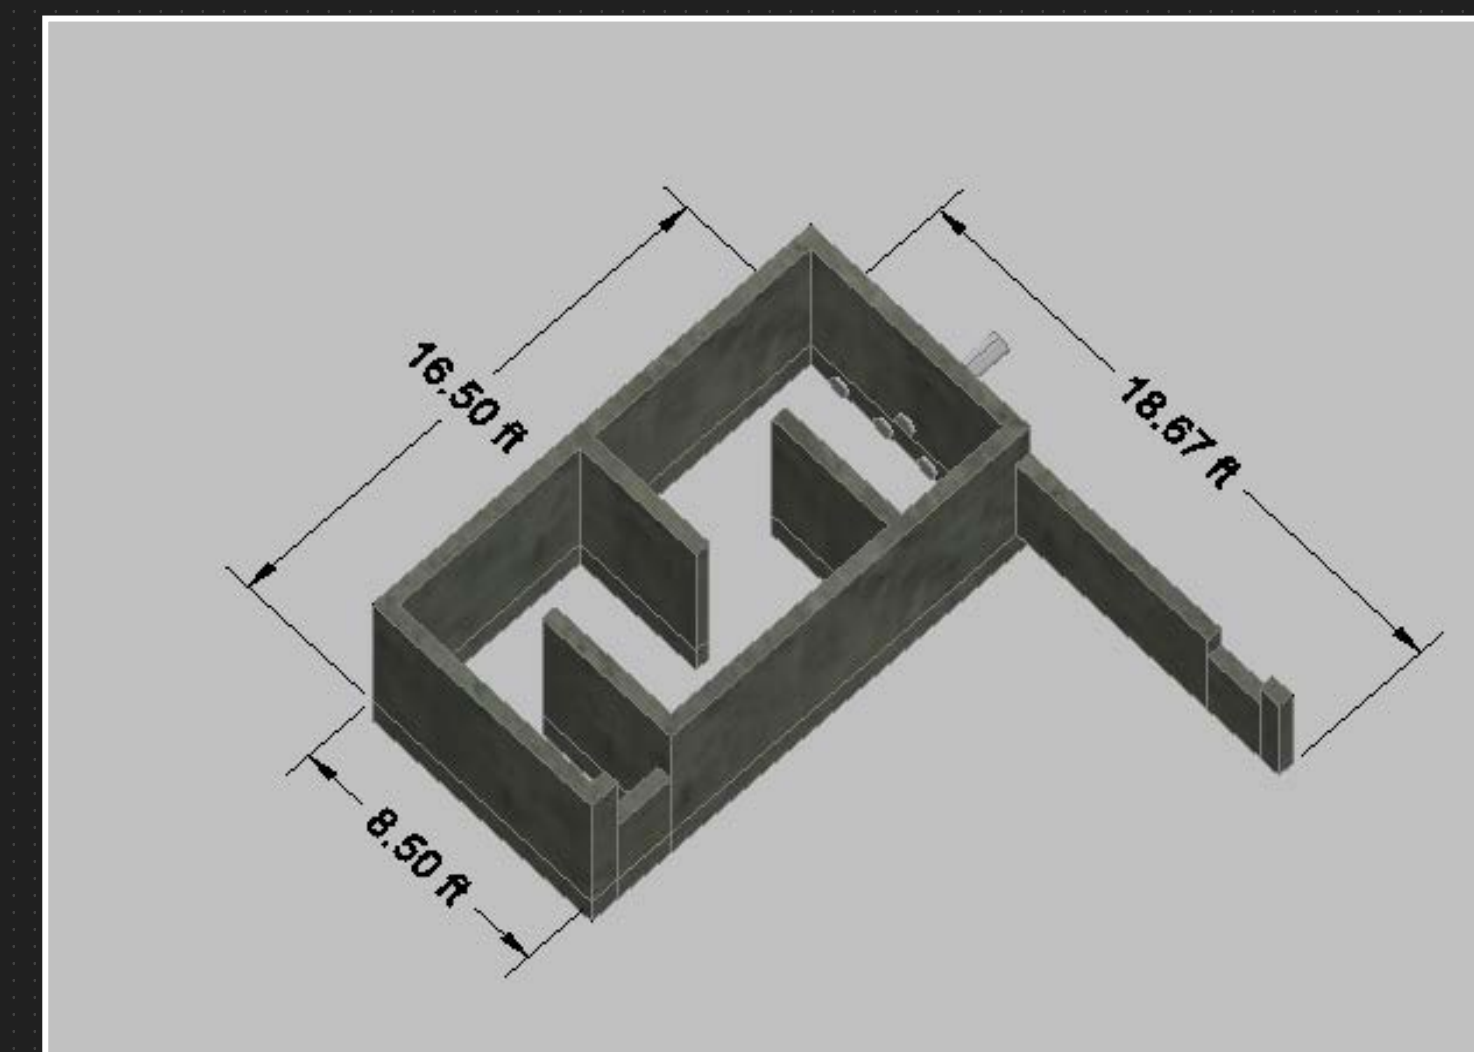
Intake structure design

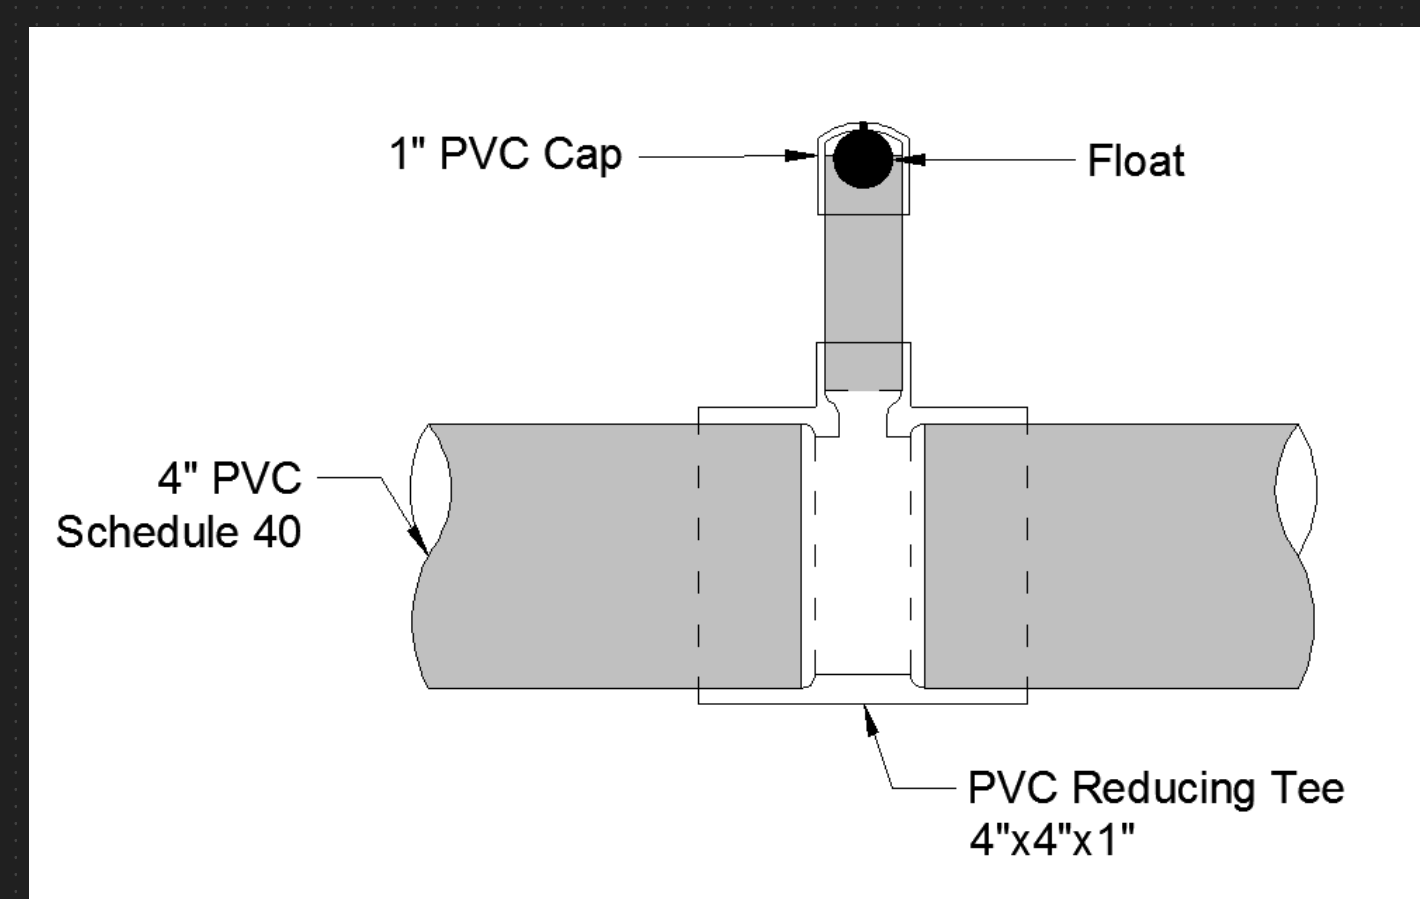
Air relief valve

Approximately a third (7550 ft) of the existing pipeline has been exposed to sunlight and fire from slash and burn farming techniques. This malfunctioning pipe section will be replaced with buried 4" Sch. 40 PVC pipe. In addition, 18 air relief valves will be added at the high points in the pipeline to prevent air pockets from blocking the flow in the pipeline. These valves are easily made from commonly found PVC material and have been successfully used on the other pipeline. The valves are shown in the below figure (left). In addition, a water hammer arrestor will be added near the storage tank to prevent damage due to pressure surges associated with closing the waterline. This can be seen in the figure below (right).

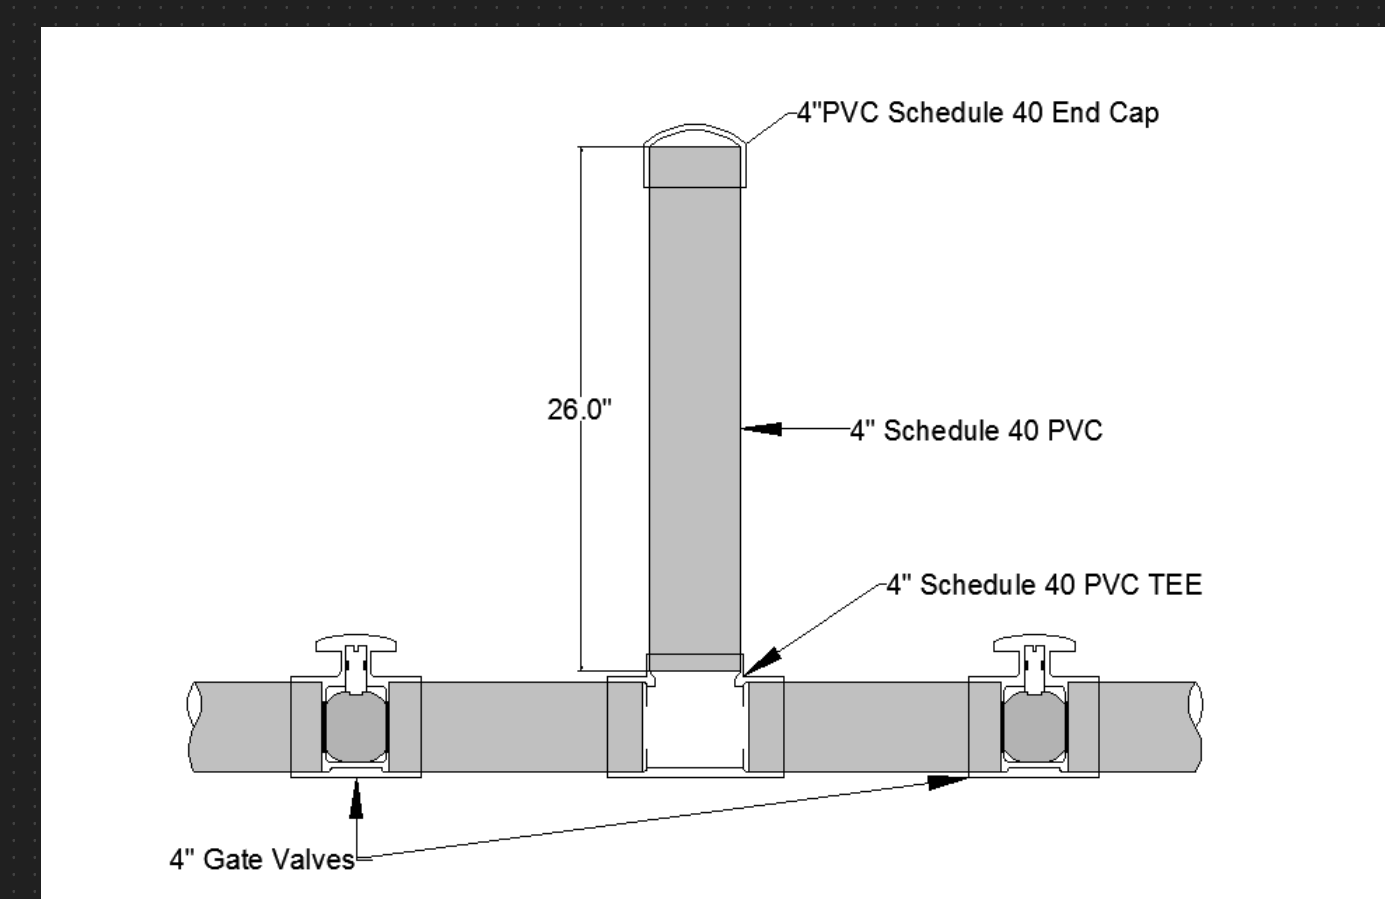
Water hammer arrestor
