# Water for Honey Hill: Supplying Water to the Community of Cerro Miel

International Senior Design 2012

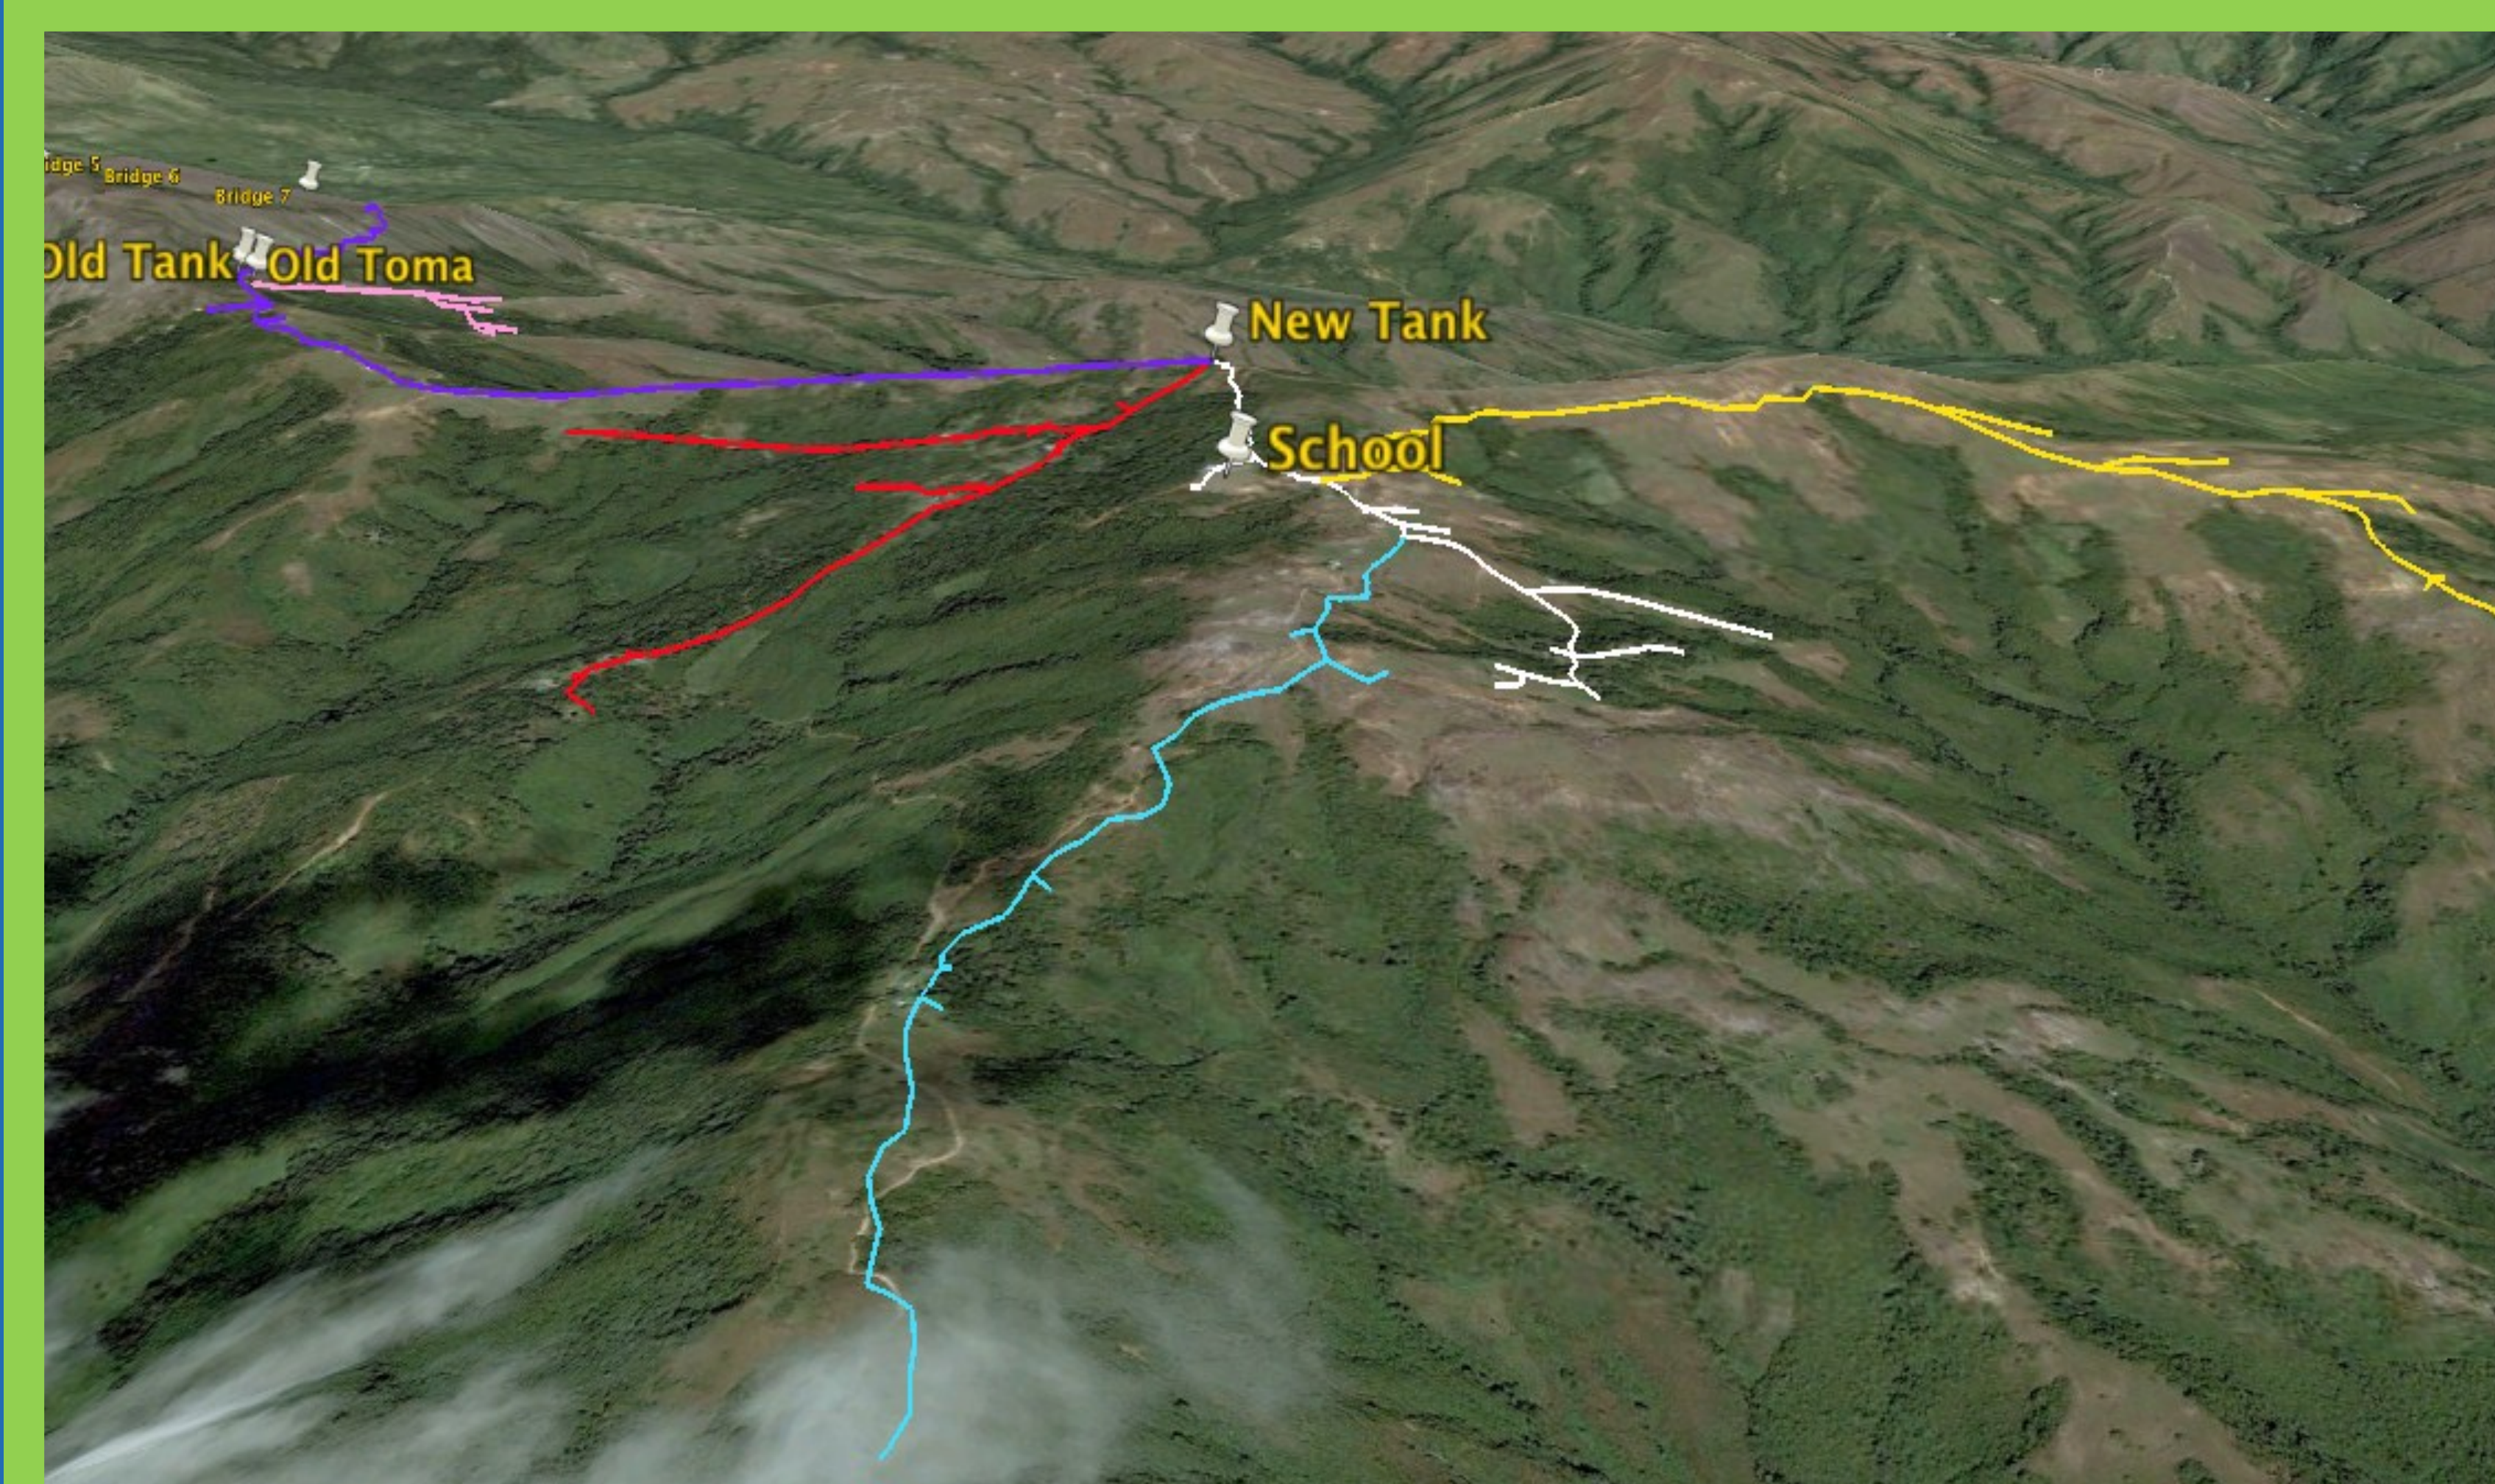
- It is recommended that the old system be used to supply water to eight homes that are near the spring source for the system.
- The remaining homes should be serviced by the new system. There are a total of 62 homes that will be connected to the new system (Map to the left)

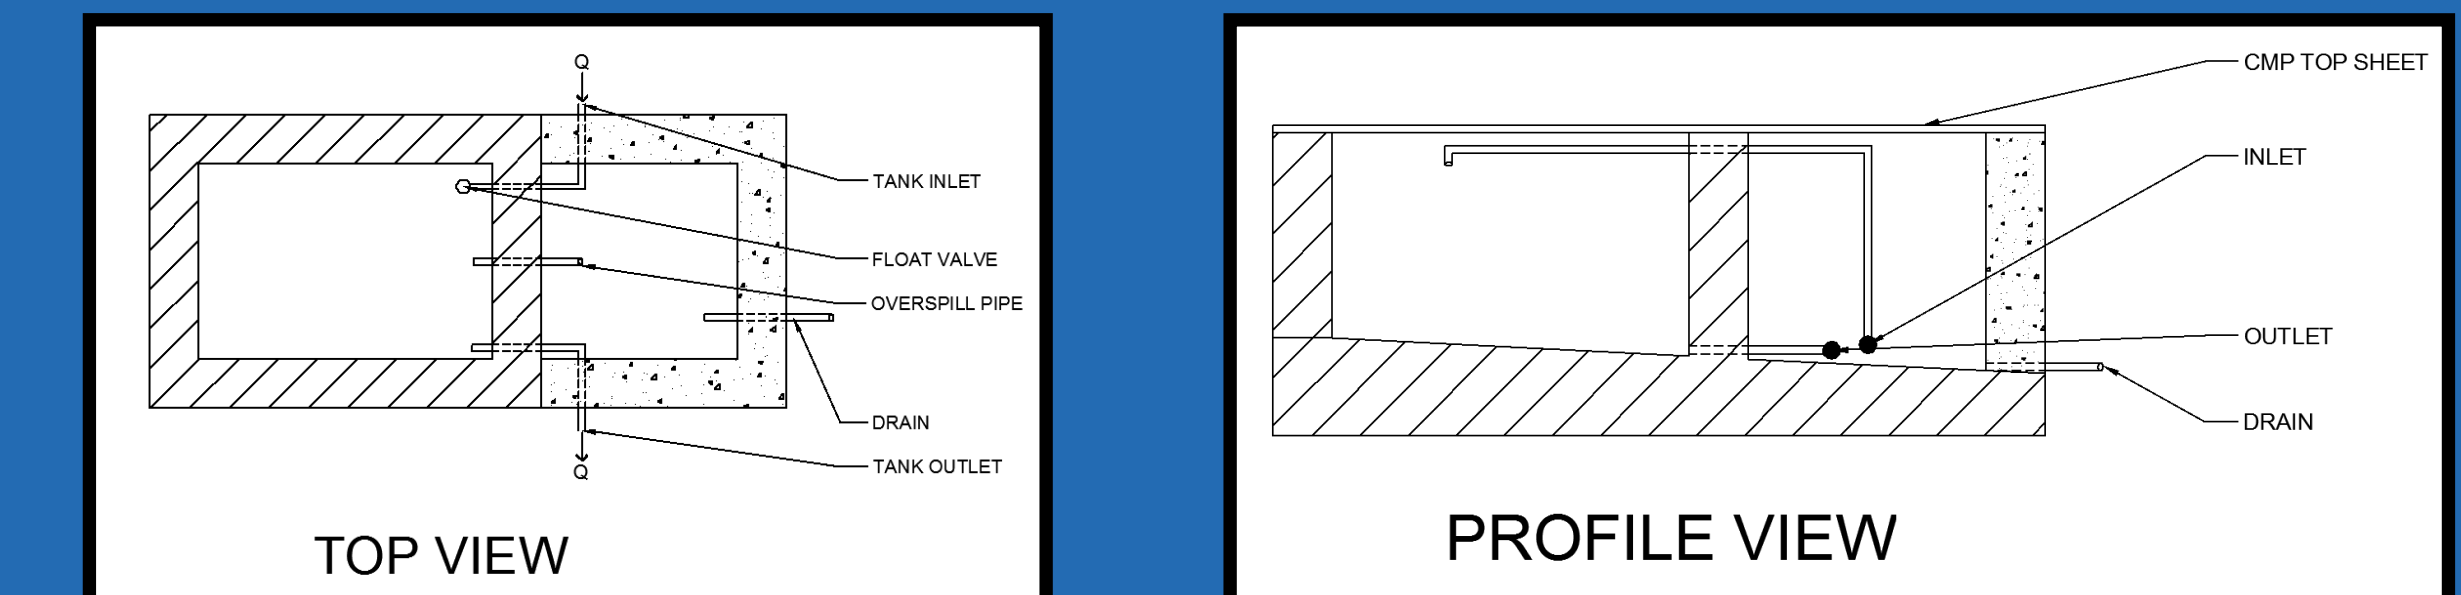
Figure 4: Mason-Break Pressure Tank Design

- Addition of the tanks will alleviate pressure within the pipes, preventing pipe breaks from occurring. There are three recommended locations within the community of Cerro Miel where pressure release tanks should be located. The mason-break pressure tank is recommended at these three locations (Figure 4).

- An additional tank will be located near a storage tank in the community of Tugri. This tank is located on the supply line that feeds the new tank in Cerro Miel. High pressures have made maintenance of a slow sand filter and chlorination system dangerous. The pressure release tank would provide safer conditions for maintenance of the water treatment devices.

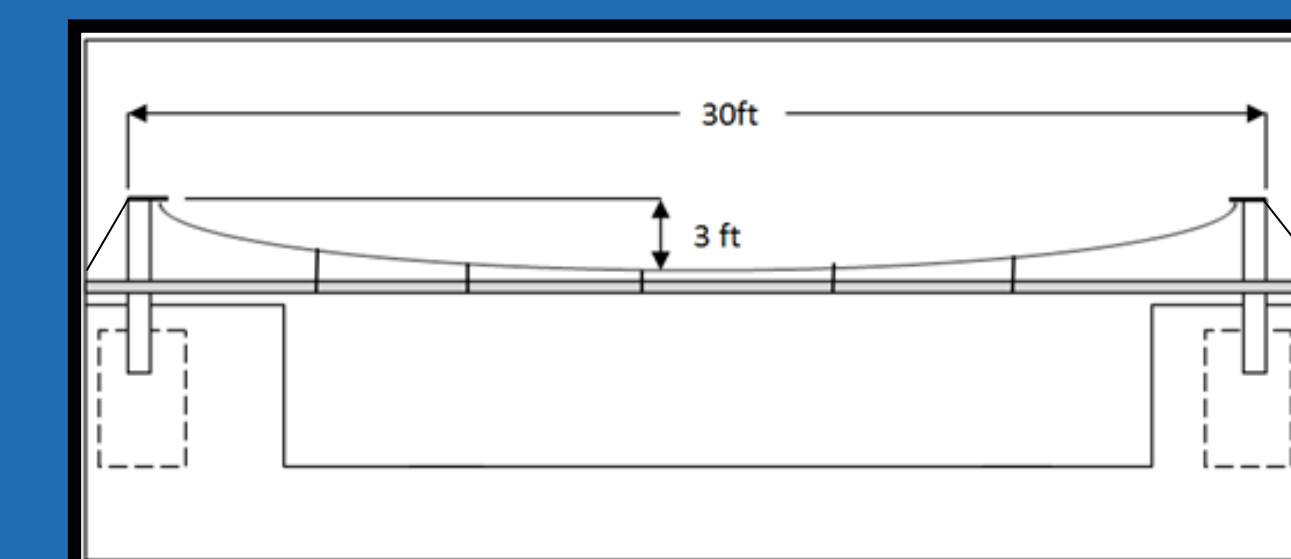
Figure 5: Gully Crossing Support Diagram

- Weak points exist in the system when unsupported PVC pipe crosses a gully. To create a more reliable distribution system, suspension supports will be installed (Figure 5).

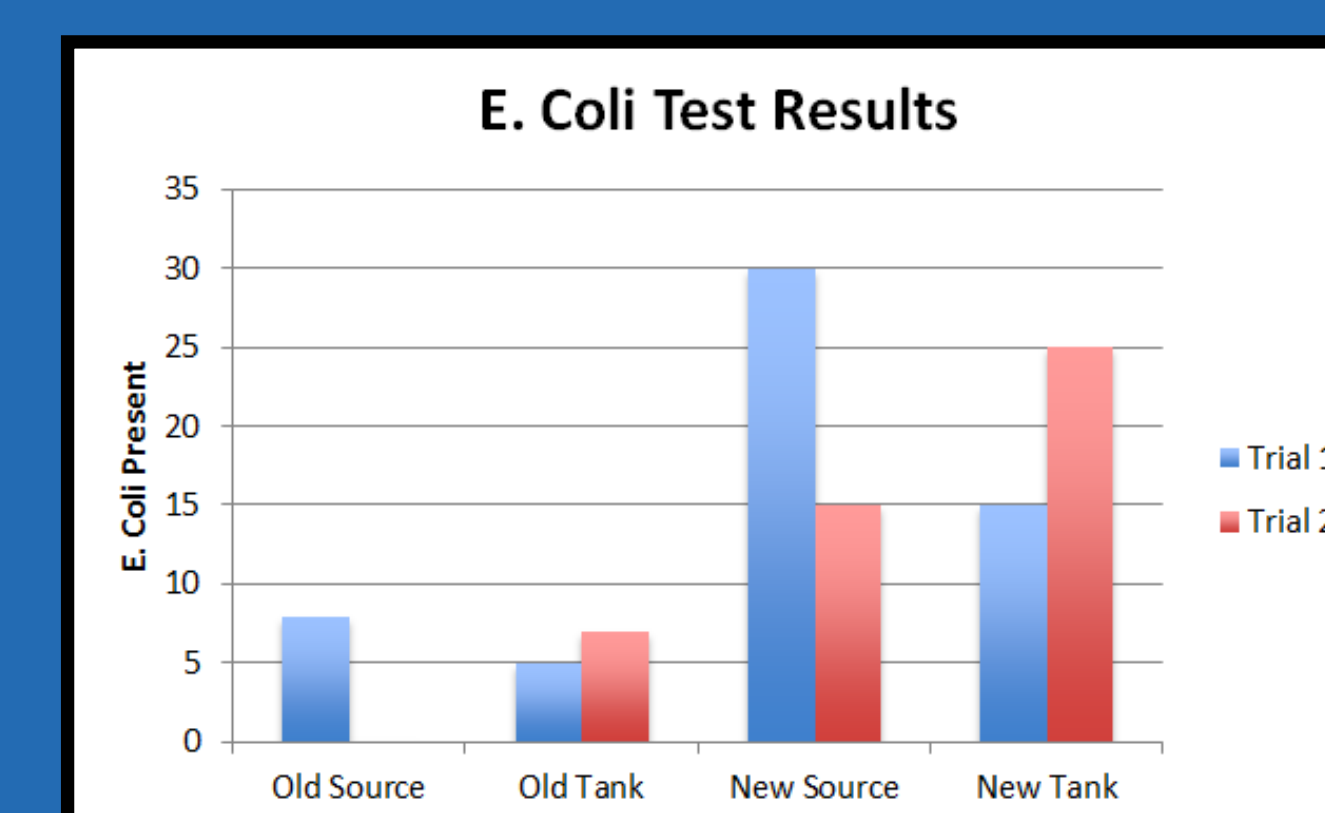
Figure 2: Results from coliform bacteria testing

- Water Quality Testing:** 3M Petrifilms were used to find the amount of coliform and aerobic bacteria in the two water sources. This was used to evaluate the need for water treatment. (Figures 2 and 3)
