WATER RESOURCE DEVELOPMENT VALLE ESCONDIDO, PANAMÁ

Katie Blodgett, Hayden Henderson, Kristen Jung, and Dominic Oldani
MICHIGAN TECHNOLOGICAL UNIVERSITY

International Senior Design

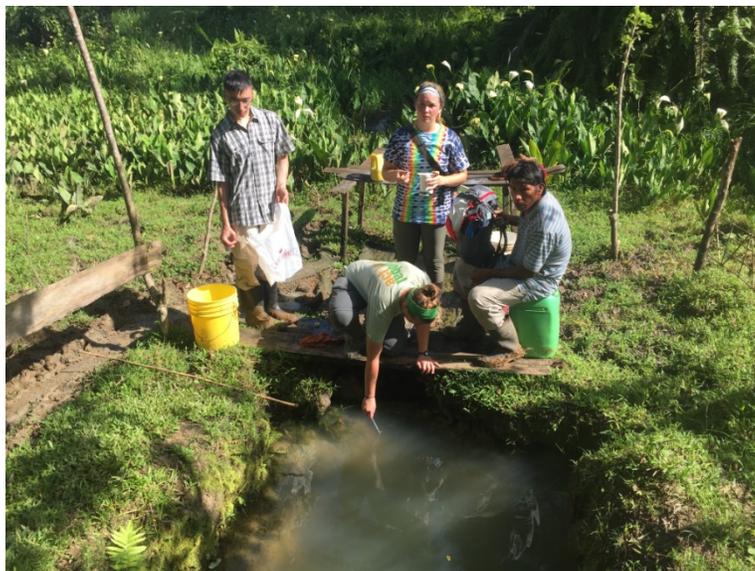
Figure 2: Team members collect water samples from wells for quality testing

The team conducted tests of existing wells and springs currently in use by the community. Some families were connected to the aqueduct system while others used shallow wells located near their homes for water. Unfortunately, these wells were susceptible to contamination from livestock, the environment, and people. Figure 2 shows the team collecting a water sample from one of these shallow drinking wells.

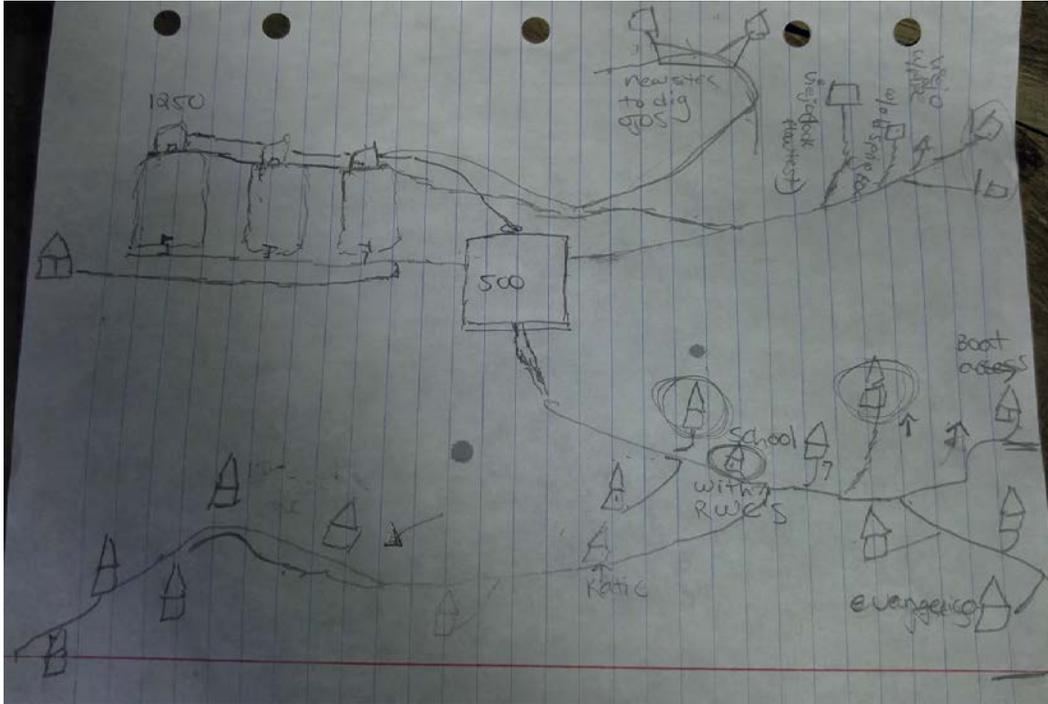
Figure 3: Sketch of the aqueduct collection and distribution lines in Valle Escondido based on a drawing by the Aqueduct President.

To gain an understanding of the current aqueduct system, the team worked with the local aqueduct president to survey the main water line and the distribution system. Figure 3 shows a sketch of the whole system drawn

by the aqueduct president. During the survey of the main water line, from the springs to the storage tanks, the rangefinder was used in order to determine the distance and elevation change from each point on the line. Additionally, the team noted where changes in pipe size occur. The survey data collected will be used to determine pressure and head loss in the line.

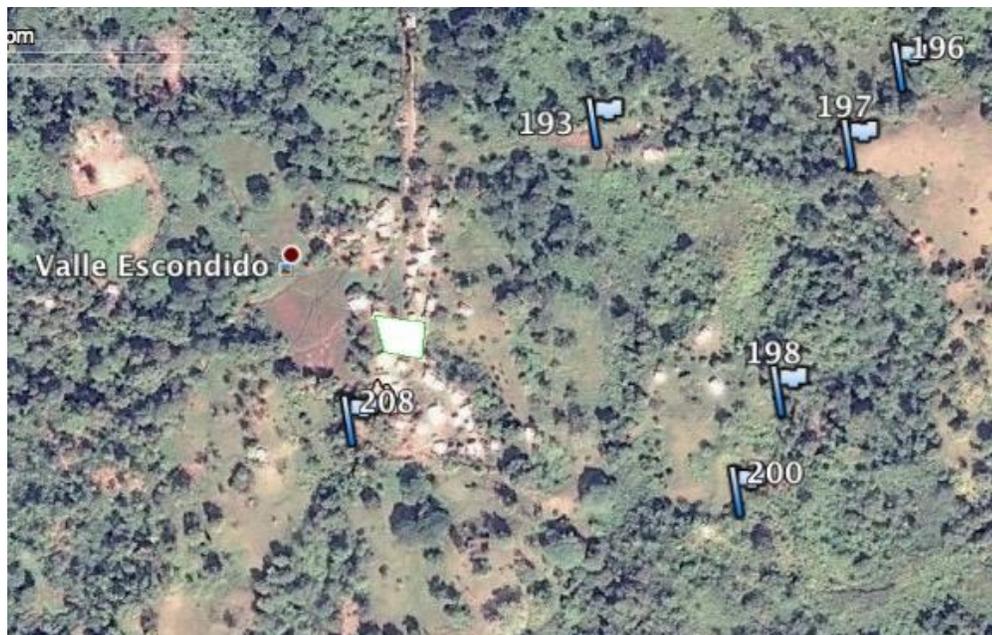
Figure 4: Water Quality Test points in Valle Escondido

Images of the 3M petrifilms used to test water quality are shown in Appendix B. High counts of coliform bacteria (present in fecal matter) and *E. coli* were found in all of the shallow wells used by community members for drinking, bathing, or laundry. Often there were such large numbers of coliform bacteria (indicated by red colonies) that there were too many to count for the accuracy of these plates (which is a maximum of 300 colonies) [1]. This means that there could have been more growth, but the food source in the agar was not enough to sustain that much growth. Fecal coliform contamination is dangerous and can cause many diseases. A very dangerous coliform that can make people violently ill is the *E. coli* strain, which was indicated by blue colonies on these count plates. All wells showed *E. coli* contamination ranging from 1 to 10 colonies per milliliter of water. Figure 4 shows the locations of these wells around the community, with the white polygon representing the PCV's house in the center of the community. The contamination of the wells is a result of the open defecation practiced near these sources, as well the livestock grazing fields that were near many of the wells. Other natural fecal contamination could occur from wildlife in the area.

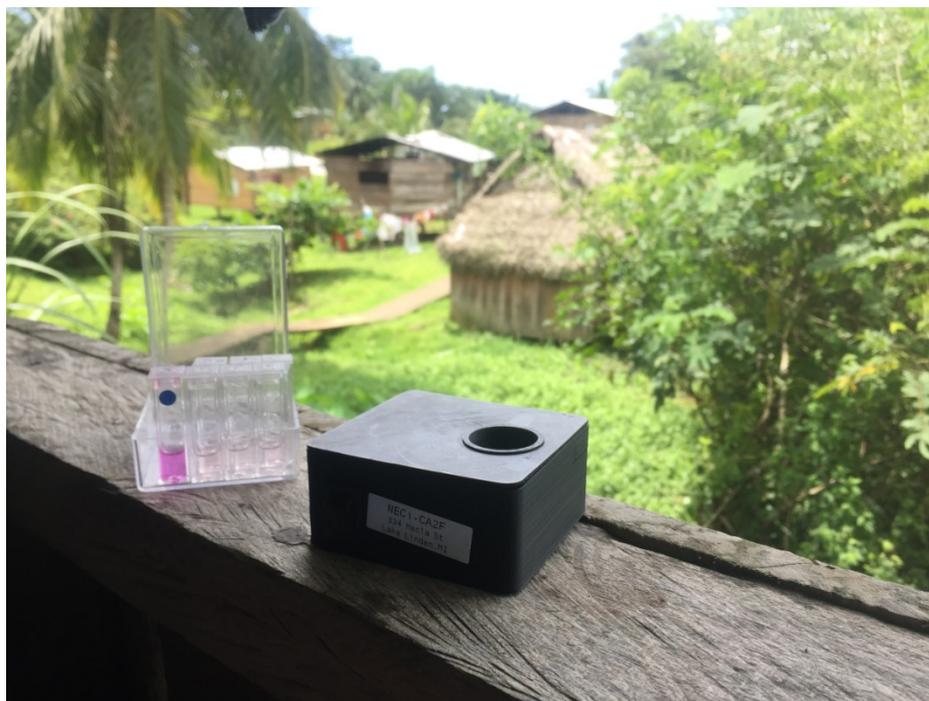
Figure 5: NECi Field Kit & Photometer

The team was able to test various water sources where there was a concern with overuse of fertilizers using field test kits and a handheld photometer from Nitrate Elimination Company in Lake Linden, MI. This kit is shown in Figure 5. Any sample containing more than 30 ppm Nitrate-N would be considered dangerous to

overall health. The test kits utilize an enzymatic process and produce a magenta color indicating the concentration in the sample. This process is completed in methacrylate cuvettes which are then placed in the handheld photometer, displaying the concentration of the sample on an Android device. All of the wells and the spring sources tested contained less than 1 ppm nitrate. Farm land located near wells and the spring source did not cause any high levels of nitrate to accumulate in the water sources. It may be advisable to retest these sites after a couple of years, as agriculture is expanding on the island.

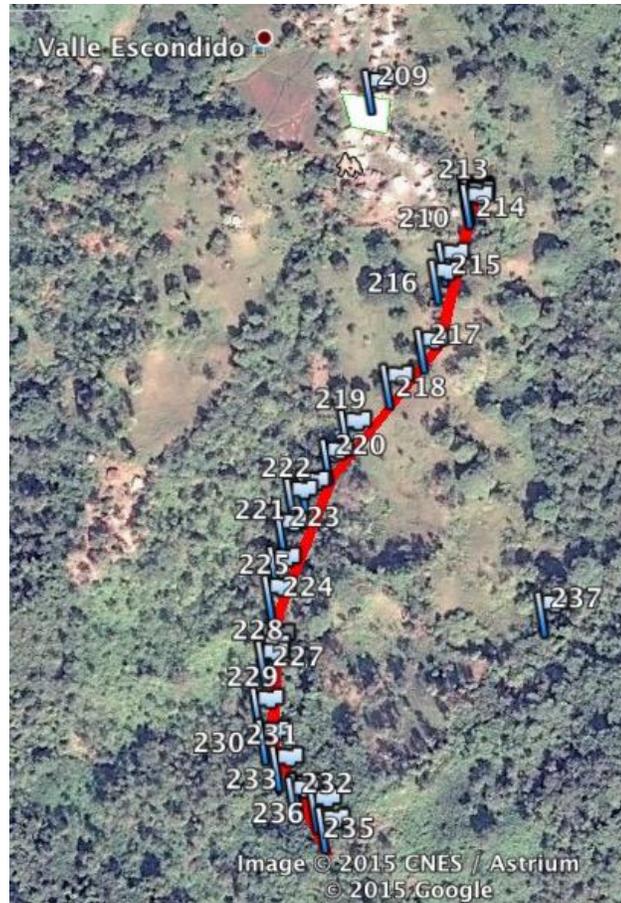
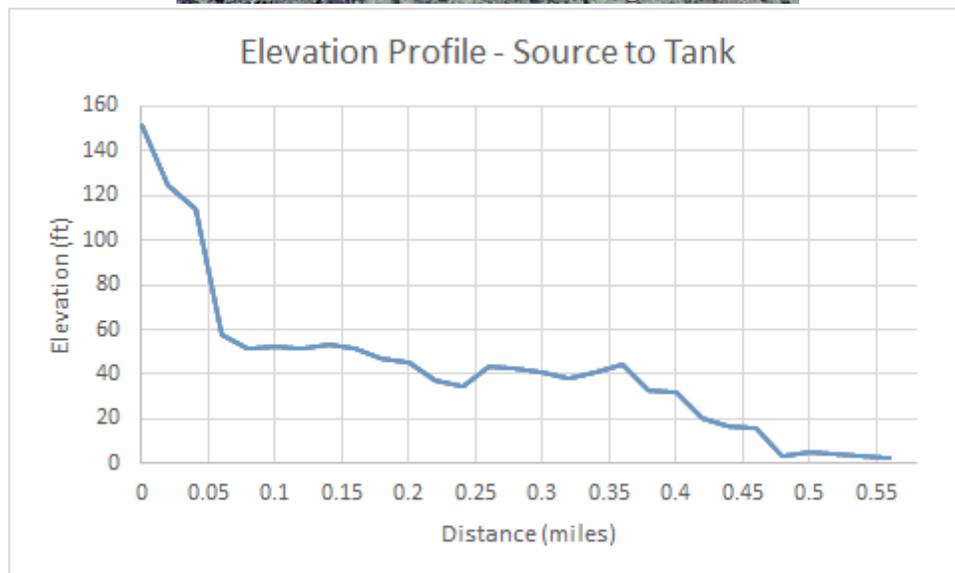
Figures 6a and 6b: GPS waypoints along aqueduct collection line (235 indicates spring location, while 213 shows the storage tanks), elevation profile

The current aqueduct was surveyed in order to document the state of the system so that recommendations could be made for improvements or additions. Figure 6 shows a visual representation of the aqueduct connecting the spring to the holding tanks near the community center. Point 235 is the old spring system currently in use, while point 237 is a new spring found nearby that has the potential to be connected to the aqueduct line. Point 209 is the Peace Corps Volunteer's home that is located in the center of the community. The team was also able to take elevation readings in order to get a more detailed land description of the current aqueduct system. Notes were made regarding locations of buried pipe versus exposed pipe and what type of environment the pipe was running through (pasture, jungle, houses). Additionally, the pipe size throughout the aqueduct was recorded. An elevation profile was created and is displayed in Figure 6. Using the figures it can be determined that the line from the source to the tanks has a greater elevation difference, resulting in a greater amount of head, while the line from the tank to community has a much smaller elevation difference.

The existing system features about 5100 feet of plastic PVC pipe in varying sizes, with the majority of the line being 2" or 1.5", before decreasing to 0.5" in the community as it branches to the houses. As seen in Figure 6,

it spans approximately 0.6 miles with 170 feet of elevation change from source to tank. This existing system supplies sufficient pressure the majority of the time. Additional houses being added to the system may require recommendations regarding replacement of sections and rerouting of aqueduct lines.

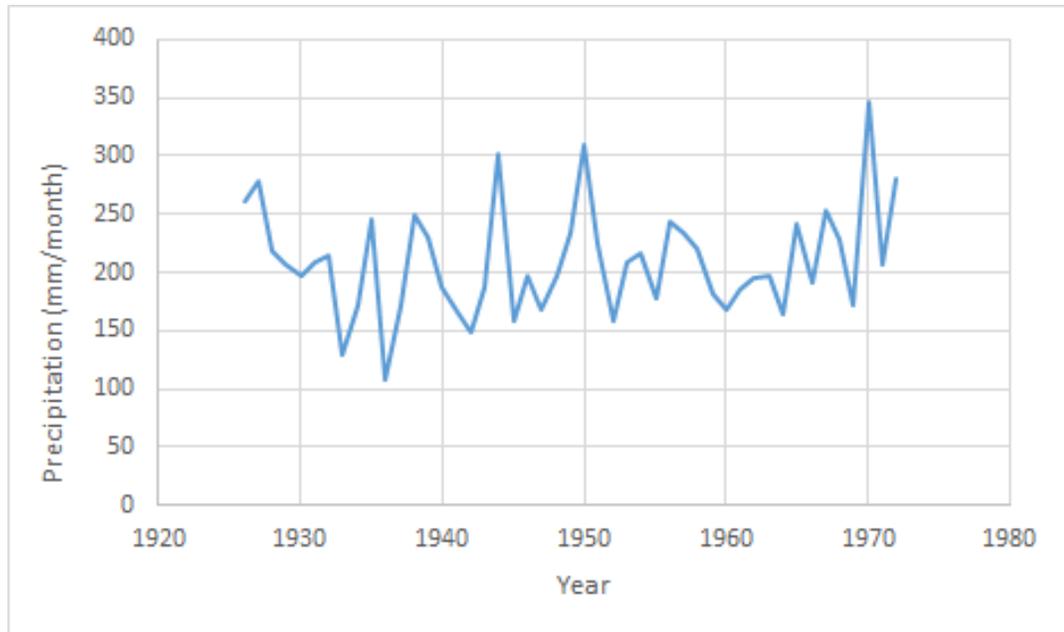
Figure 7: Changuinola yearly precipitation based on data from 1926-1972 [2]

Rainwater catchment has been recommended as a feasible alternative to lessen the demand on the aqueduct system. Monthly precipitation data in a nearby community, Changuinola, made it possible to determine both yearly and monthly averages of rainfall in this region of western Panama [2]. Figure 7 shows the yearly averages of rainfall, while Figure 8 shows monthly averages throughout the 47-year span. Figure 7 shows the high variance in rainfall throughout the years. Precipitation varies from approximately 100-350 mm/month. According to Figure 8, the month of September produces the least amount of rain, with an average of 106 millimeters per month. The average amount of precipitation per month was determined as approximately 200 mm/month, resulting in an estimated 2,400 mm of rain annually for this region of western Panama. This rainfall data also confirms the lack of dry seasons in the area.

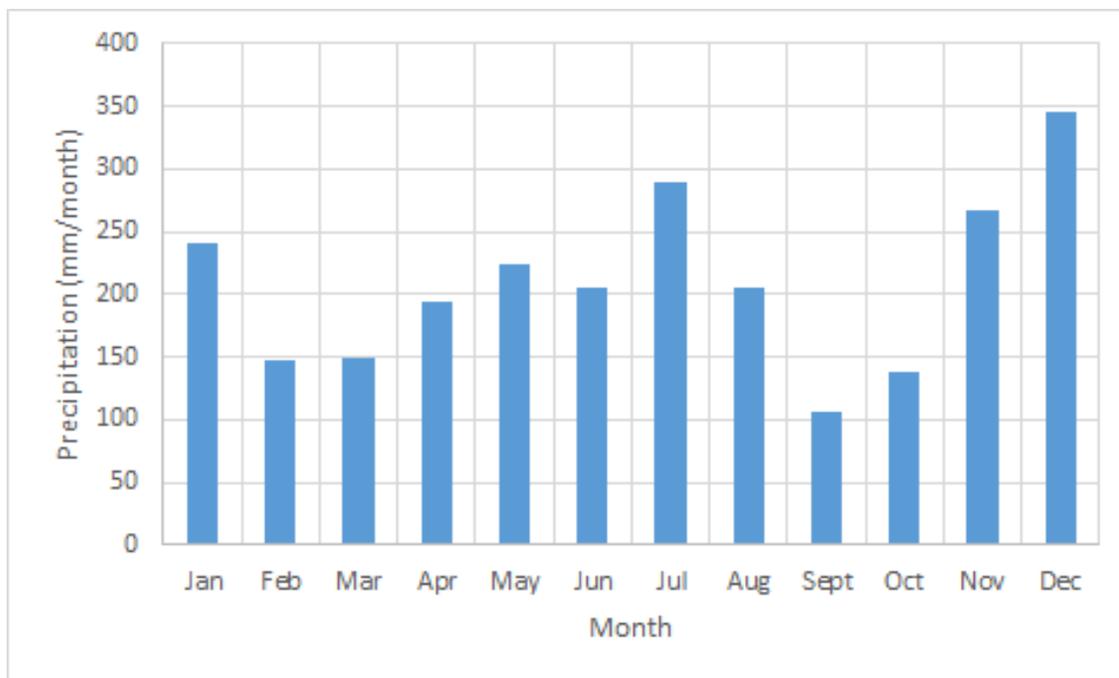
Figure 8: Changuinola monthly average precipitation based on data from 1926-1972 [2]

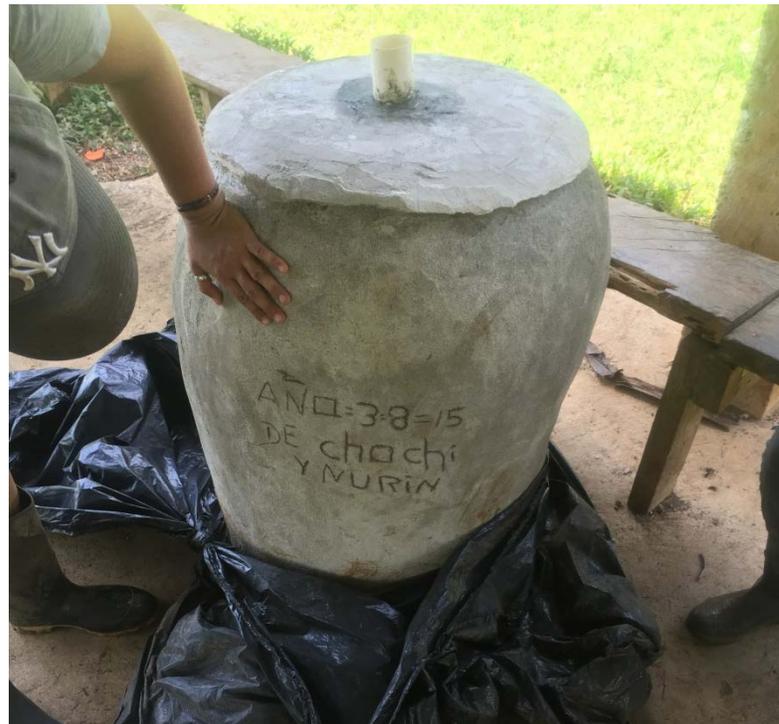
Figure 9: First ferrocement rainwater collection tank constructed by Peace Corps volunteer and community members

It is highly recommended that ferrocement rainwater catchment basins be installed by homeowners to lessen the demand on the current aqueduct system, as well as provide needed water. No long period of rainwater deficiency in the western area of Panama occurs; therefore water can be collected any time throughout the year. Problems that may occur with the implementation of the rainwater catchment system would include finding and transporting materials for the first flush system, due to the location of the community on the island.

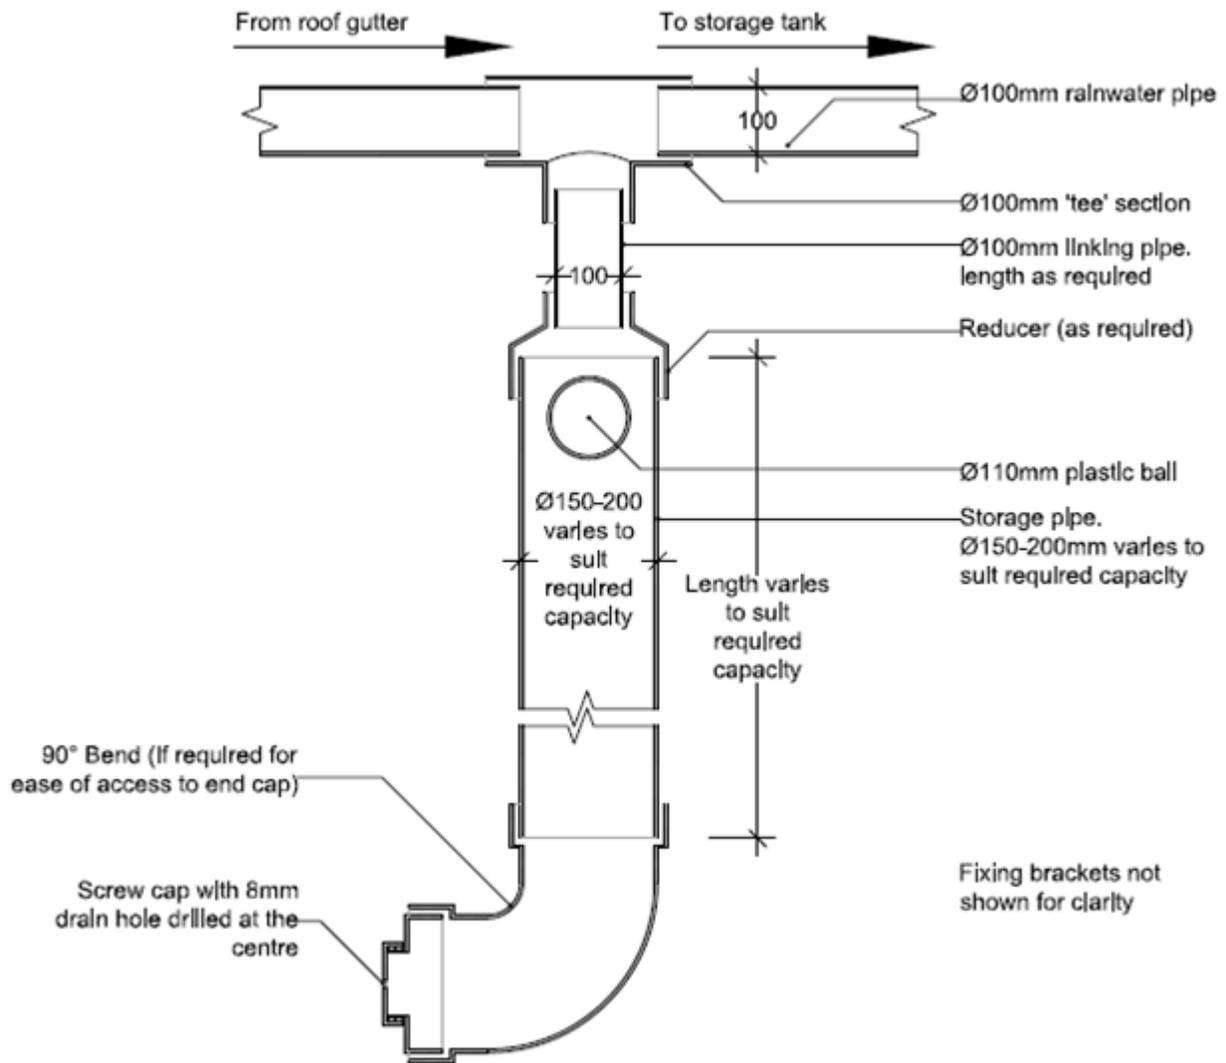
Figure 10: Design of Arkitrek first flush diverter [5]

Installing a first flush system would also be beneficial for maintaining sanitary drinking water. This low-maintenance system prevents sediment, insects, debris, bird droppings, and other undesirable substances that are washed off of the roof during the first flush of rain from entering the ferrocement tank [4]. Basic versions of a first flush system include the addition of PVC pipe and ball that fits within the pipes. Figure 10 shows a basic design of the potential system, provided by Arkitrek [5]. Upstream of the first flush system, it is also recommended to place a screen in the piping in order to remove large particles such as leaves or twigs. The

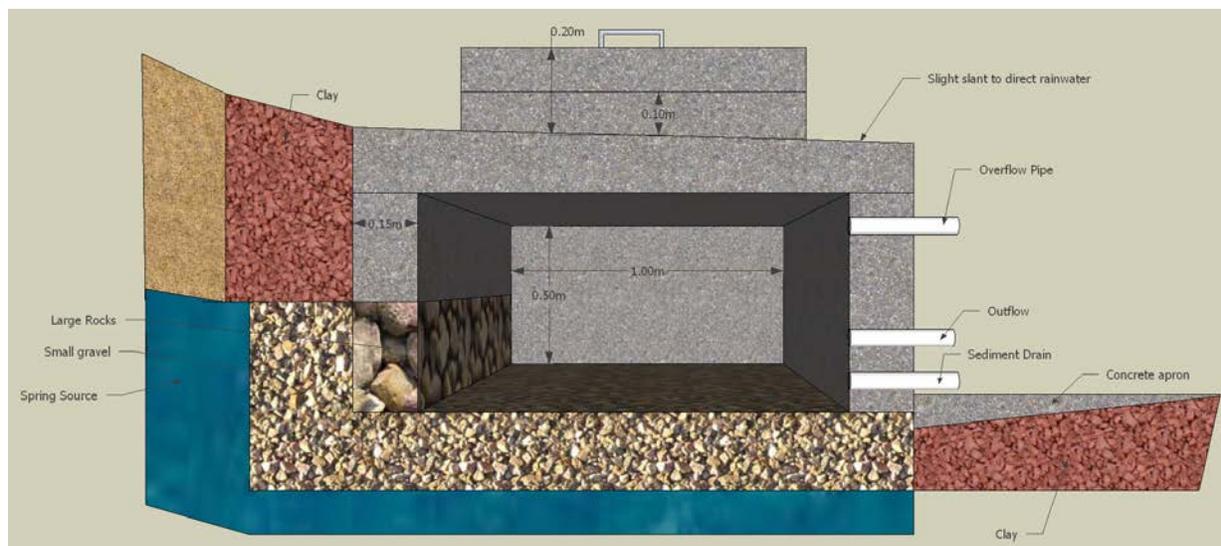
Figure 11: Spring box Schematic Side-view

Generally, there are two types of designs for a spring box: one with a bottom open to collect water from the spring below, and an open sided one to collect water flowing from uphill [6]. The spring pools feeding the aqueduct sat on steep hills, receiving flow from drainage above as well as below, therefore the team has decided to use an integrated design. Figure 11 shows a section-view sketch of this integrated design. The “open” side of the spring box will lack concrete but will be lined with large stones and/or gravel, to filter sediments from the water flowing into the box. This will still have a partial concrete wall for structural support and to prevent surface flow from entering the box, which is more likely to be contaminated.

The spring box itself will include three different pipe outflows: the water line to the storage tanks; an open, screened pipe to allow for overflow in the event that the box fills completely; and a clean out drain with a valve. The sediment drain will be placed very low in the box to allow the sediments (which will settle to the bottom) to be flushed out. The overflow pipe should be placed very near the top of the front wall of the box, so water only flows out when the box is at its maximum capacity. The water line outflow should be lower so water flows through even when the water level is low, but should not be as low as the sediment drain.

The spring box was also designed with an opening (with a removable cover) to allow for maintenance and cleaning. The dimensions of the opening were estimated based on the space required for a person to be able to reach inside easily. Runoff can be prevented from seeping into the box from under the cover by including a ridge was designed around the opening which will divert water flow. This can be seen in Figure 11, and a detailed view of the top is given in Figure 12.

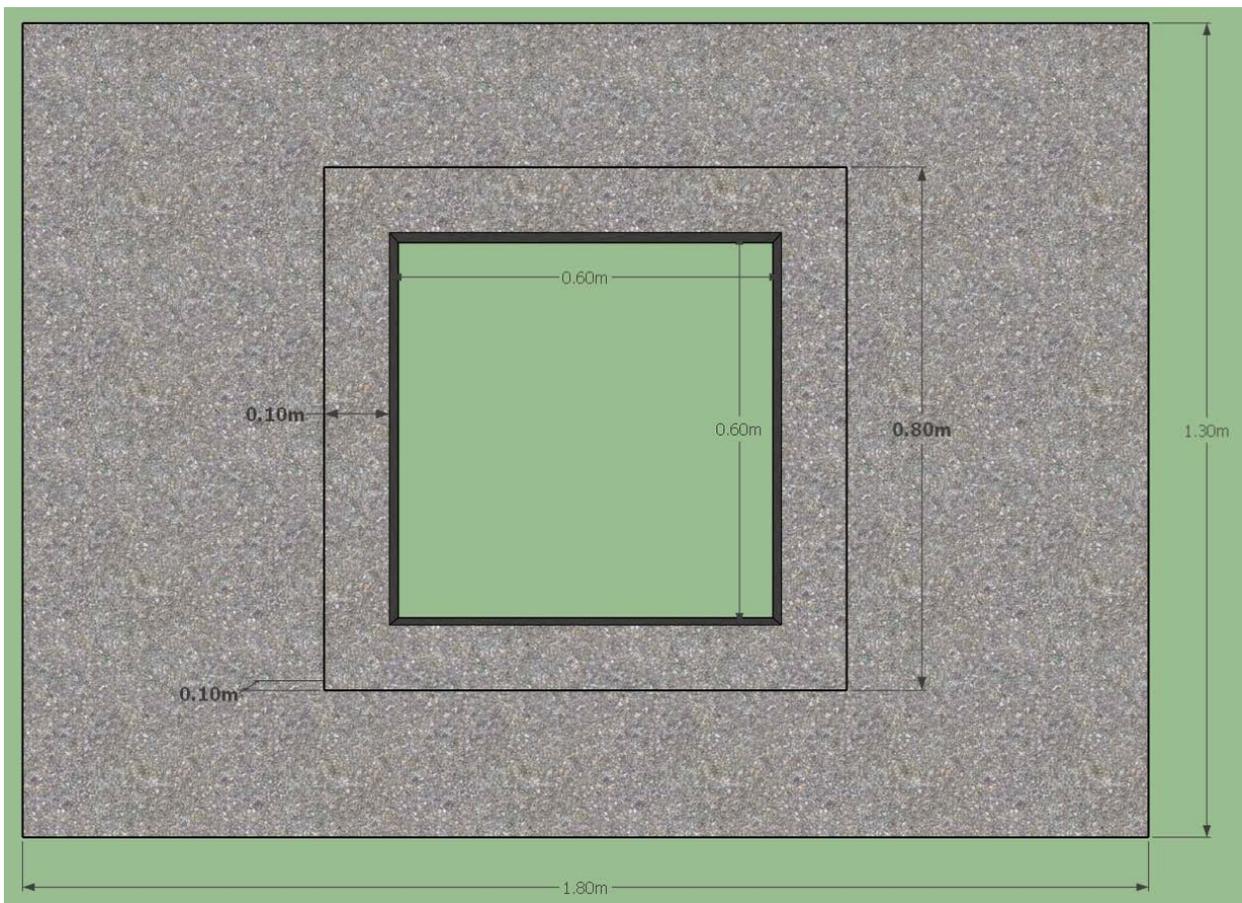
Figure 12: Top view of spring box showing opening with raised ridge

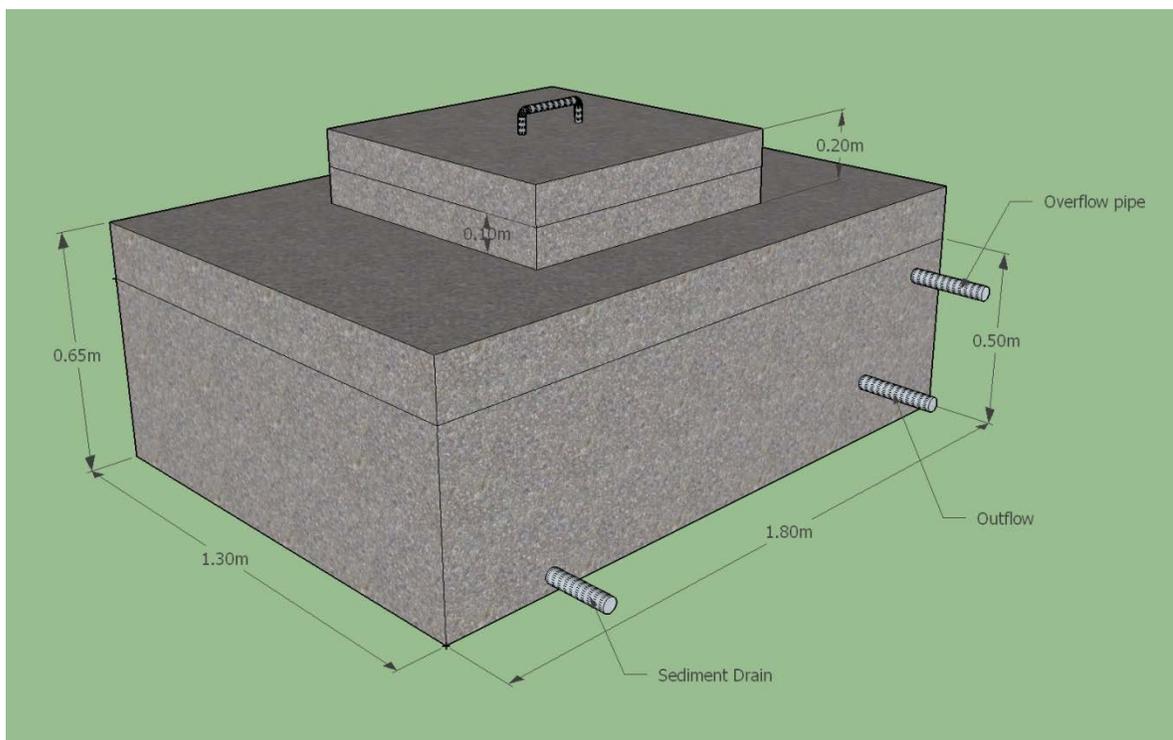
Figure 13: Spring box schematic overall dimensions

The overall dimensions of the spring box were determined using the current size of the spring pool in order to collect water as efficiently as possible. Based on visual estimates of the length and width of the pool, the team came up with the inner void dimensions shown in Table 4. The height was chosen to allow for some filling of the box, but it was kept as minimal as possible to reduce the amount of concrete required to construct the box. Based on the *Water for the World* manual on constructing spring boxes, the side walls should be approximately 0.15m thick to allow for proper support [6]. Based on this information, the team could then calculate the outside dimensions of the box. These dimensions are summarized in Table 4 and Figure 13.

Dimension	Inner Chamber (m)	Outer Wall (m)	Opening (m)	Cover (m)
Length	1.5	1.8	0.6	0.7
Width	1	1.3	0.6	0.7
Height	0.5	0.65		
Back wall		0.25		
Thickness	0.15	0.15	0.15	0.15

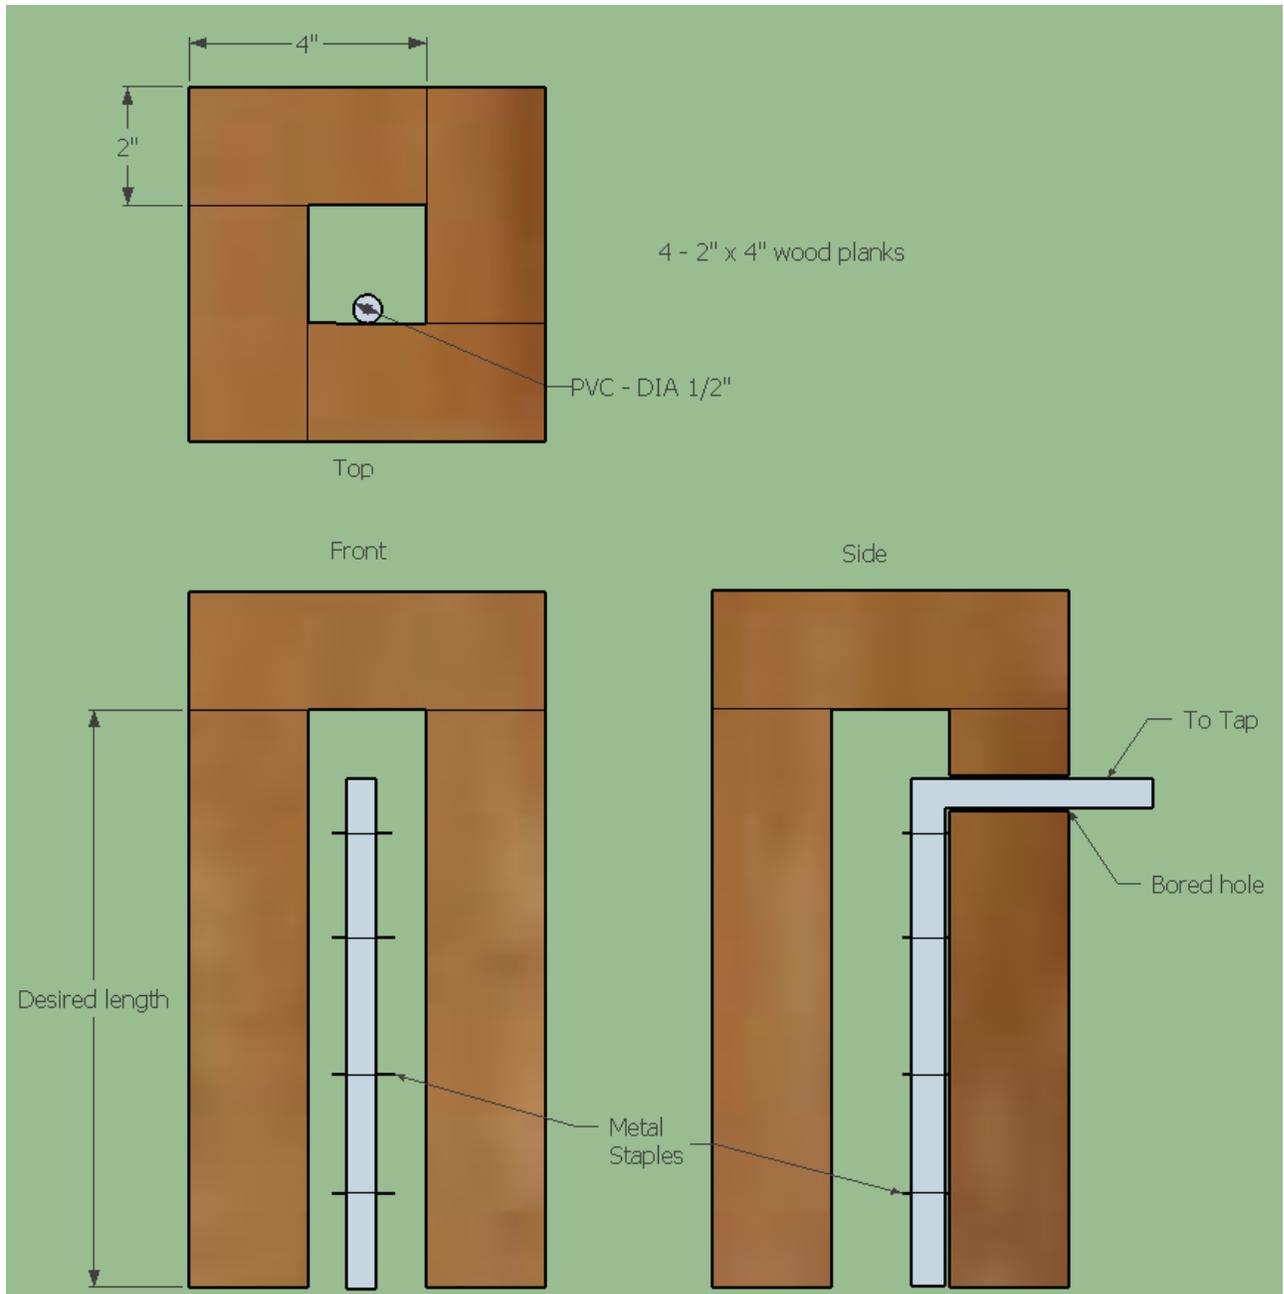
Figure 14: Tap stand schematic drawing

A simple tap stand could be constructed by connecting 2’ x 4’ wood boards in the square pattern shown in Figure 14 below. The figure also shows that metal staples will hold the pipe in place on one of the boards, and a hole can be drilled through this board for the tap to exit. The height of the tap stand would vary depending on the length of pipe up to the house. Overall, the design uses material readily available in the community and a simple design to provide protection for the tap pipes.

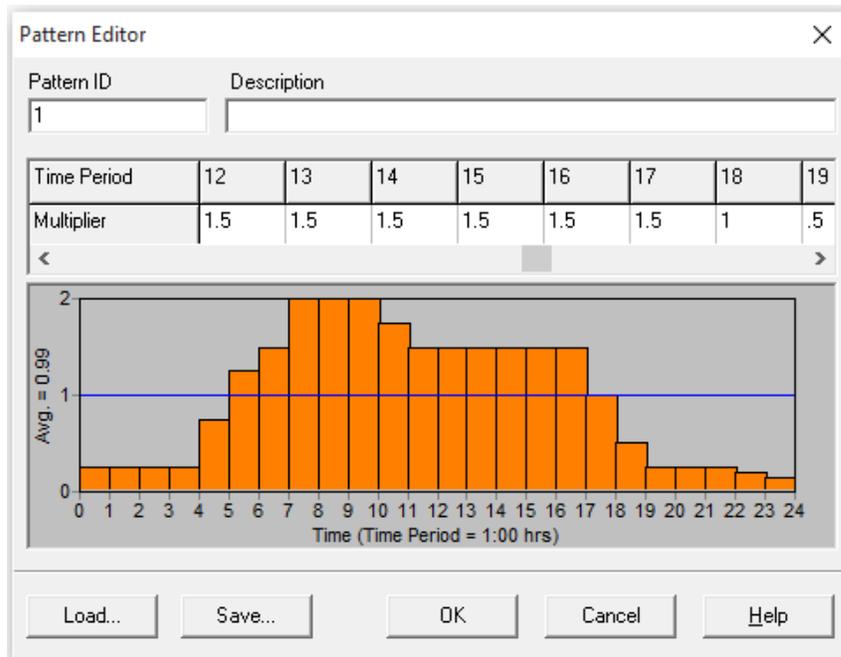
Figure 15: Time varying water demand

Using EPANET, a pipe network modeling software, 13 additional homes were added to the existing pipe network system [8]. It was determined that without adjusting any pipe sizes, the additional 13 houses could be added to the water line without the issues of back flow or suction in the pipes. Table 6 tabulates the current water demand per family per week as 180 gallons, however this number is very small, therefore the aqueduct system will be designed for a water usage of 30 gallons per person per day. This demand was modeled with the hourly use pattern shown in Figure 15:

The water demand for each household varies with time; there will be more water used in the morning when everyone is awake versus night time when there is minimal water use. The base demand, mentioned above, of 30 gallons per day per person was multiplied by a factor depending on the time of day to complete Figure 15. It is important to note that the base demand used is higher than that of the current base demand. This is to account for an increase in water use due to increased water availability. This time varying water demand was used to determine the average hourly flow rates through the community in Figure 16.

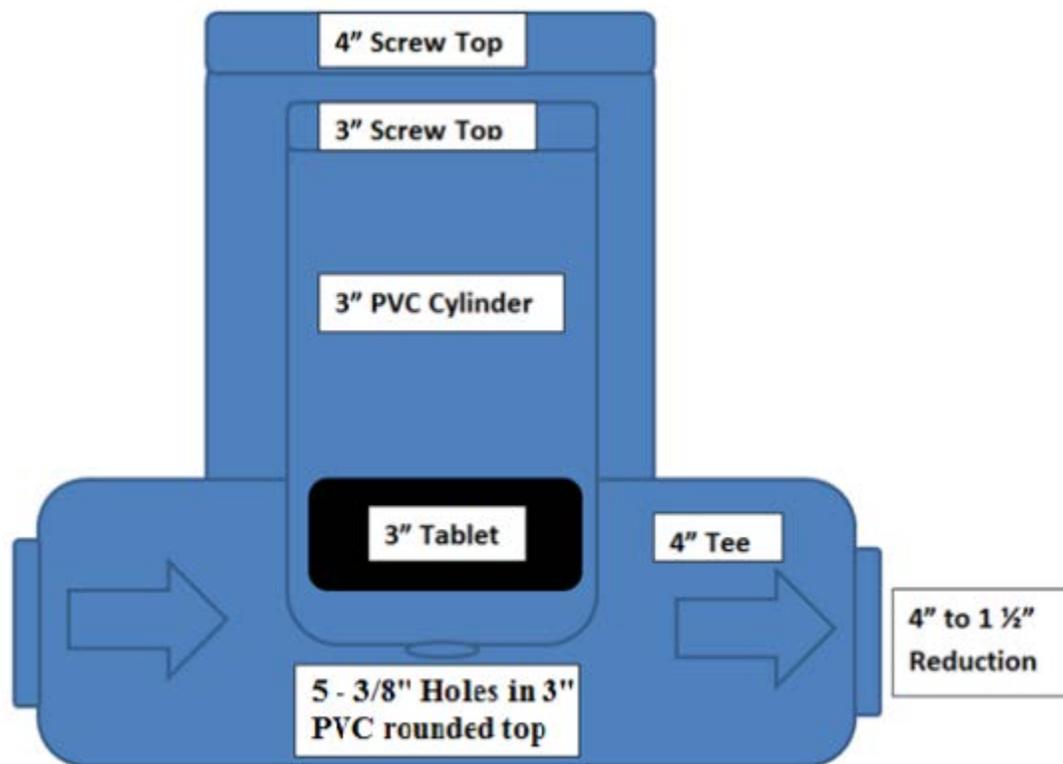
Figure 17: MINSA In-Line Chlorinator

Additionally, Todo Debe recommends that an in-line chlorinator, constructed from PVC, be added as the water line approaches the storage tanks as shown below in Figure 17. Currently, the water is chlorinated by removing the tank door and adding the appropriate amount of household bleach. The addition of this chlorinator will reduce the frequency of maintenance required of the system operator. The water entering the in-line chlorinator passes through a capped tee fitting holding chlorine tablets, into the storage tank, offering enough time for sufficient treatment. These tablets are available locally at a cost of \$2 each. It is estimated that two tablets will be needed each week for treatment, as estimated in the User Field Guide. A chlorine concentration of 0.20 mg/L is recommended in the User Field Guide for MINSA’s In-Line Chlorinator, per tests conducted in another region of Panama using the same chlorinator. A contact time for the 1,250 gallon tanks was calculated to be 93 minutes to treat the typical pathogens listed by Panama’s Ministry of Health, with the highest contact time requirement being 35 min-mg/L, as listed in Table 8 [9]. Appendix F details the calculation for contact time.

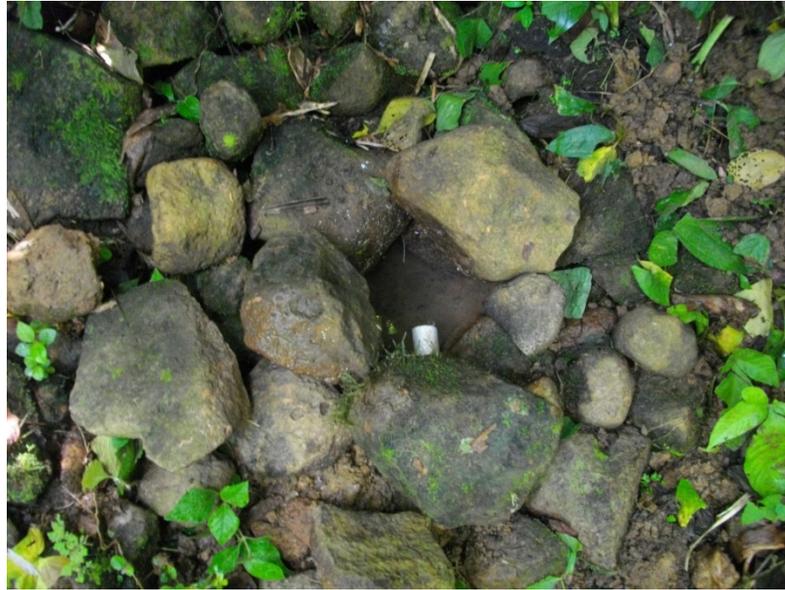
Figure A5: Aqueduct spring currently in operation (Ojo viejo)

The various water sources were tested using 3M Petrifilm tests to determine the levels of *E. coli* and total coliform bacteria. In accordance with the use and interpretation guide provided by 3M, 1 mL of contaminated water was placed in the center of the agar and then the sample was spread and sealed using the plastic coating and circular spreader. The *E. coli*/total coliform samples incubated for 48 hours while the aerobic bacteria incubated for 36 hours [1]. Two samples of both *E. coli* and aerobic bacteria petrifilms were taken at each site. Samples of water collected from existing rainwater catchments, water from kitchen sink nozzles, and water treated with chlorine were also tested. Water sources that were located near farming or agricultural areas were also tested for nitrates, to see if fertilizers were contributing to poor water quality. Photos of most of the wells where samples were taken, as well as the spring currently supplying the aqueduct (*ojo viejo*), are shown in Appendix A.
