WATER RESOURCE DEVELOPMENT VALLE ESCONDIDO, PANAMÁ

Katie Blodgett, Hayden Henderson, Kristen Jung, and Dominic Oldani
MICHIGAN TECHNOLOGICAL UNIVERSITY

International Senior Design

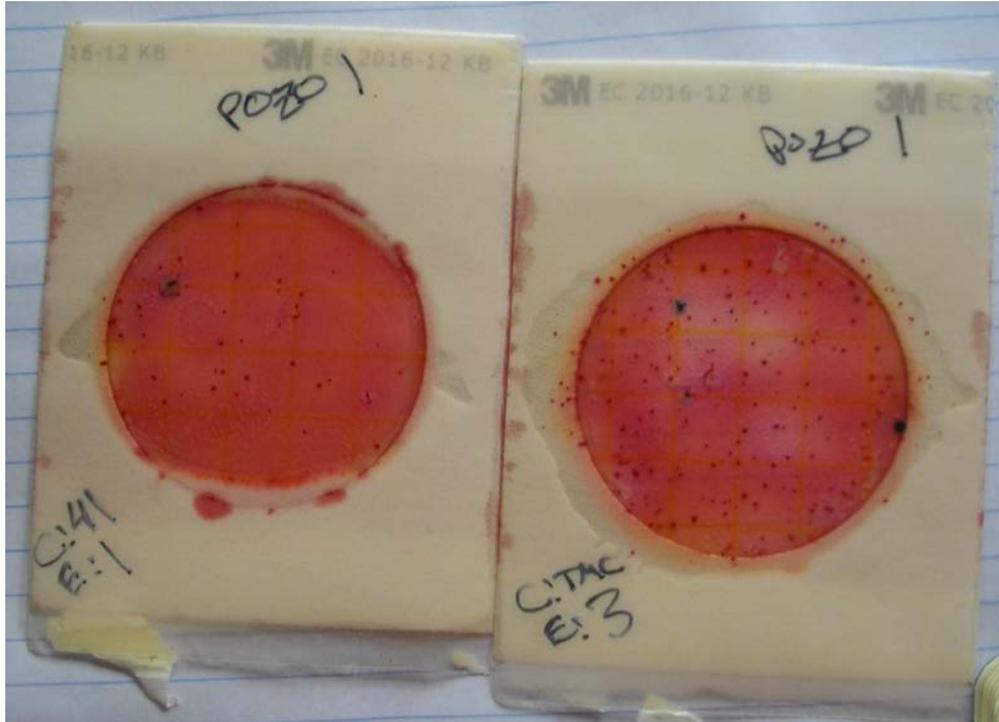
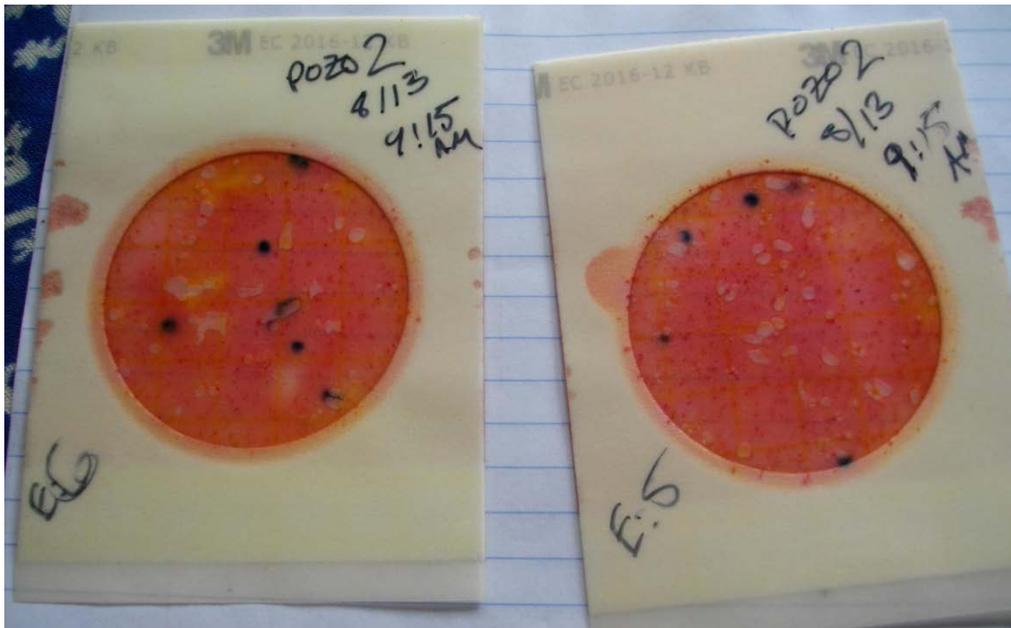
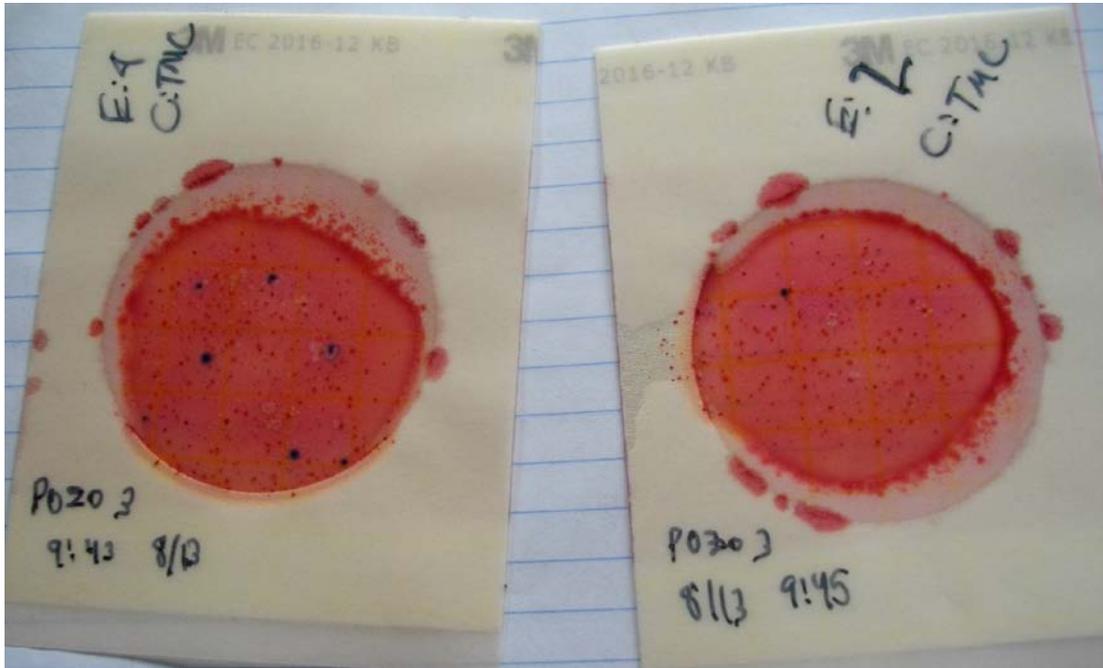
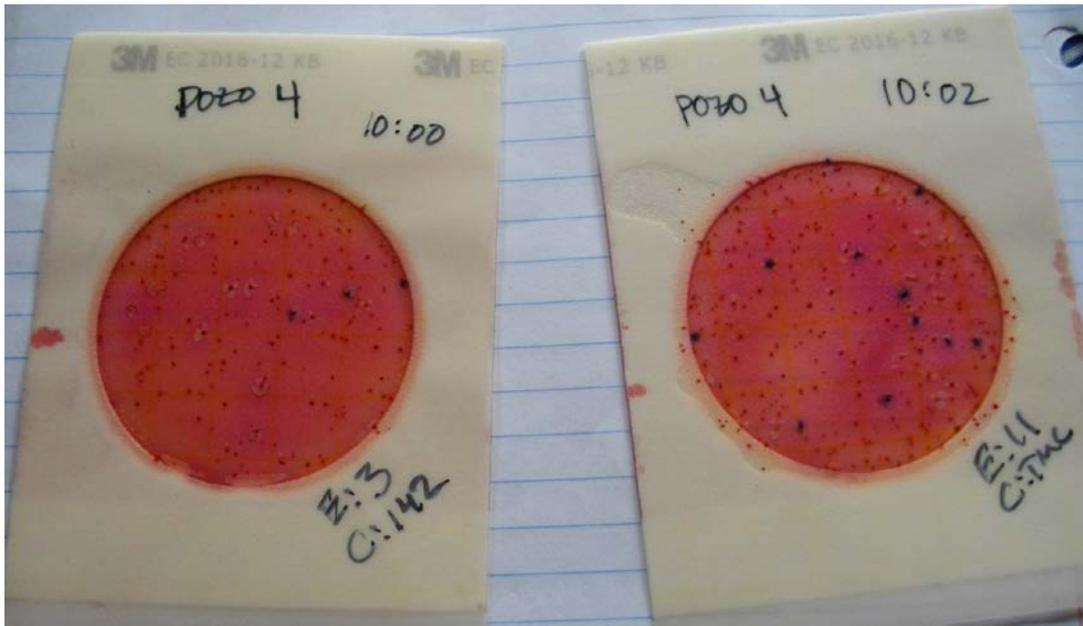
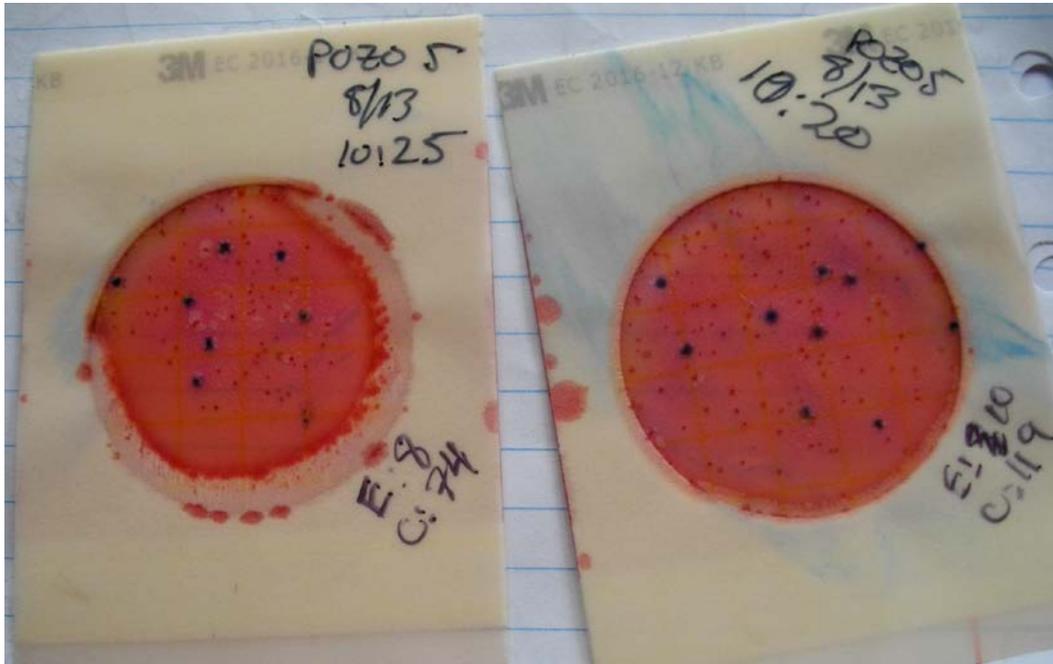
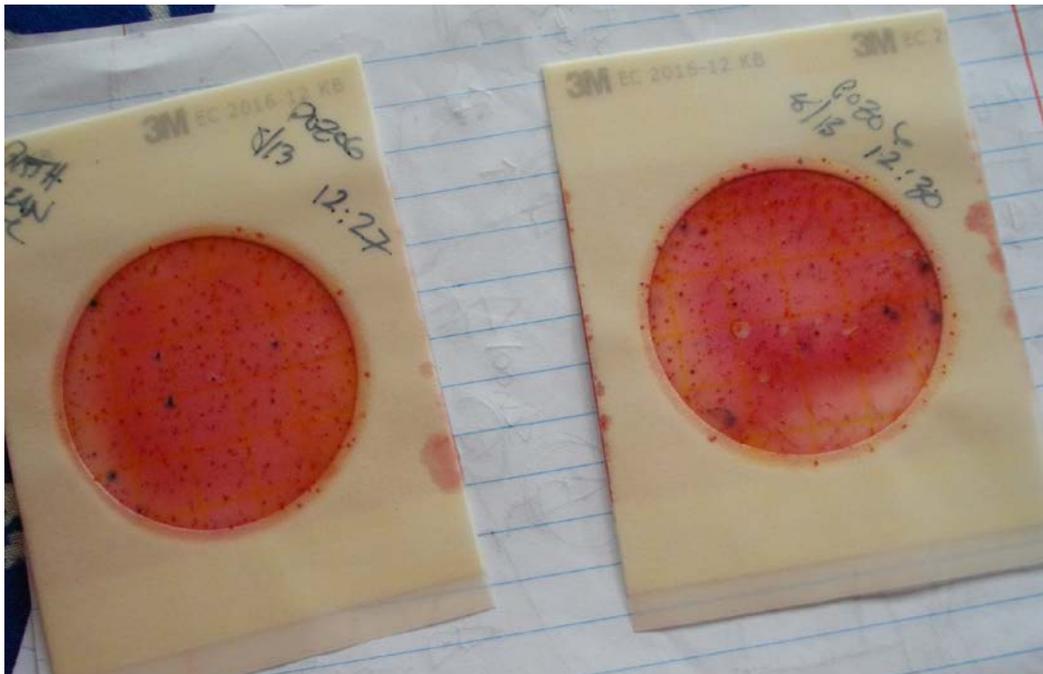
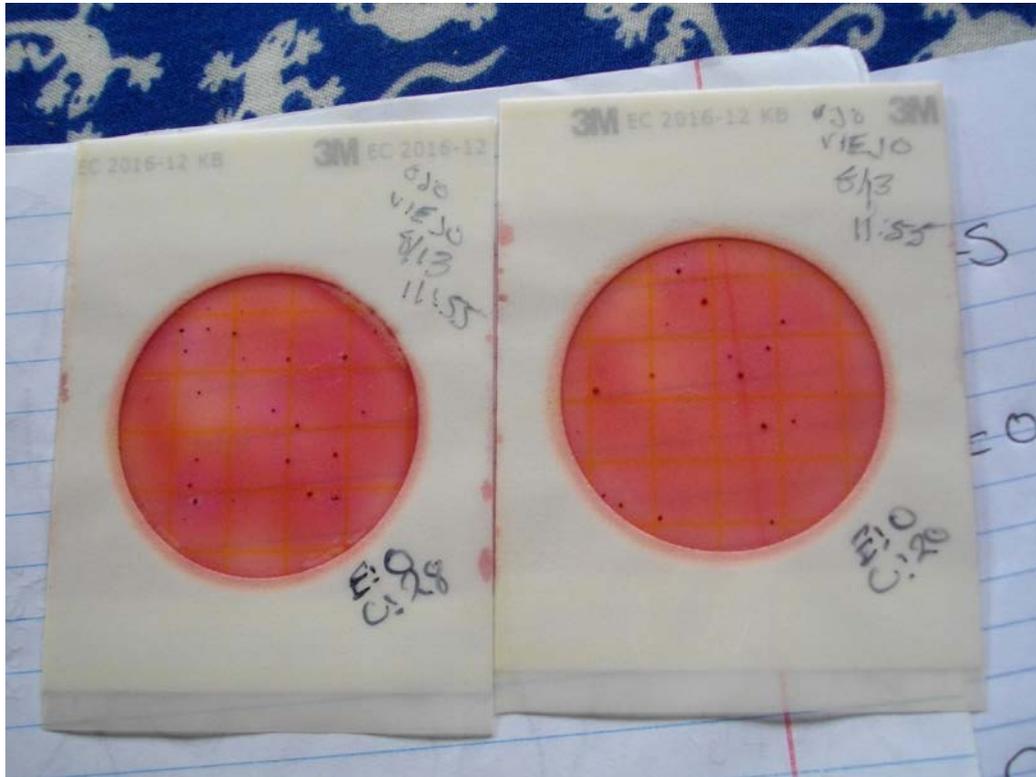
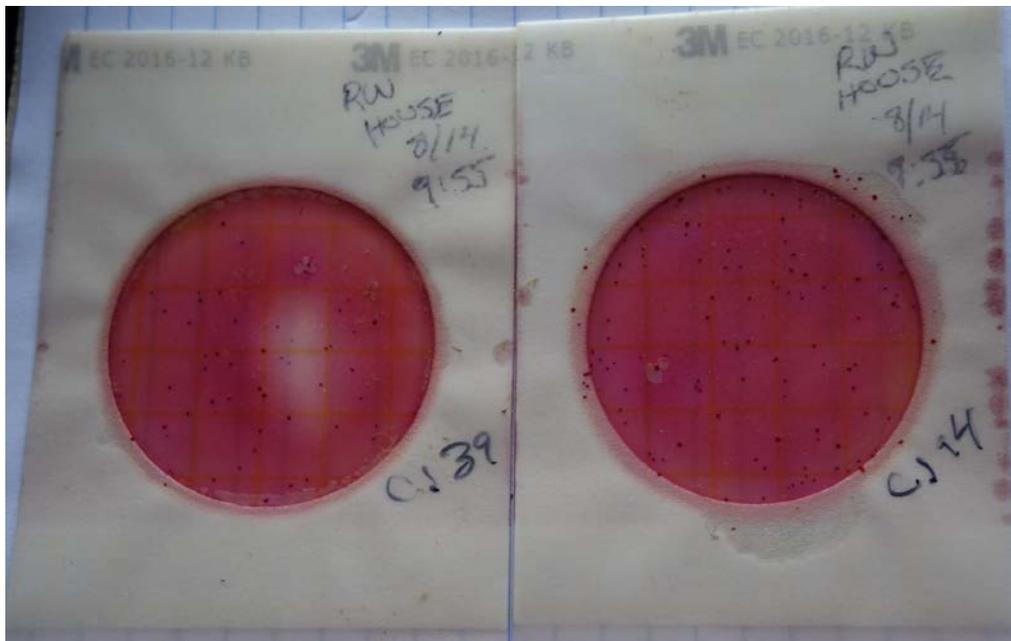
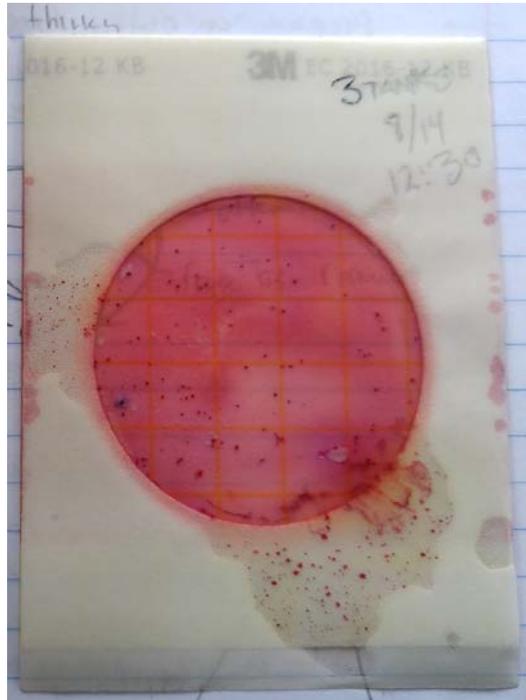
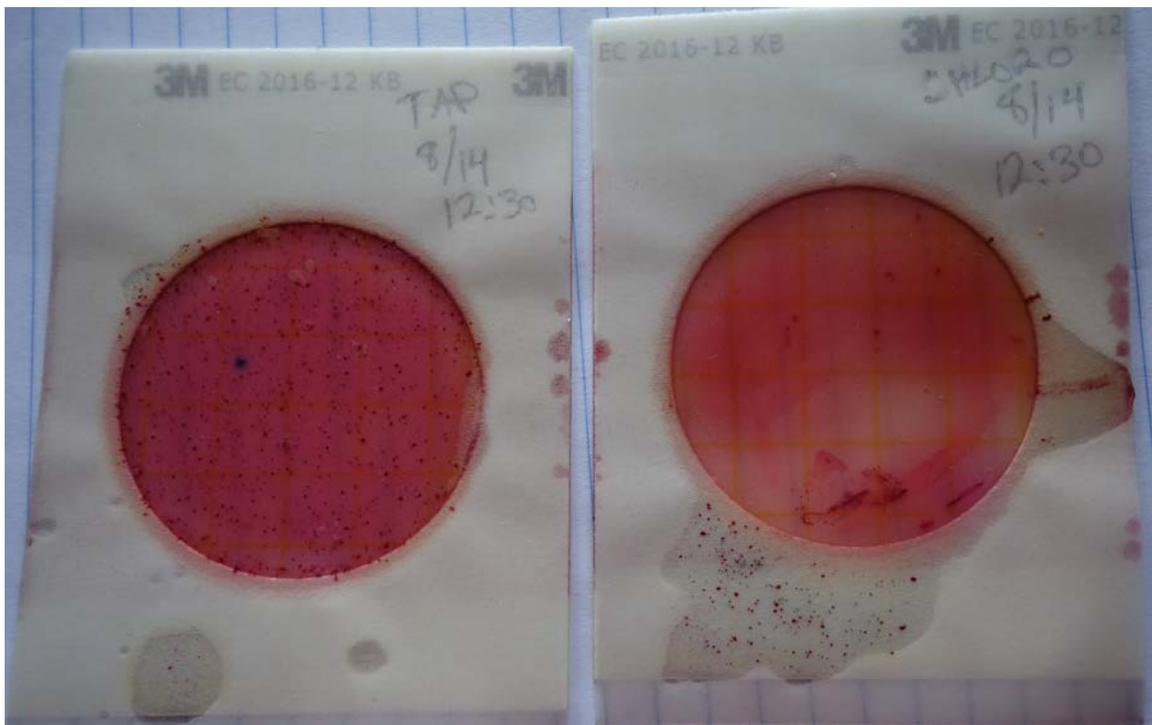
***Note: Red dots indicate coliform bacteria colonies while blue dots are E.coli colonies.**

Images of the 3M petrifilms used to test water quality are shown in Appendix B. High counts of coliform bacteria (present in fecal matter) and *E. coli* were found in all of the shallow wells used by community members for drinking, bathing, or laundry. Often there were such large numbers of coliform bacteria (indicated by red colonies) that there were too many to count for the accuracy of these plates (which is a maximum of 300 colonies) [1]. This means that there could have been more growth, but the food source in the agar was not enough to sustain that much growth. Fecal coliform contamination is dangerous and can cause many diseases. A very dangerous coliform that can make people violently ill is the *E. coli* strain, which was indicated by blue colonies on these count plates. All wells showed *E. coli* contamination ranging from 1 to 10 colonies per milliliter of water. Figure 4 shows the locations of these wells around the community, with the white polygon representing the PCV's house in the center of the community. The contamination of the wells is a result of the open defecation practiced near these sources, as well the livestock grazing fields that were near many of the wells. Other natural fecal contamination could occur from wildlife in the area.

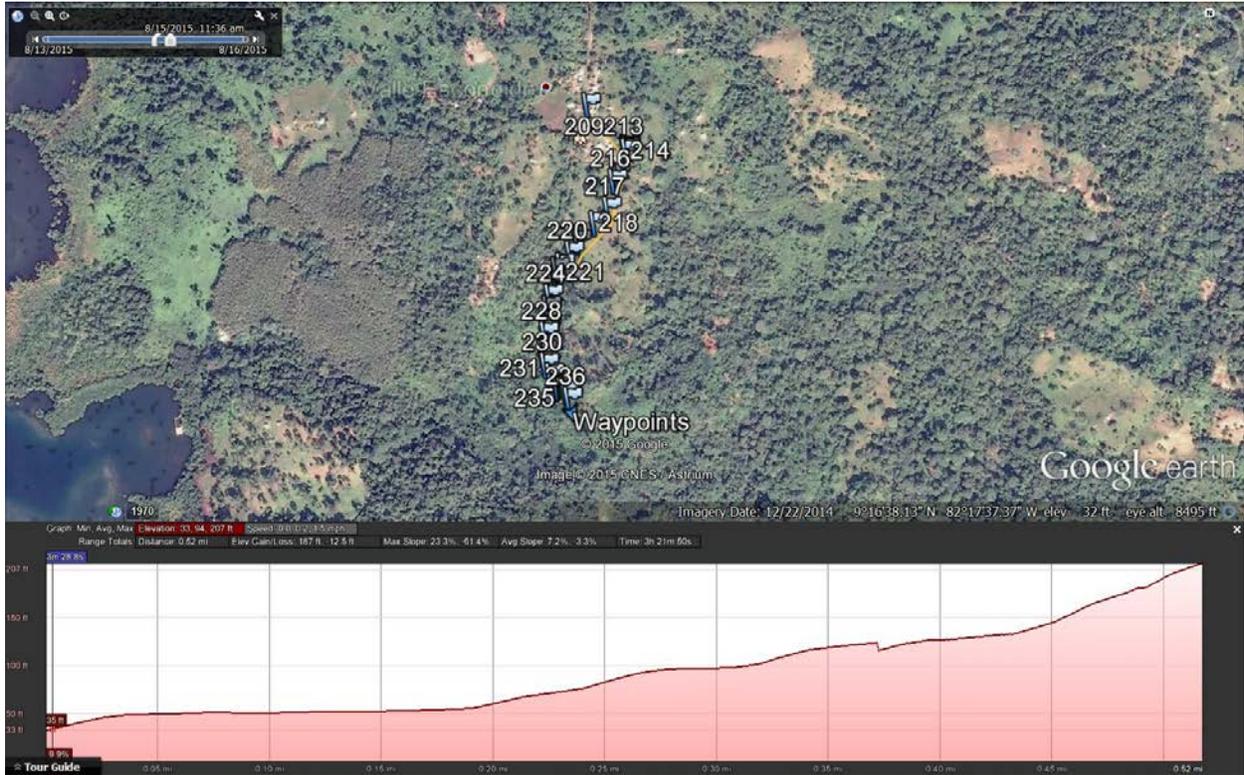
Figure E1: Elevation profile for source to tank water line

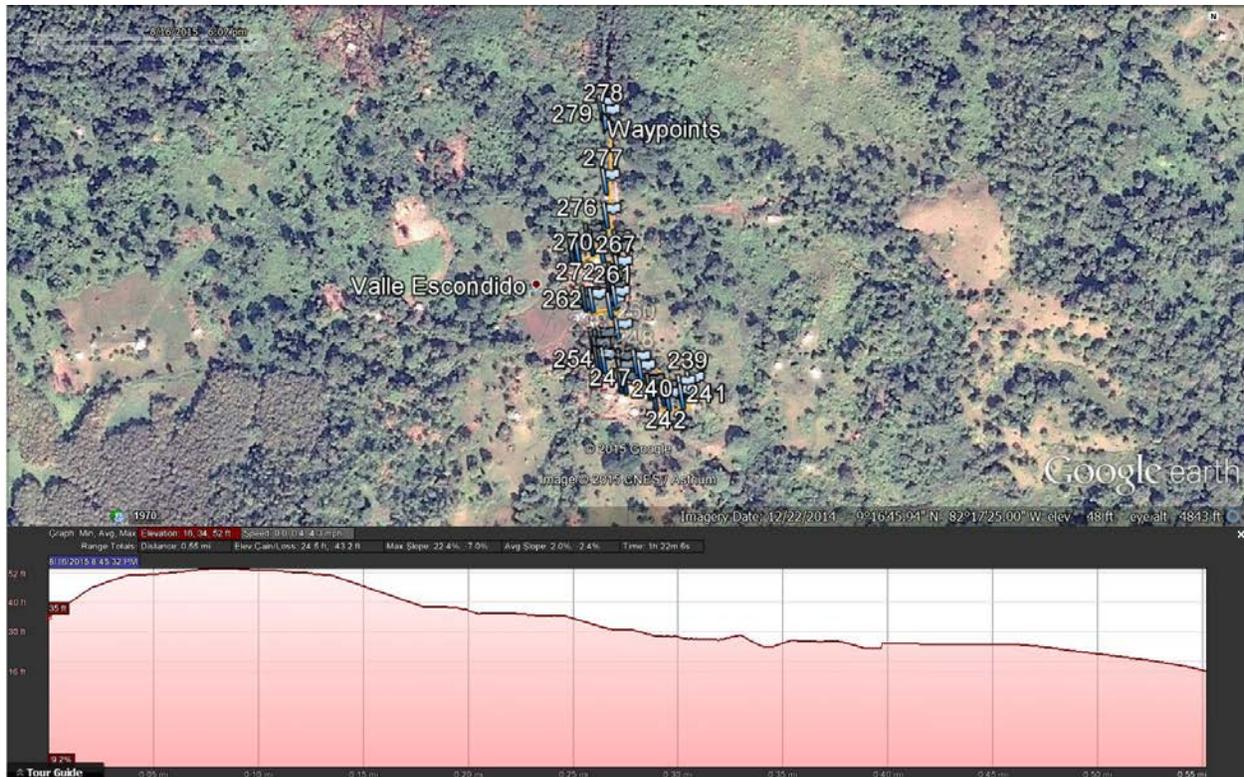
Figure E2: Elevation profile for tank to community water line

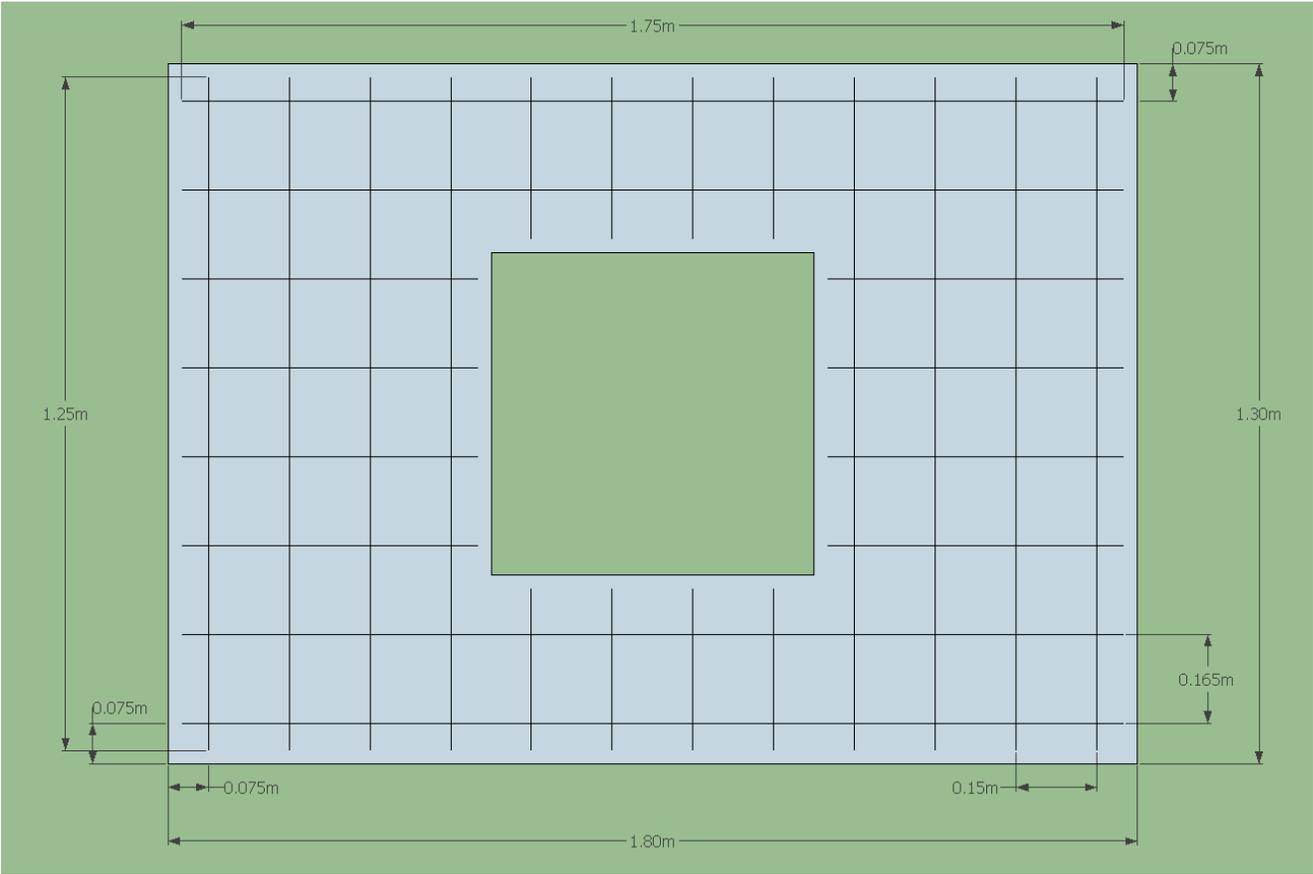
Figure E1: Rebar schematic for top side of spring box

8. Oil the forms with vegetable oil so concrete will not stick to them.
9. Prepare reinforcing rods (shown in Appendix E), and tie together with wire. Handles for the cover (two recommended) can be made using bent rebar, pipe, or other available material. Grids should then be placed in the forms.

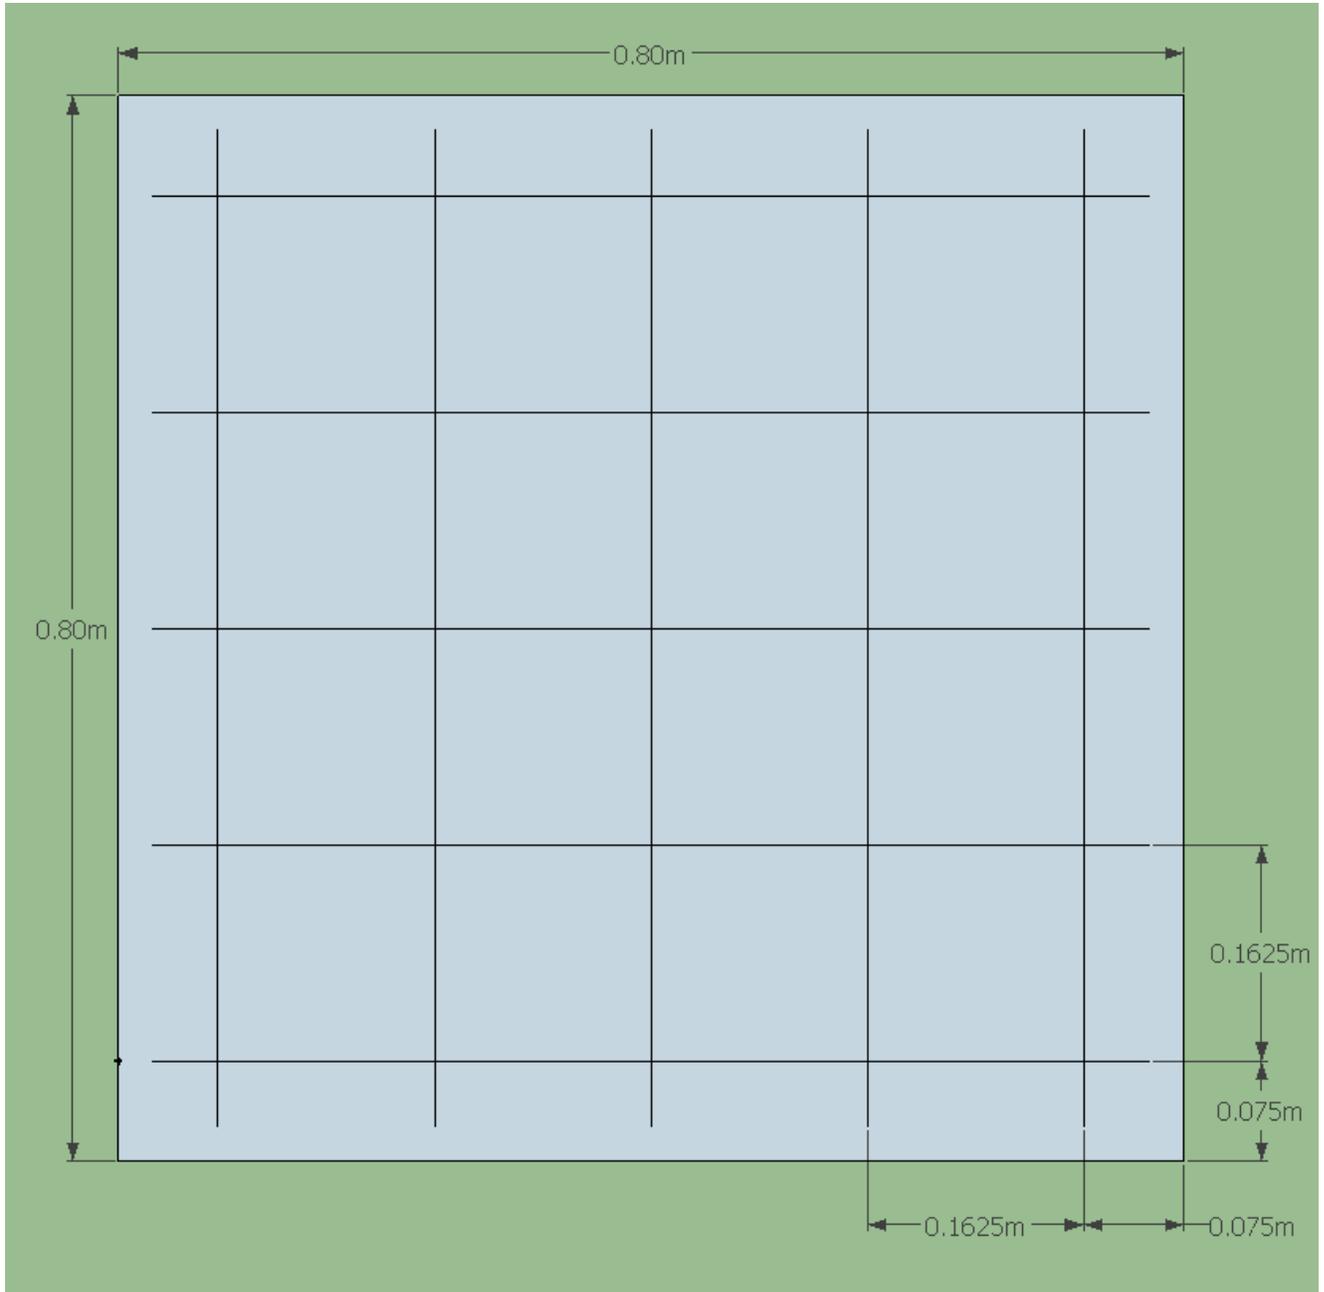
Figure E2: Rebar schematic for cover of spring box

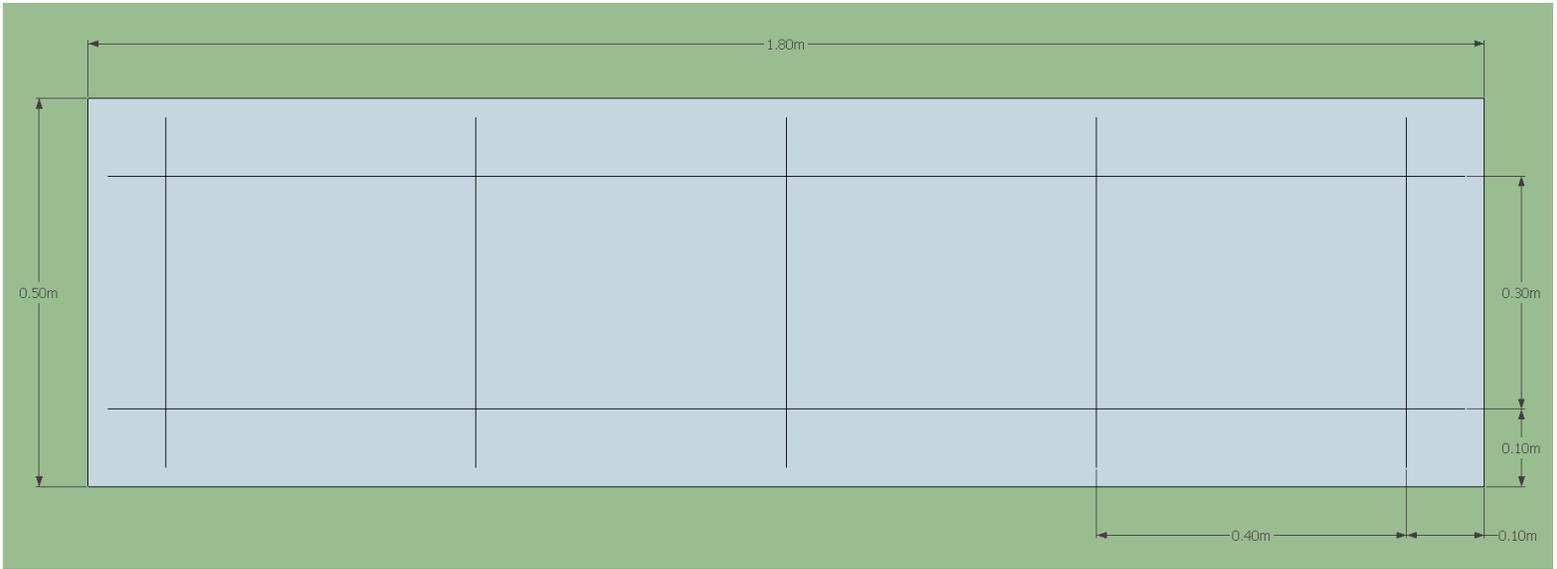
Figure E3: Rebar schematic for front side of spring box

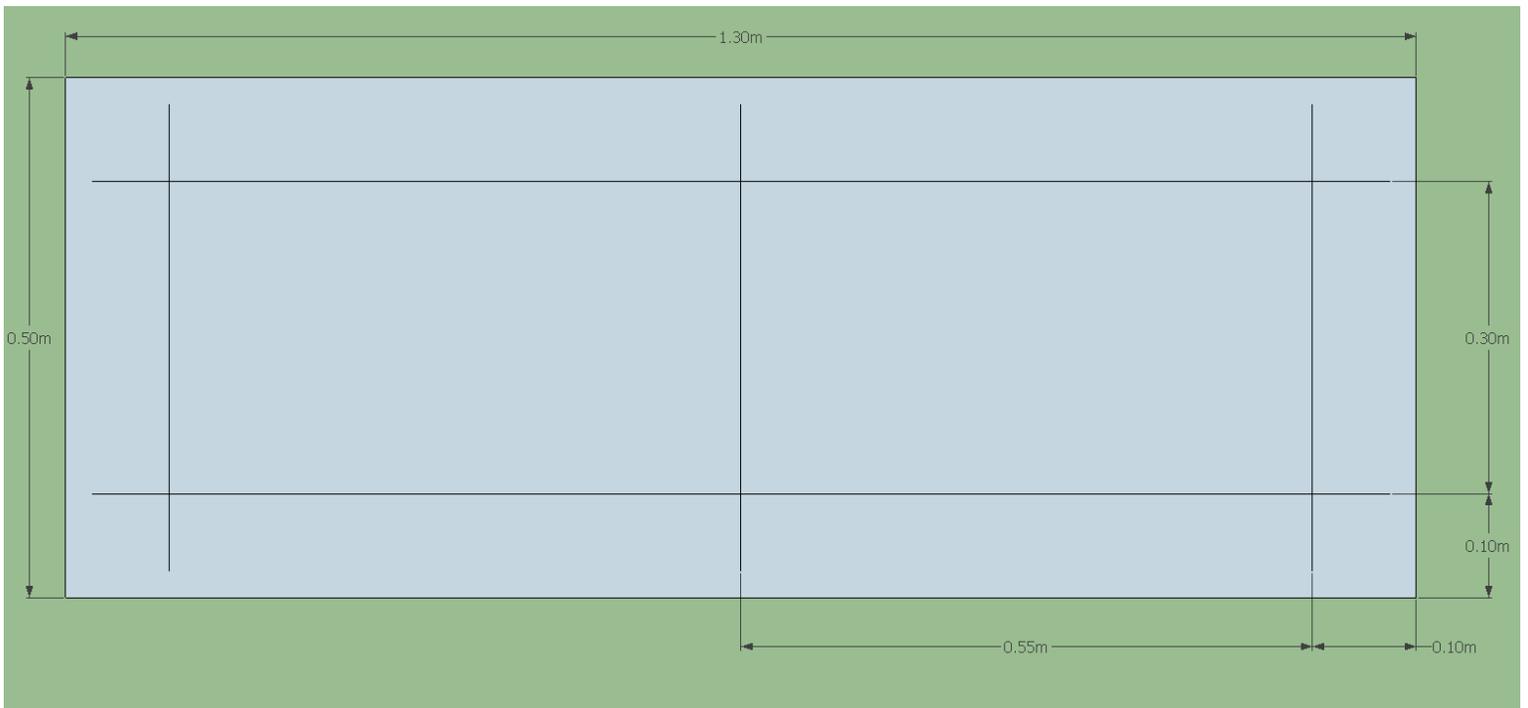
Figure E4: Rebar schematic for left and right side of spring box

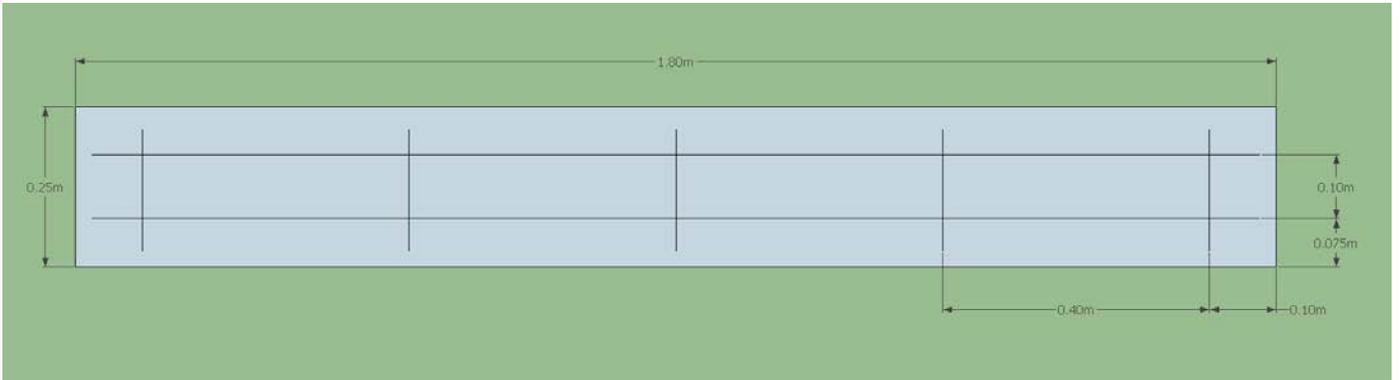
Figure E5: Rebar Schematic for back side of springbox

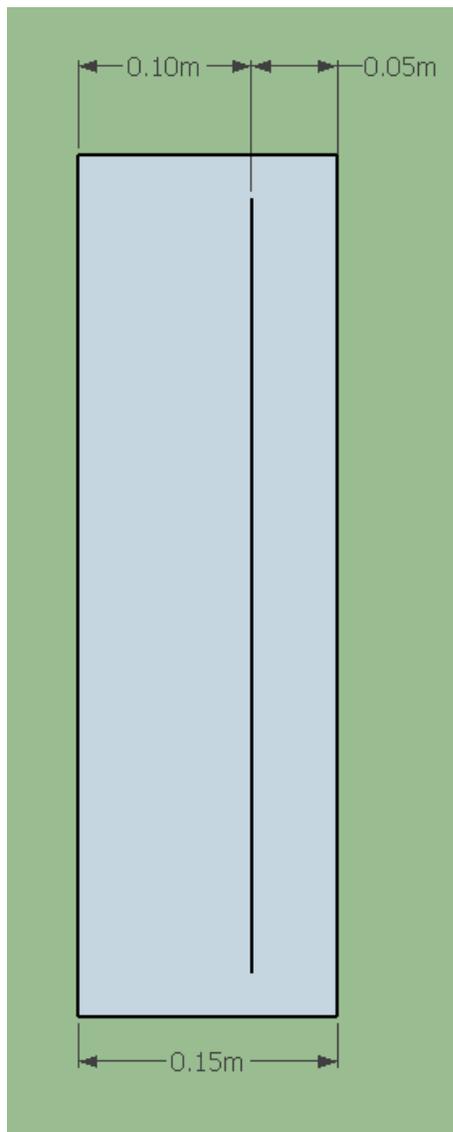
Figure E6: Profile view for rebar placement in all side of springbox
