CHICHICA AQUEDUCT SYSTEM

CHICHICA, PANAMA

• International Senior Design 2011

TMC Engineering

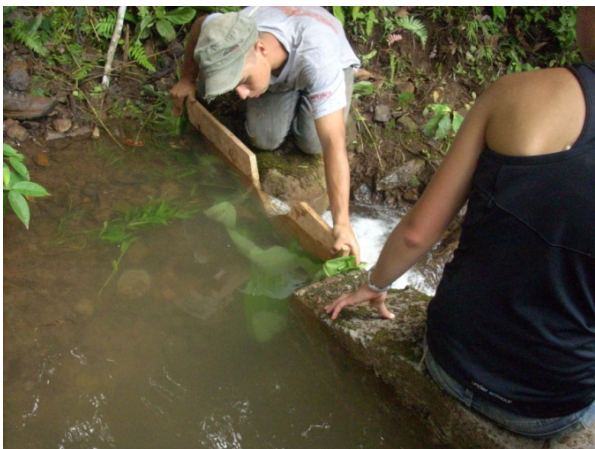
To measure the flow rate in the river, all of the cleanout valves on the dam were plugged and a 60° triangular weir was placed across the spillway. By measuring the height of the water surface from the bottom of the weir the flowrate was calculated as seen in Figure 8. Chris Kingsley, the aqueduct specialist, had done some flow measurements during the dry season at the same location. (Kingsley, 2011) This provided us with an estimate of the annual river flow fluctuations. River flow calculations can be found in Appendix B.

Figure 8. Weir on Spillway of Dam

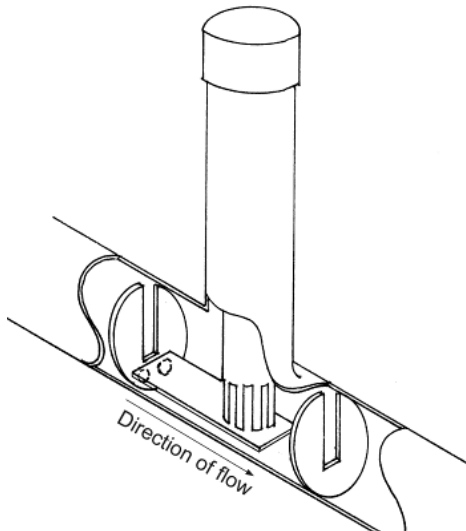
The village of Chichica currently has an in-line chlorinator connected to their gravity-fed potable water system. The current operating system consisting of two spring boxes and one 10,000 gallon tank utilizes the present chlorinator by adding chlorine tablets supplied by the government free of charge. It is unclear as to how often the chlorine tablets are changed and what condition they are in at the time the refill takes place. Essentially, the chlorinator delivers a controlled dosage of chlorine that is sufficient to inactivate most disease-causing organisms. As show in Figures 14 and 15, the flow of water is directed to the center of the chlorinator, allowing a portion of the flow to encounter the chlorine tablets. This drawing does not represent the exact chlorinator found in Chichica, but the function is the same. If the flow of water is increased, the water travels upward in the chlorinator stand pipe and comes in contact with a greater amount of surface area of the tablets. This ensures that no matter the flow rate, the concentration of incoming chlorine will, for the most part, remain constant.

Figure 14. Drawing of Chlorinator Cutaway View

The residual chlorine concentration present in the tank and distribution system is a function of organic matter found in the water. Since the water in the tank was not tested, it is recommending that a chlorination test kit be purchased and the testing be performed. Based on this test, the water committee will know how many chlorine tablets are necessary and how often they need to be changed to keep the residual chlorine level at World Health Organization drinking water standards of 0.2 to 1.0 mg chlorine/L water (Guidelines 2011). The basic calculations for various amounts of tablets may be found in Appendix E and are provided simply as a reference. These calculations do

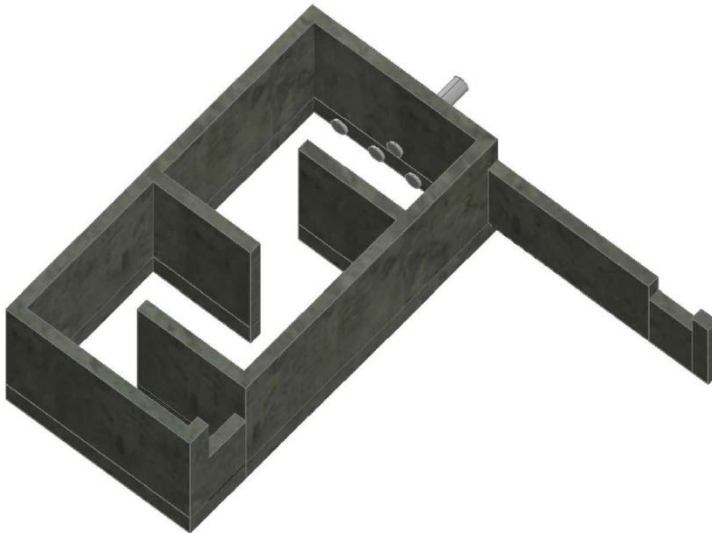
Figure 18. A 3D model of new intake structure. (Note: A concrete floor 4" thick will be built for the intake structure)

The new design addresses the sedimentation issue by adjusting the direction of intake gate perpendicular to the flow of water. The new intake pipe is designed to be placed 1.5 ft. above the bottom floor instead of placing it right on the bottom. This design ensures the function of the intake and requires less frequent maintenance, since it offers more space for settled sediment.

It is recommended that a new intake structure be constructed and the old intake structure removed. The constraints for the intake structure are: (1) no more than fifty percent of the river can be diverted during the dry season, and (2) the intake should filter out sediment in the water during high flows. The existing dam will be used, and all the existing pipes through the dam will be closed. The new structure will be placed on the west river bank. This structure consists of an intake entry perpendicular to the flow of the river. The amount of water entering the intake structure will be regulated by the spillway. The intake spillway will be built to the exact elevation and width as the spillway on the dam. This will prevent too much water from being diverted from the river during the dry season. The intake structure itself is 16' long, 8.5' wide, and 6' tall. All of the walls will be 6" thick and reinforced by rebar. It has three evenly spaced wing walls inside it to slow the water down as seen in Figure 18. The retention time of the water is designed to be 30 minutes so that all of the large and some of the small particles will settle out. The sand filters at the end of the pipeline will filter out the rest of the particles before the water is distributed to the community. See calculations in Appendix K.
