Water for Honey Hill: Supplying Water to the Community of Cerro Miel

iDesign 2012

CERRO MIEL AQUEDUCT SYSTEM

Cerro Miel, Panama

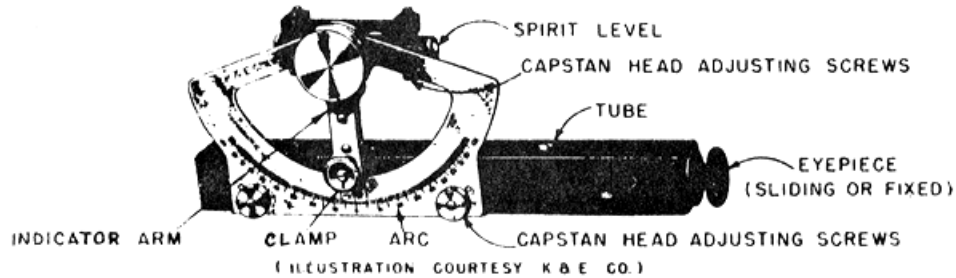
Figure 1: Abney Level Diagram
(fao.org)

During the assessment trip to Cerro Miel, a topographical survey needed to be performed of the existing and proposed pipeline. Some of the options that were available were to use a Total Station, a theodolite survey, or an Abney level and GPS. Due to the rugged terrain of the region, Uno Más decided to employ the use of an Abney level and GPS to survey the existing and proposed pipeline. An example of an Abney level is presented in Figure 1.

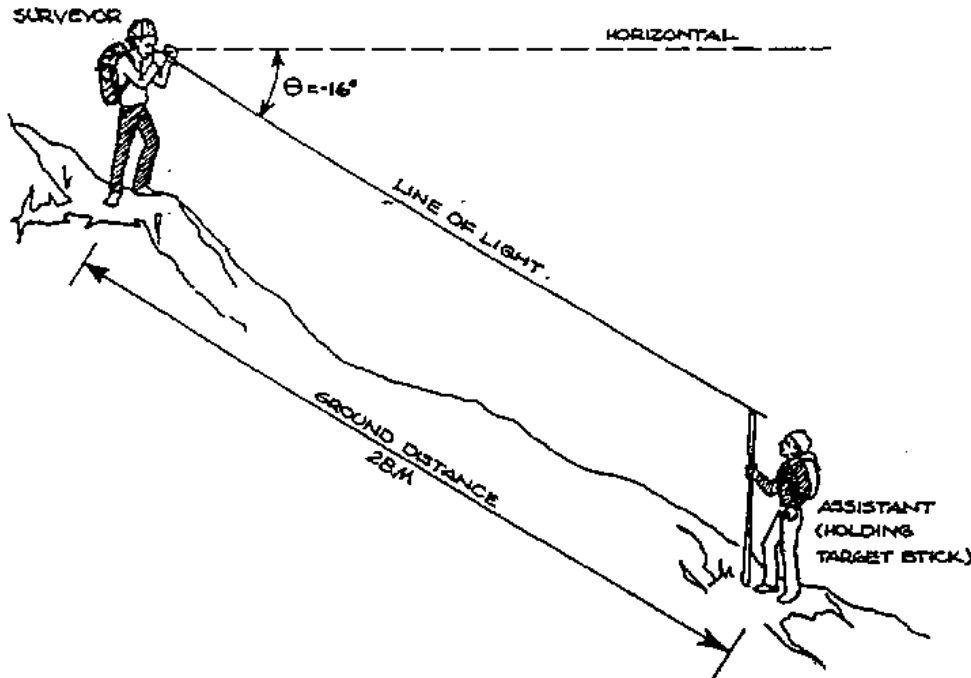
Figure 2: Abney Leveling Method
(nzd1.org)

The surveying was completed using the setup found in Figure 2. Each person in the figure makes a reading with the Abney level and a compass bearing. A GPS point is taken at each location. A total of 7 miles of surveying was completed within the community of Cerro Miel.

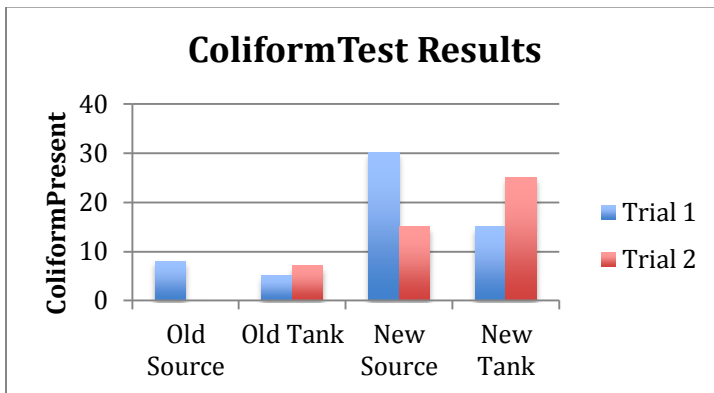
Figure 3: Coliform Bacteria Test Results

During the assessment trip in August, two types of water quality testing were conducted: coliform bacteria tests and aerobic bacteria tests. This was done using 3M Petrifilm plates. At each location where water quality information was considered useful, two samples of each test were taken to reduce the uncertainty of the sample results. The locations sampled were the spring box and tank of both the old and the new system. One ml of water was placed onto a biofilm using a clean disposable pipette before the biofilm was pressed and labeled. The samples were then incubated using body heat for 24 hours. The colonies of bacteria were then counted and recorded. The results from these tests are presented in Figure 3 for the coliform bacteria and Figure 4 for the aerobic bacteria.

These tests show that the water in both the spring box and the tank of the old system have a relatively low number of coliform bacteria. Coliform bacteria are commonly used as an indicator organism for drinking water supplies. Absence of coliform bacteria indicates that there are no disease-producing organisms in the water. The presence of coliform bacteria does not necessarily mean that the water is contaminated, because some coliform bacteria are found naturally in soils, but it is still used as an indicator of poor water quality [Metcalf & Eddy, p. 117-118]. Additionally, the test results show that the old system has a low count of aerobic bacteria, which can also be used as an indicator of water quality. The new system, on the other hand, had a much higher count in both coliform bacteria and aerobic bacteria. This indicates that the water quality is not as good

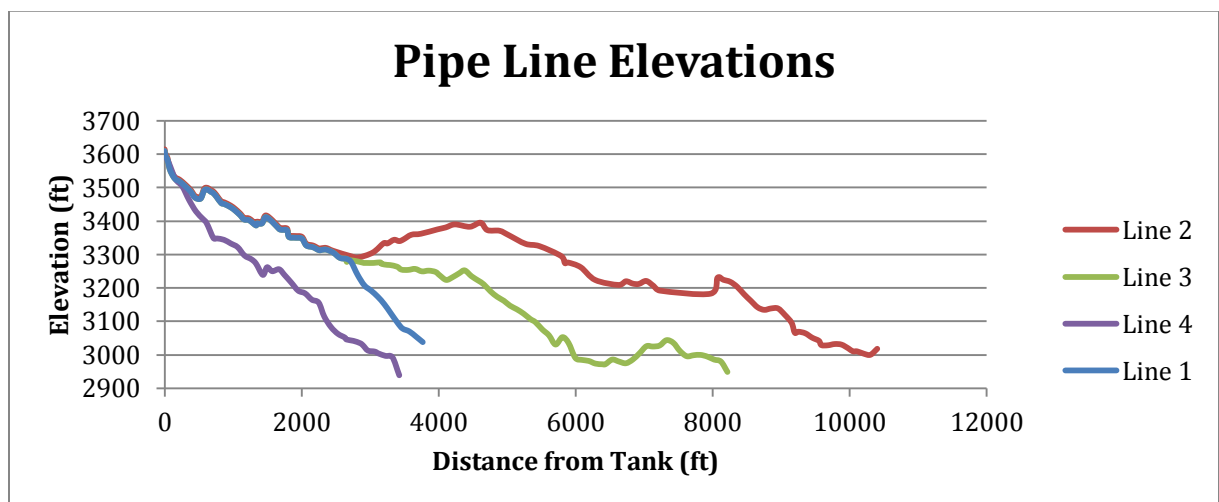
Figure 5: Pipe Line Elevation Profiles

During the assessment trip, it was evident that the pipeline would travel over a very large elevation drop for each of the proposed lines. Elevation drops will cause increased pressure buildup to occur within the pipes. In order to quantify the elevation drop that each pipeline would need to travel, an elevation profile was made using data from the Abney level survey. The elevation plot can be found in Figure 5.

From the elevation profiles shown, it can be seen that Line 4 is the line that will experience the greatest elevation difference, and therefore experience the highest pressure within the pipes. The elevation plots for each line aided in determining where pressure and air release would be required for the project.

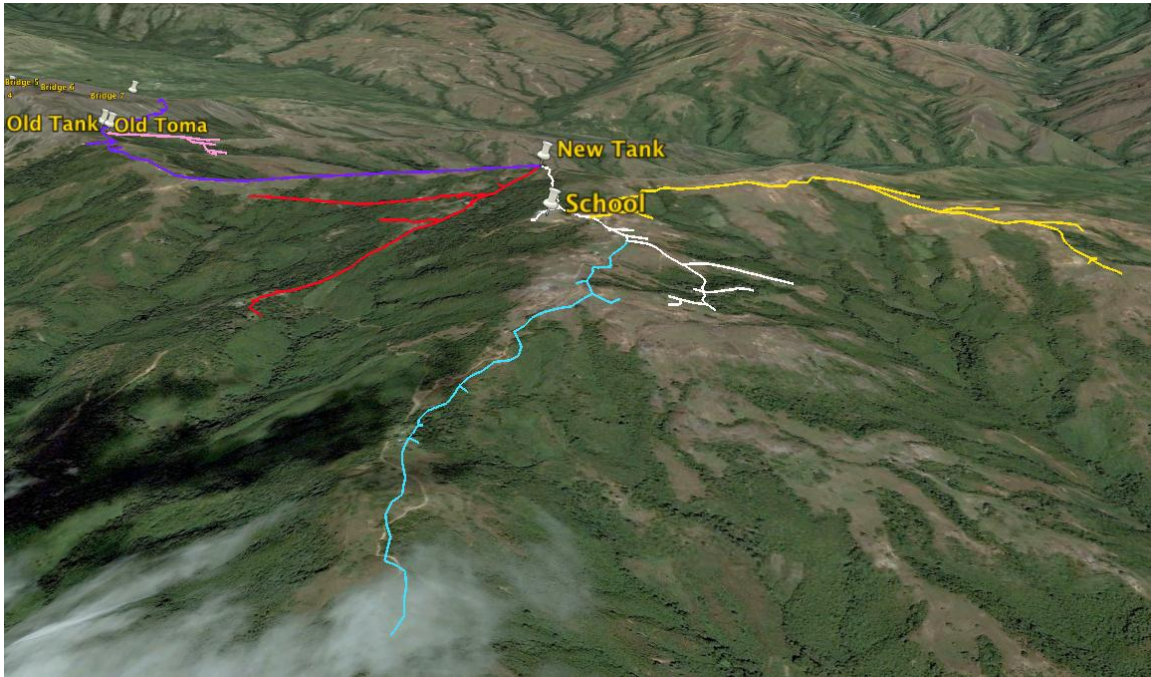
Figure 6: 3D Layout of Pipeline in the Community

The Google Earth maps were used to find lengths of piping for the entire system. The total length of pipe in the system is 16.2 miles. The longest section is the 9 mile supply line from the water source above Tugri to the tank in Cerro Miel. Seven miles of pipe are located within the community.

Figure 6 shows the main lines in the community. They are organized by distinct colors. The purple line is the supply line for the New Tank, which is located at the high point in the community and is the main water supply. The Old Tank is located to the northwest of the community and only supplies Line 6, which includes 8 homes.

After all of the data was sorted, Google Earth was used to compile the GPS survey data to make a map of the entire system (Figure 6). In order to get the survey data into Google Earth in an easy to edit format, the system lines and locations of taps were created as kml files and edited using Text Edit. This allowed the team to make changes to their system quickly and easily. An example of the code used to draw the lines and place the taps is included in Appendix D and an actual copy of all of the code is included on the supplemental CD. Examples of maps of the system are included in Appendix E for reference.

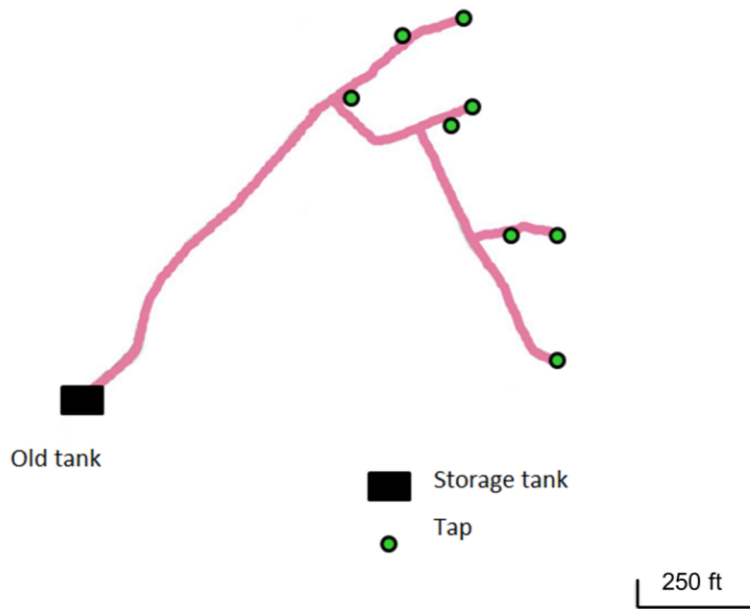
Figure 9: EPANET Model of Expansion of Old System

The team found that it would not be feasible to install a pressure break tank at line 5. The reason for that is that there was no location where it could be placed that would at the same time provide enough pressure for the water to run over a hill and provide adequate relief at the end of the line. This section, consisting of 8 houses, was therefore taken off the new system and attached to the old. The school is now attached to the new system.

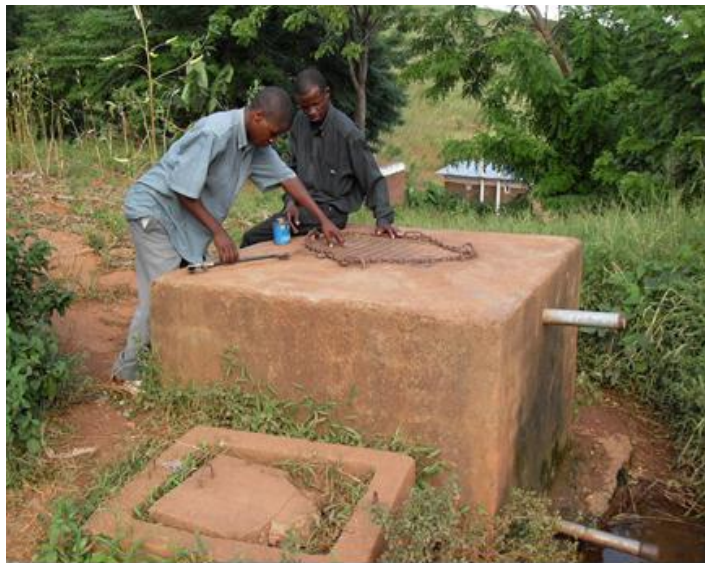
Figure 10: Example of Mason-Break Pressure Tank [Barefooteconomics.com]

The mason-break pressure release tank resembles a small water storage tank. An example of the mason-break tanks can be found in Figure 11. A schematic of the mason-break pressure tank the has been designed for Cerro Miel can be found in Figure 12.

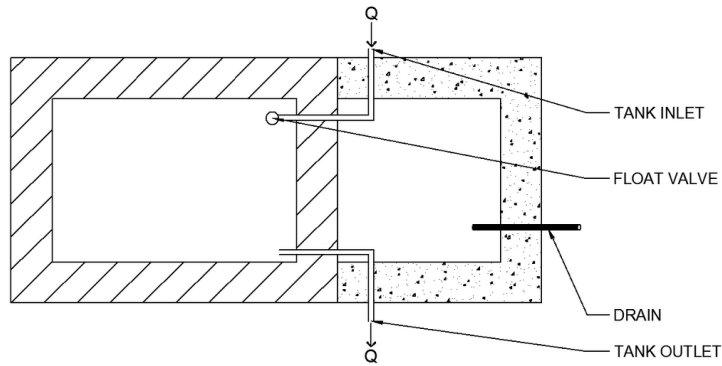
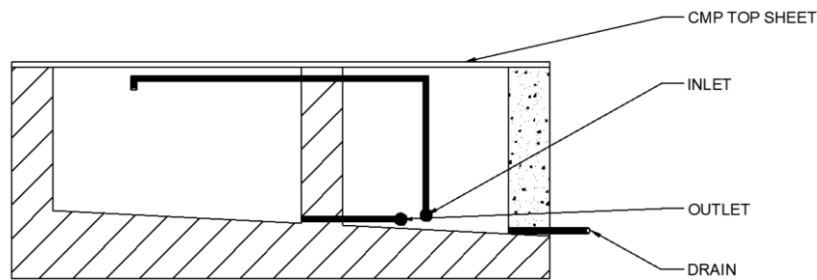
Figure 11 : Mason-Break Pressure Release Tank Diagram

TOP VIEW

PROFILE VIEW

The tank itself is made of concrete. A float valve is located inside the tank to prevent overflows. The design volume of the pressure tank is $8.27ft^3$, with a wall thickness of 8 in and a base thickness of 12 in. There are a few advantages to using a mason-break pressure tank, the main one being durability. Since the tank is made of concrete, the tank will be much less likely to break than other pressure release options. Another advantage is the float valve incorporated in the design, which serves as a water saving device.

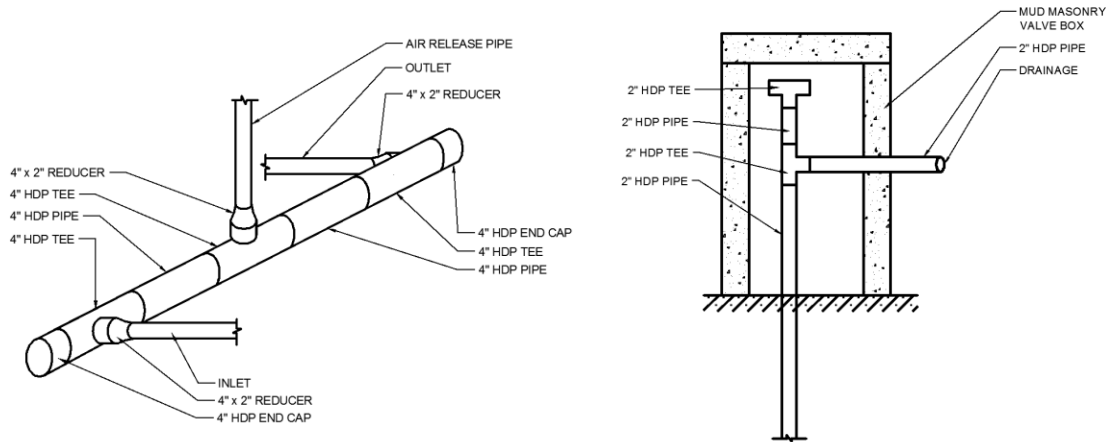
Figure 12: HDP Tank Schematic

The HDP tank is buried beneath the ground. When operating at steady state, water from the pipeline enters through the inlet. Pressure is released via a drainage pipe at the surface. HDP pressure tanks are an ideal option for the Cerro Miel aqueduct because they are inexpensive and easy to construct. A disadvantage to the HDP tank design is that there is no valve incorporated into the design; therefore, water may continually discharge from the pipe when the flow is disrupted. Although water supply is not an issue, the discharge can cause erosion if a properly designed discharge channel is not included in the system.

An HDP tank operates in the same manner as the mason-break pressure tank. The tank itself is made up of HDP pipe. A schematic of the HDP tank designed for Cerro Miel can be found in Figure 13.

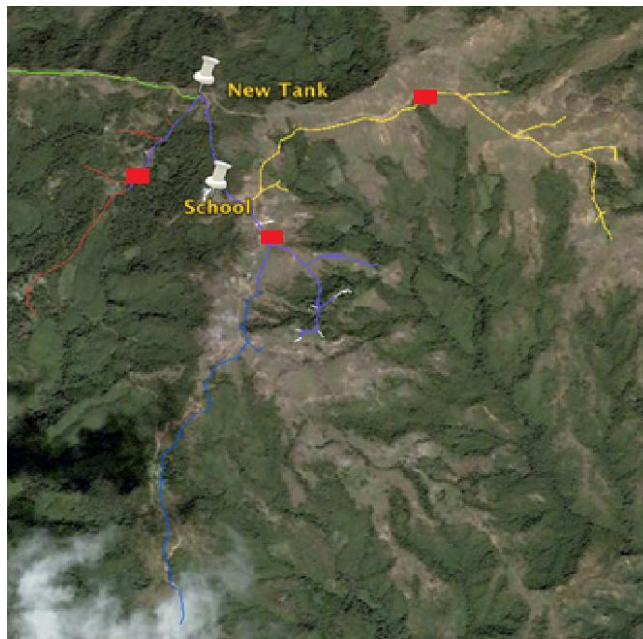
Figure 13: Location of Pressure Break Tanks

There will be four pressure tanks required for the Cerro Miel aqueduct system. Three of the tanks will be located within the community of Cerro Miel. Figure 13 shows the location of these pressure release tanks.

Uno Más recommends that these three tanks located within the community be the mason-break pressure design. These tanks will be much more durable than the HDP tanks. The float valve will also help prevent water from being wasted in the community. The mason-break pressure tanks will provide for a long-term solution to the pressure release requirements in Cerro Miel. A fourth pressure tank will be required near the tank in Tugri. High pressure for the slow sand filter and in-line chlorinator located there has made maintenance dangerous. To release the pressure at this location, Uno Más recommends an HDP tank be installed. Although an HDP tank is less durable than the mason-break pressure tank, at this location it is more feasible to install the HDP tank. In the future, the option may arise to locate the sand filter and chlorination tank at the storage tank in Cerro Miel. If this is done, the pressure tank in Tugri will not be needed. Since the pressure release tank in Tugri is not meant to be a long-term solution, the HDP tank is recommended at that location. The drawings for the two tanks can be found in Appendix G.

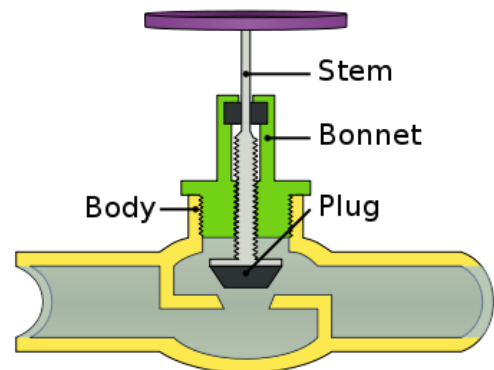
Figure 14: Globe Valve [Aimonen]

At the location of the highest velocity shown in the EPANET model, the pressure increase due to water hammer is 54,949 psi. If the valve is closed quickly, this could damage the system. To counter the increase in pressure from water hammer, alternative valves can be used. Slow turning valves will reduce water

hammer. A globe valve is recommended to be used to accomplish this. An example of a globe valve can be found in Figure 15.

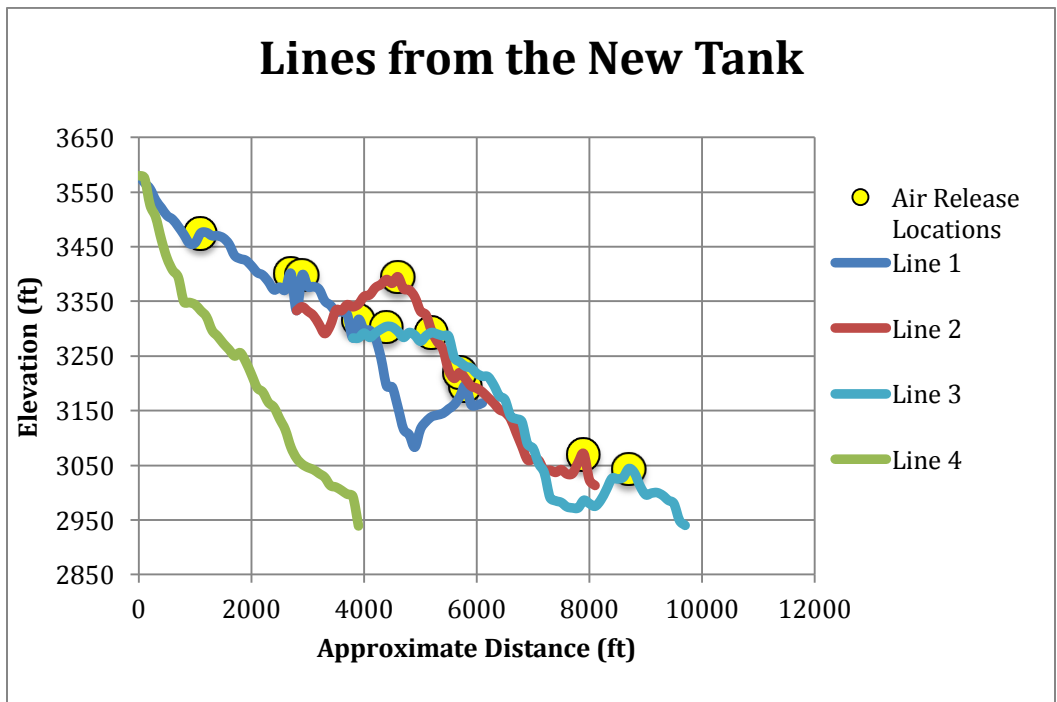
Figure 15: Air Release for Lines 2 and 5

To design for air release in the community air release locations were first identified. Locations chosen were those with a high point that was at least 20 higher than the pipe nearby on either side. To find these locations, elevation profiles from each line were used to find high point. Eleven points were found on the lines that come from the main tank and one additional location was found on Line 6 off the Old tank. There are also eleven locations where air release valves are recommended when the supply line to Tugri needs to be replaced. Figure 15 below shows the locations on the lines from the new tank.

In this figure the yellow circles indicate points where air release is recommended.

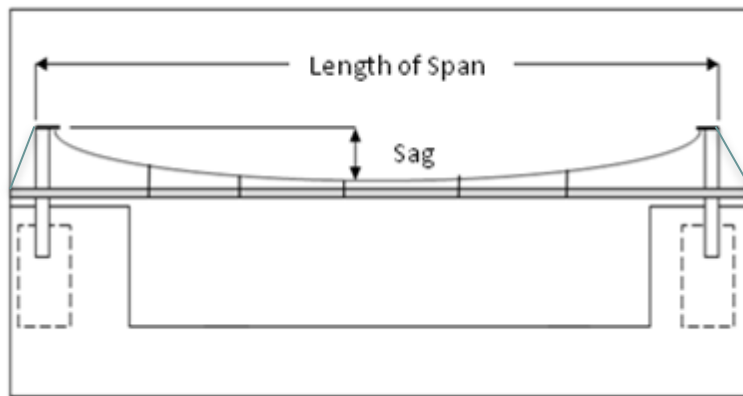
Figure 16: Gully Suspension Bridge

There are seven gullies on the supply line from Tugri to Cerro Miel that were require support. Constructing cable bridges at these points will make the system more reliable. For these cable bridges, an initial sketch of the design was made, as shown in Figure 16. This design is recommended because the pipe is supported equally along the length of the pipe.

When designing this system, there were a few constraints that had to be considered. First, the size of pipe that the bridge would support was known. From that data, the weight of the pipe could be determined as well as the weight of the water that would be flowing in the pipe. Also, the spans of the each bridge were known. Lastly, change in elevation was determined for each of the gullies. A difference in elevation will lead to changes in the shape of the bridge.

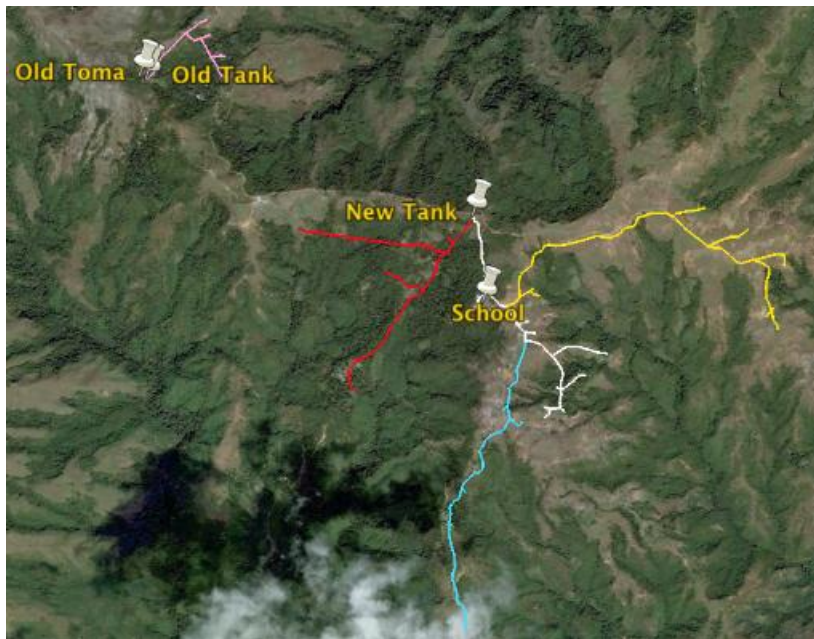
Figure 17: Map of Pipeline

Before the pipeline can be constructed, the path that the pipeline will follow must be cleared of any debris, foliage, or large rocks. The path to be cleared can be found in the map below. The path is approximate, but should follow the map in Figure 17 as much as possible.

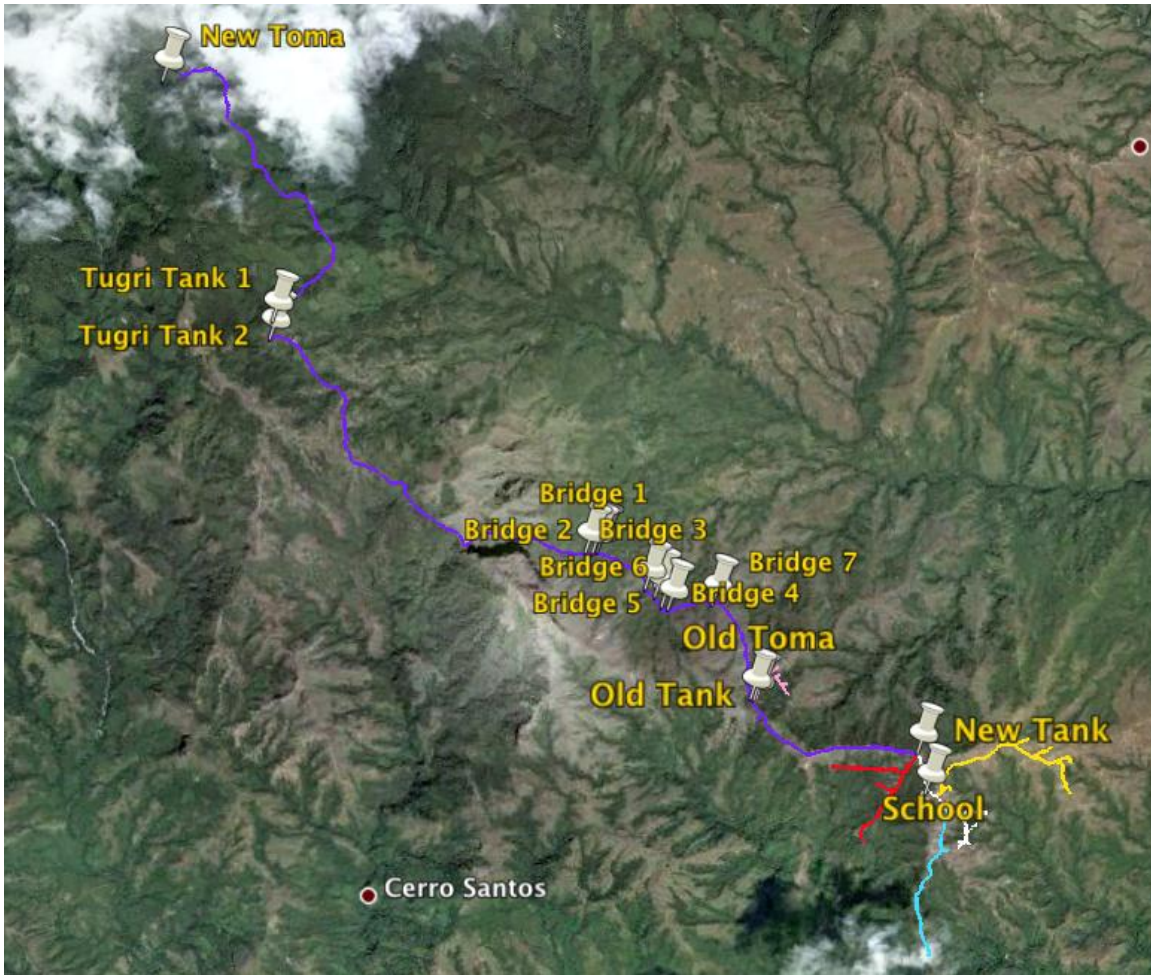
The water for this project comes from a small river in the mountains northwest of the community of Tugri. The line then comes down to Tugri where it is filtered and chlorinated and enters a tank (Tank 1 Tugri). From there the water travels to the New Tank in Cerro Miel and is distributed in the supply lines as shown above. There are several places between Tugri and Cerro Miel where the pipe crosses large gullies and is unsupported these places. These places labeled as bridges above, are the proposed locations of the cable suspension bridges.

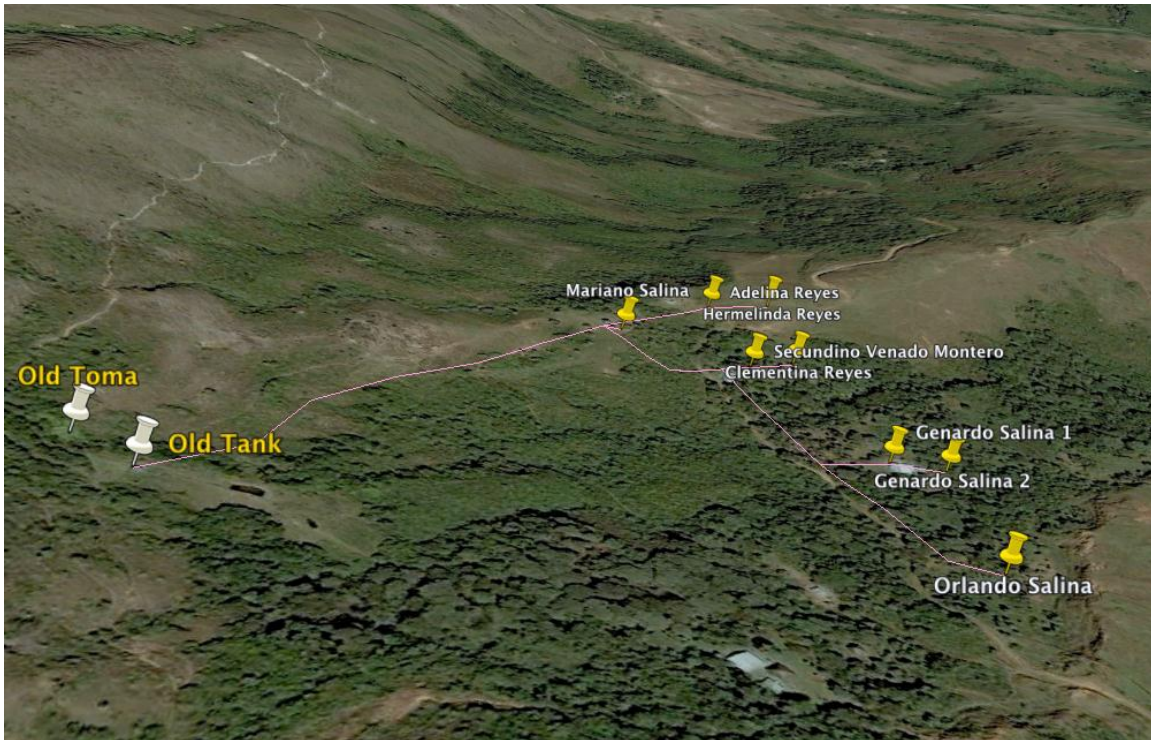
The image above shows the houses that were changed from the New System to the Old System to alleviate pressure issues. The pipe from the New System would have to cross the large hill located on the left, which was the cause of the pressure problems.

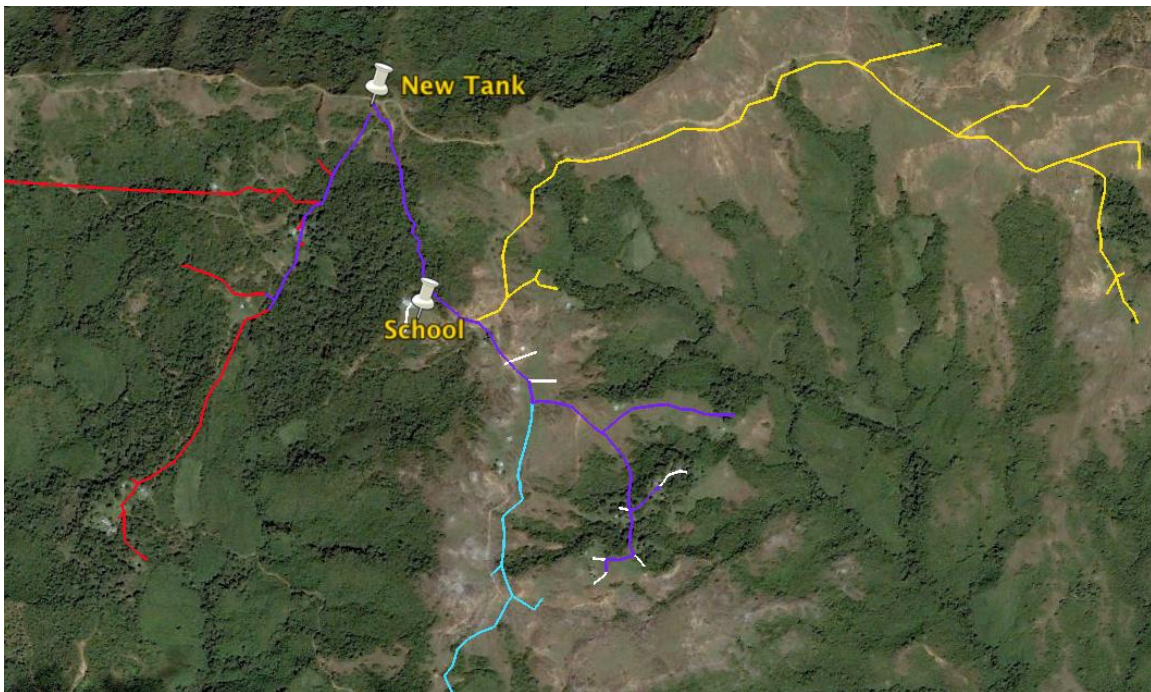
Here, all the pipeline in Cerro Miel that is currently in existence is highlighted in purple. Much of this pipeline is in poor condition and will need to be replaced anyway.

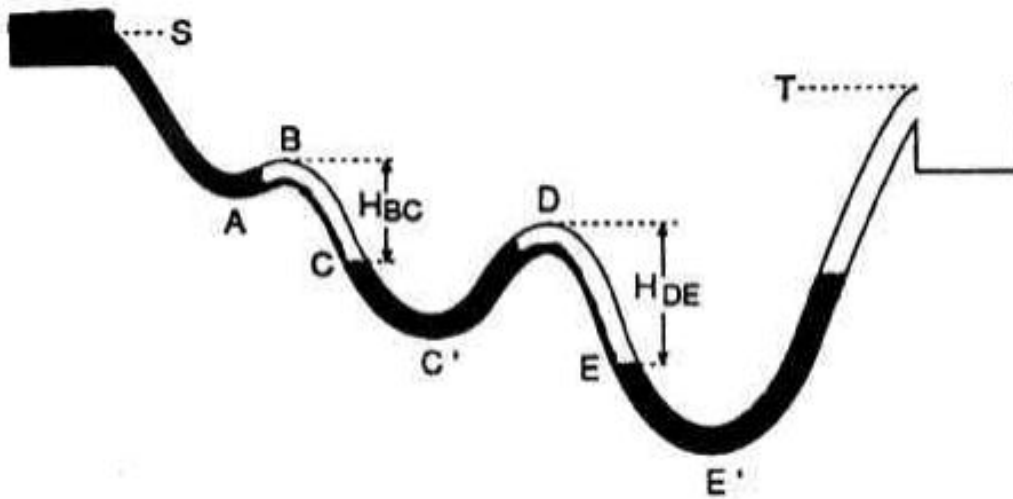
This diagram is useful for understanding how air collects in water distribution pipes.

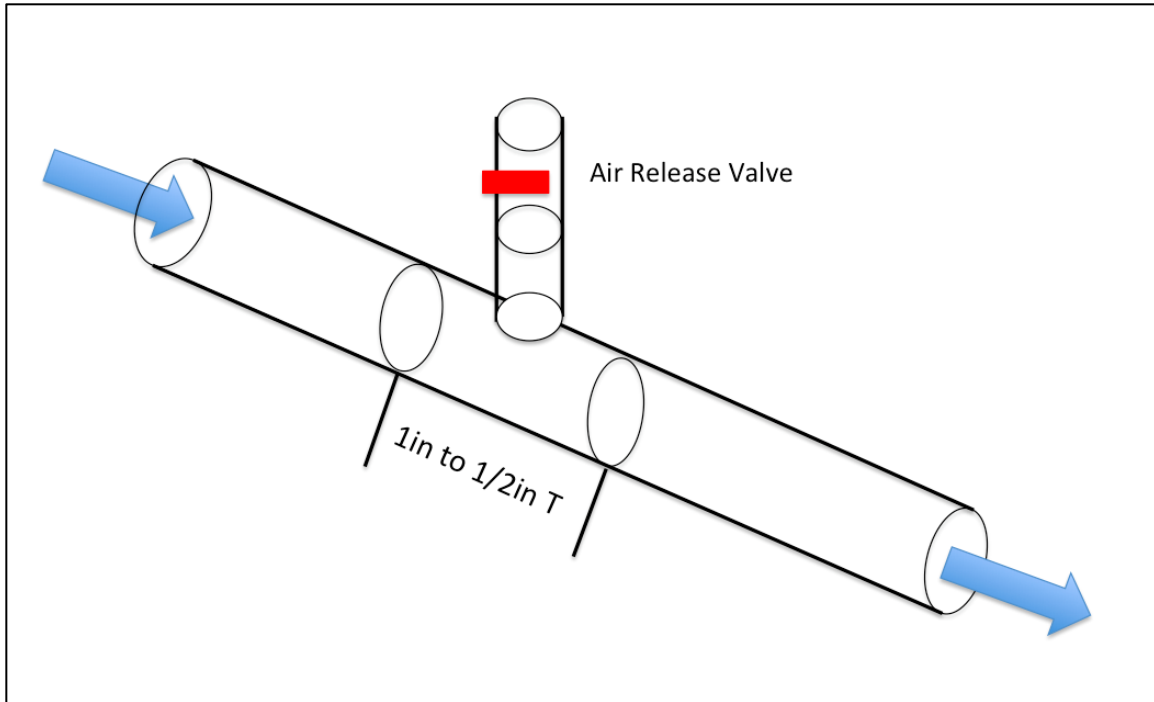
This figure shows how the air release valves will be installed in the system.

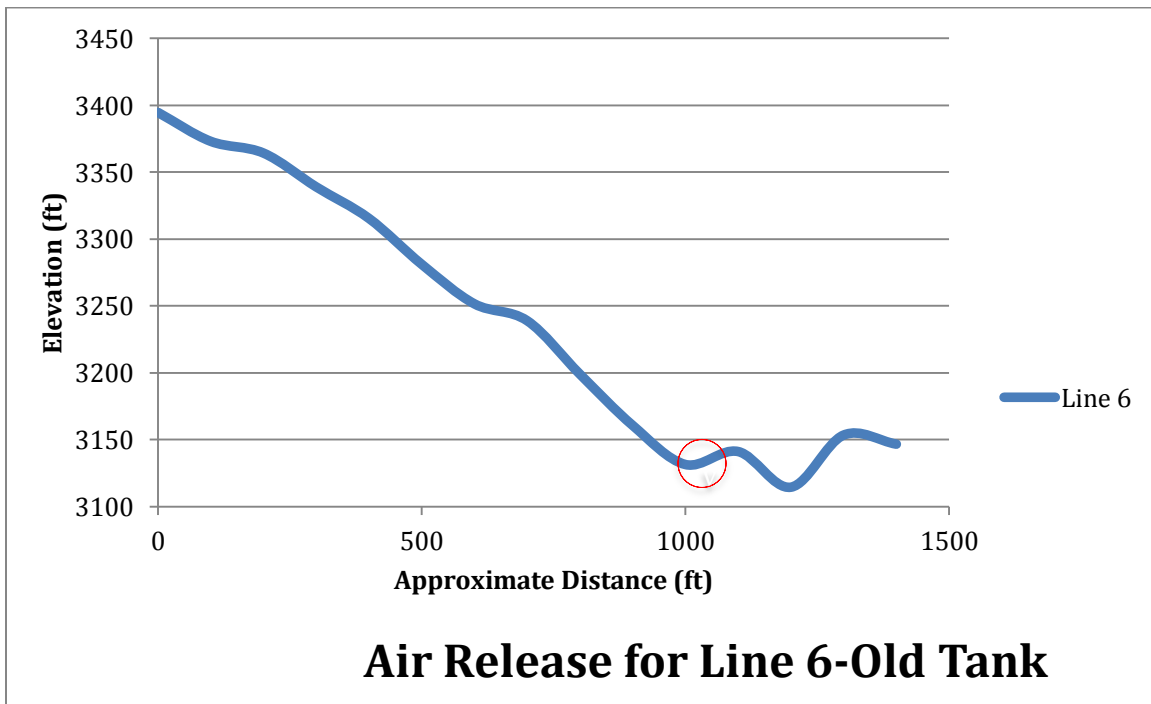
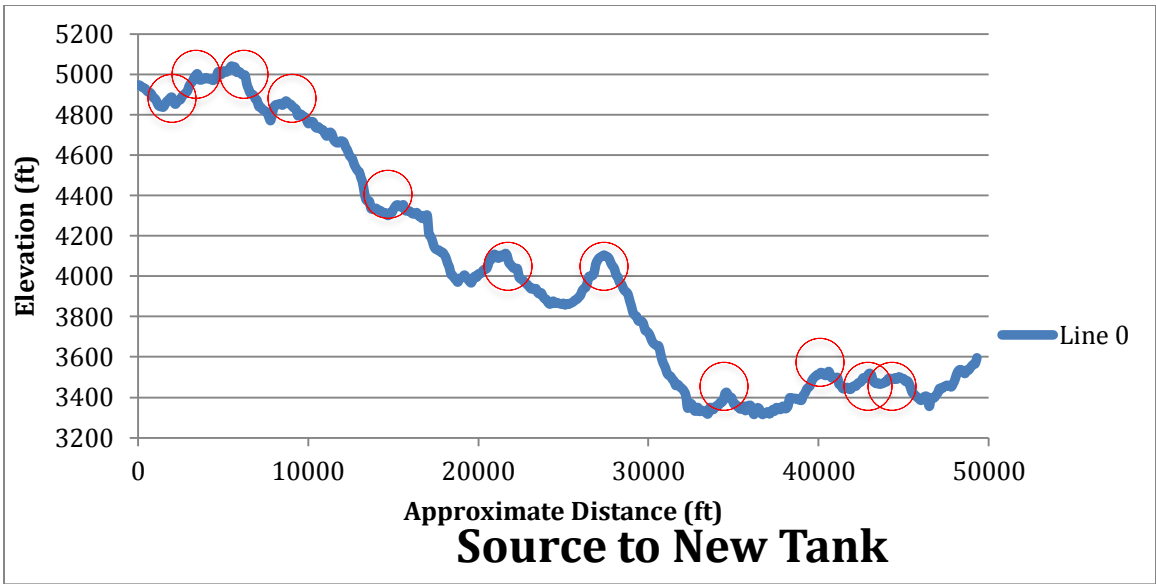
This appendix is meant to give the reader a better understanding of air block problems, and air relief in this system. The two graphs in this appendix are the elevation profiles used to determine the locations where air release would be necessary for the supply line and Line 6. Due to the fact that much of the data collected for this system was done using a GPS these elevation profiles were made from the elevations collected by the GPS data assuming 100ft between each reading. .

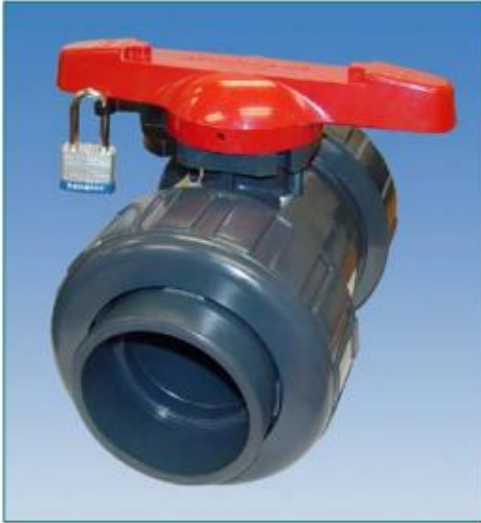
This is the chosen option for air release in the community. The locking handle provides extra security and the valve is relatively easy to install. The cost of each valve is \$15 not including the padlock.
